Visual Site Inspection Report

Project Name	H-600 Pipeline Spread H	AFE	124300138	Spread	H-600 Pipeline Spread H
Contractor	Precision			Report #	8880
Inspector	Dustin Lyons			Date/Time	10/5/2018 6:13 AM
Permit #	TBD	Inspection Type	VA SWPP	Station Begin	12005+00
State	VA	Inspection Area	Partial	Station End	12072+00
County	Montgomery	Ground	Dry	Temperature (°F)	76.00
Municipality	N/A	Weather	Cloudy	Rain Gauge (in)	0.00
GPS Location	37.2706822213133, -80.3143766988817			Rain Accumulation Time (days)	1.00

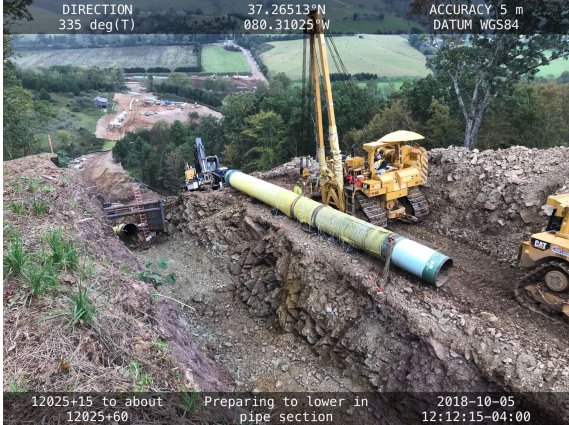
<p>DIRECTION 335 deg(T) 37.26513°N 080.31025°W ACCURACY 5 m DATUM WGS84</p> <p>12025+15 to about 12025+60 Preparing to lower in pipe section 2018-10-05 12:12:15-04:00</p>

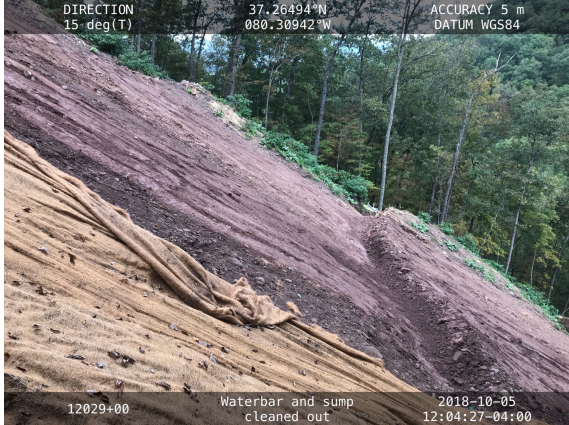
<p>DIRECTION 15 deg(T) 37.26494°N 080.30942°W ACCURACY 5 m DATUM WGS84</p> <p>12029+00 Waterbar and sump cleaned out 2018-10-05 12:04:27-04:00</p>		GPS Location 37.2658070549716, -80.3106931038949 Description See photo for gps data. Photo shows the contractor preparing to lower a pipe section between 12025+15 and 12025+60.	GPS Location 37.26589808244, -80.3106097877774 Description See photo for gps data. Photo shows the water bars cleaned out between 12028+00 and 12030+00.

7. Identify all remedial measures that have been taken since the previous inspection was conducted. The following items were performed in this area since the last SWPPP inspection: - waterbars and sumps were cleaned out between 12028+50 to 12029+94 (punch list item 1190) - Sumps from 12048+00 to 12051+00 were cleaned out (includes area of punch list item 1195) - P-1 silt fence on the west side of the ROW at 12064+80 and 12067+50 was cleaned out (punch list item 1275) - Waterbar end treatment at 12068+30 was cleaned out and reconstructed.					
Comments (Reference above questions as appropriate.) I completed the SWPPP inspection from station 12005+00 to station 12072+00 today. The rain gauge at Catawba indicated no measurable rainfall since yesterday morning or since the last SWPPP inspection. No impacts were observed to streams S-G36, S-G38, S-G39, S-G40 or S-PP23. No off-ROW impacts were observed. PPL's environmental crew (Matt Myers-foreman) addressed a few issues in this section today. They reinstalled the SSF along the west side of SG40 at 12035+00, in order to key-in the wire and fabric at its base. They placed curlex on the slope adjacent to SG40 near the bridge, placed CFS adjacent to SG39 at the footpath crossing, stabilized the footpath with seed, mulch, and curlex, and repaired damaged P1 on the west side of the ROW at 12049+80. WSSI personnel (Matt Brand and Ben Farmer) were on the ROW to resurvey the post-construction stream profiles at S-G40 and PP23. PPL's tie-in crew (Zane Hudson - foreman) worked on the tie-in weld at about 12036+75 and continued to excavate trench from about 12037+50 to about 12038+50. Small amounts of water continued to seep into the trench near the tie-in weld. The contractor used the dewatering structure adjacent to SG40 during the trench dewatering. Tim Neal (UI) observed Zane's activities. PPL's tie-in crew (Sam Litton - foreman) lowered in a section of pipe from about 12025+15 to about 12025+60. At about 1:30 pm the crew was addressing fit-up issues associated with this section. Welton McAdams (weld inspector) and Cody Benally (UI) observed these activities.

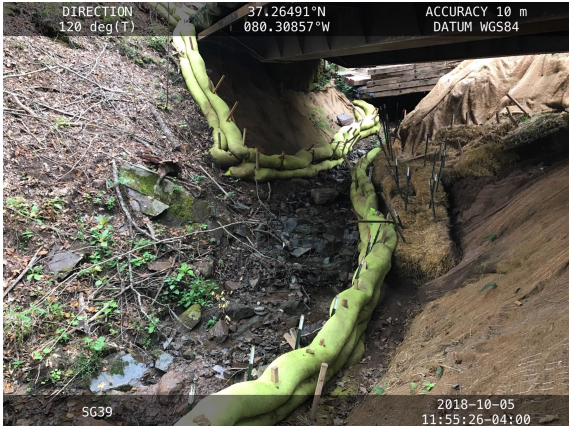
<p>DIRECTION 120 deg(T) 37.26491°N 080.30857°W ACCURACY 10 m DATUM WGS84</p> <p>SG39 2018-10-05 11:55:26-04:00</p>

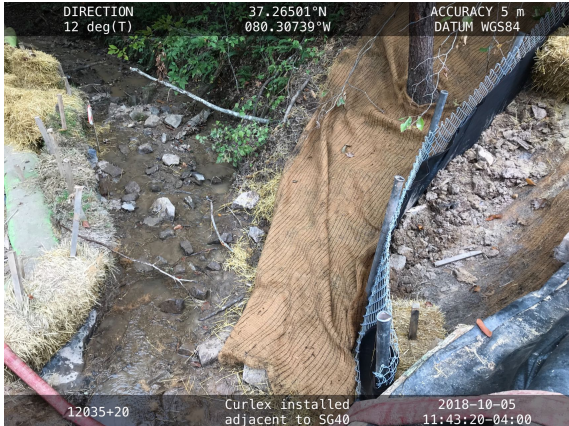
<p>DIRECTION 12 deg(T) 37.26501°N 080.30739°W ACCURACY 5 m DATUM WGS84</p> <p>12035+20 Curlex installed adjacent to SG40 2018-10-05 11:43:20-04:00</p>		GPS Location 37.26589808244, -80.3106097877774 Description See photo for gps data. Photo shows the general condition of SG39. No issues observed.	GPS Location 37.26589808244, -80.3106097877774 Description See photo for gps data. Photo shows the culx installed adjacent to SG40, below the bridge.

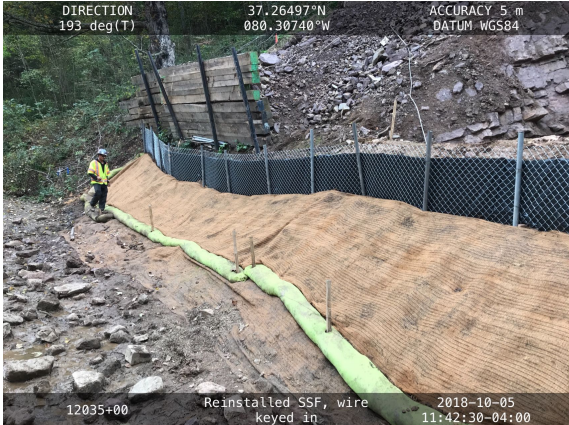
<p>DIRECTION 193 deg(T) 37.26497°N 080.30740°W ACCURACY 5 m DATUM WGS84</p> <p>12035+00 Reinstalled SSF, wire keyed in 2018-10-05 11:42:30-04:00</p>

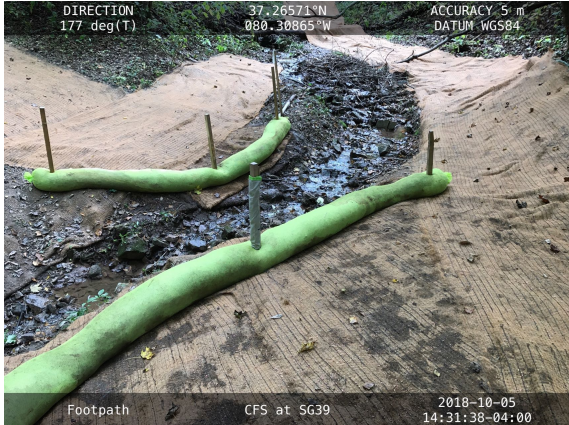
<p>DIRECTION 177 deg(T) 37.26571°N 080.30865°W ACCURACY 5 m DATUM WGS84</p> <p>Footpath CFS at SG39 2018-10-05 14:31:38-04:00</p>		GPS Location 37.265862417442, -80.31065111056 Description See photo for gps data. Photo shows the SSF reinstalled on the west side of SG40 at about 12035+00.	GPS Location 37.265862417442, -80.31065111056 Description See photo for gps data. Photo shows CFS installed adjacent to SG39 at the footpath crossing.
