Visual Site Inspection Report

Project Name	H-600 Pipeline Spread H	AFE	124300138	Spread	H-600 Pipeline Spread H
Contractor	Precision			Report #	6148
Inspector	Glenn Mike Renfro			Date/Time	8/10/2018 2:25 PM
Permit #	TBD	Inspection Type	VA SWPP	Station Begin	13415+00
State	VA	Inspection Area	Full	Station End	13670+00
County	Franklin	Ground	Damp	Temperature (°F)	88.00
Municipality	N/A	Weather	Cloudy	Rain Gauge (in)	0.00
GPS Location	36.9719059900255, -79.8701022102051			Rain Accumulation Time (days)	1.00

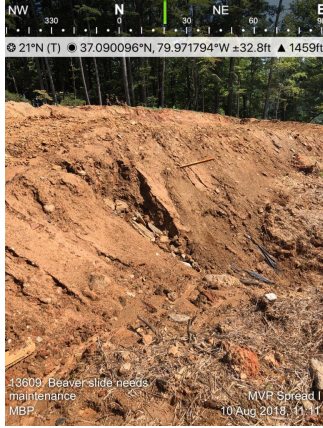
GPS Location	36.9719329344101, -79.8701219030284	GPS Location	36.9719316266162, -79.8701220950319		
Description	At kickoff looking at the GAS.	Description	Beaver slide at 13609 in need of maintenance.
