Visual Site Inspection Report

Project Name	H-600 Pipeline Spread H	AFE	124300138	Spread	H-600 Pipeline Spread H
Contractor	Precision			Report #	8849
Inspector	Glenn Mike Renfro			Date/Time	10/4/2018 1:15 PM
Permit #	TBD	Inspection Type	VA SWPP	Station Begin	13415+00
State	VA	Inspection Area	Full	Station End	13670+00
County	Franklin	Ground	Damp	Temperature (°F)	82.00
Municipality	N/A	Weather	Sunny	Rain Gauge (in)	0.00
GPS Location	36.9719216460706, -79.8699479923396			Rain Accumulation Time (days)	0.00

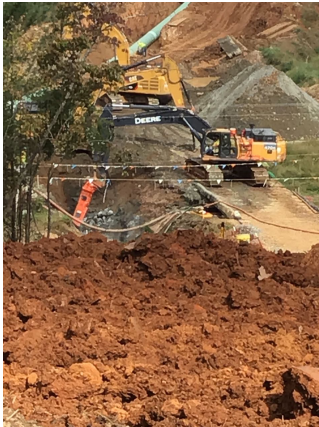
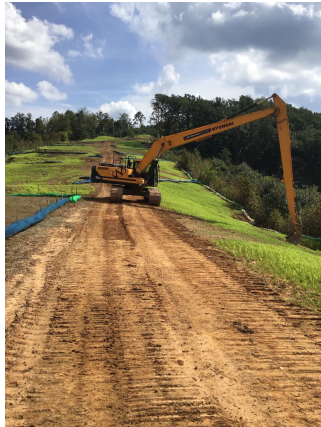
GPS Location	36.9718748336985, -79.8701502141847	GPS Location	36.9719188998186, -79.8701779683092		
Description	stream crossing activities at 13498+00 in progress.	Description	CFS maintenance operations at 13444+93

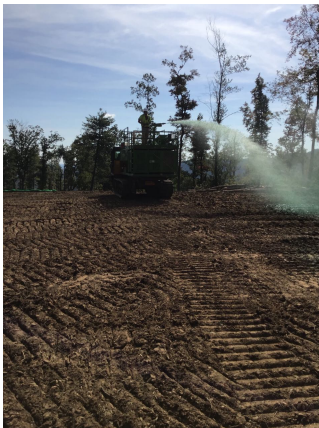
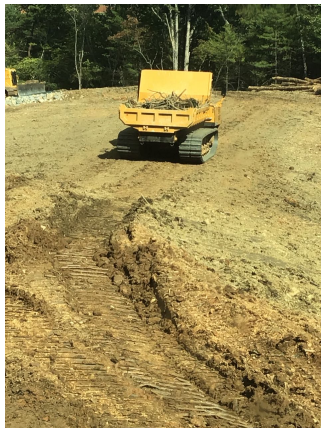
GPS Location	36.9719658606099, -79.8699338269232	GPS Location	36.971980654669, -79.8701120261847		
Description	Reclamation crew resuming hydromulching activities at 13473+76	Description	Final clean up crew at 13490+00

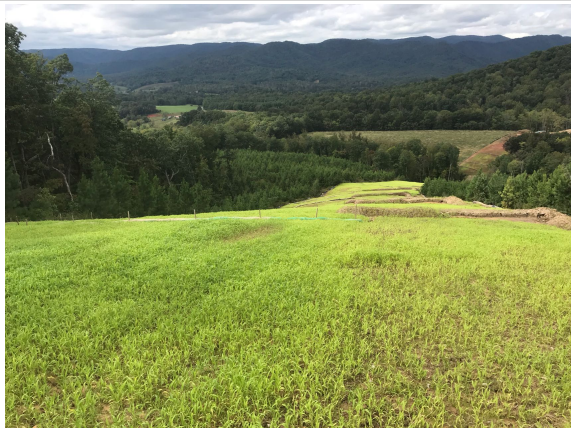
Insert image here			
GPS Location	36.9718926446857, -79.8700895626842	GPS Location			
Description	Grow in on CIS of 13437+00	Description
