Visual Site Inspection Report

Project Name	H-600 Pipeline Spread H	AFE	124300138	Spread	H-600 Pipeline Spread H
Contractor	Precision			Report #	7511
Inspector	Jason Nielsen			Date/Time	9/7/2018 10:02 PM
Permit #	TBD	Inspection Type	VA SWPP	Station Begin	12299+24
State	VA	Inspection Area	Partial	Station End	12214+63
County	Montgomery	Ground	Dry	Temperature (°F)	90.00
Municipality	N/A	Weather	Sunny	Rain Gauge (in)	0.00
GPS Location	37.3315360057536, -79.9581352518699			Rain Accumulation Time (days)	0.00

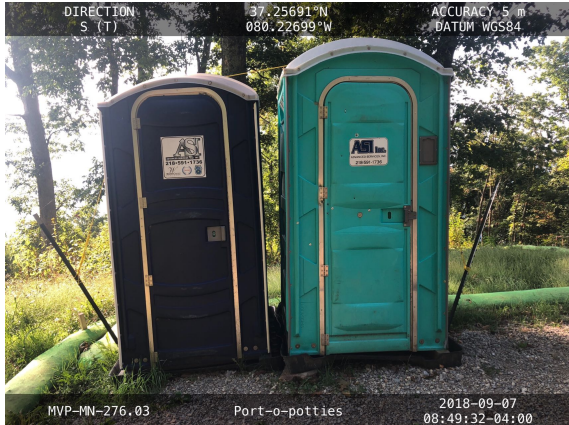
GPS Location	37.3312426855845, -79.9581360710633		GPS Location	37.3314019432639, -79.9582349975407	
Description	MVP-MN-267.03_090718 Port-o-potties on Access road. Looking S. See picture for GPS data		Description	MVP-MN-276.03_090718 Stabilized Access road leading to the ROW. Looking S. See picture for GPS data.

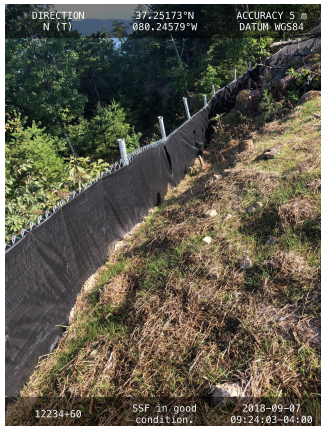
GPS Location	37.3314583534723, -79.9581431318819		GPS Location	37.3314494899767, -79.9580256347037	
Description	12284+80_090718 Stabilized ROW. Looking SE. See picture for GPS data.		Description	12234+60_090718 SSF in good condition. Looking N. See picture for GPS data.

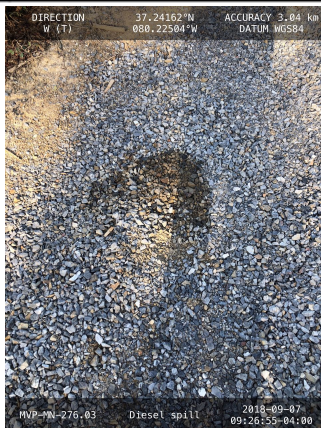
7. Identify all remedial measures that have been taken since the previous inspection was conducted. Since my last inspection of the area the environmental crew has walked the ROW and removed trash. There has been no mechanical activity in the area.					
Comments (Reference above questions as appropriate.) Went to access road MVP-MN-276.03 to walk the ROW and perform a SWPP inspection. During my walk I inspected all environmental aspects of the ROW, water bars, outlets, RCEs and ECDs. The ECDs were all in place and in good condition. The RCEs were in good condition. Water bars and outlets all looked good and were functioning during the recent rain events. The temporary ROW stabilization has held in place and is beginning to sprout. I inspected the port-o-potties to insure that they were still stable In case of windy conditions. During my inspection I found a small amount of fuel leaked on the access road, the environmental crew came and cleaned it up.

GPS Location	37.3313750373547, -79.9582070019841		GPS Location	37.3313763365497, -79.9581930042058	
Description	12234+06_090718 RCE. Looking SW. See picture for GPS data.		Description	MVP-MN-276.03_090718 Small fuel spill. Looking W. See picture for GPS data.
