Visual Site Inspection Report

Project Name	H-600 Pipeline Spread H	AFE	124300138	Spread	H-600 Pipeline Spread H
Contractor	Precision			Report #	7497
Inspector	Joe Scott			Date/Time	9/7/2018 10:52 AM
Permit #	TBD	Inspection Type	VA SWPP	Station Begin	13024+00
State	VA	Inspection Area	Partial	Station End	13120+17
County	Franklin	Ground	Dry	Temperature (°F)	84.00
Municipality	N/A	Weather	Sunny	Rain Gauge (in)	0.00
GPS Location	37.1254507452595, -80.1217230968924			Rain Accumulation Time (days)	1.00

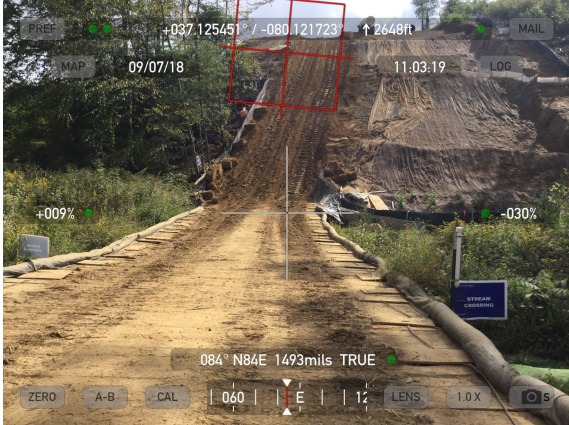
GPS Location	37.125555183773, -80.1215737313778	GPS Location	37.1276399307299, -80.1166387182475		
Description	Water bars removed. ECD's appear to be acceptable at this point. 13024+50	Description	Bridge mats over S-H1 have shifted and need realigned.13043+00

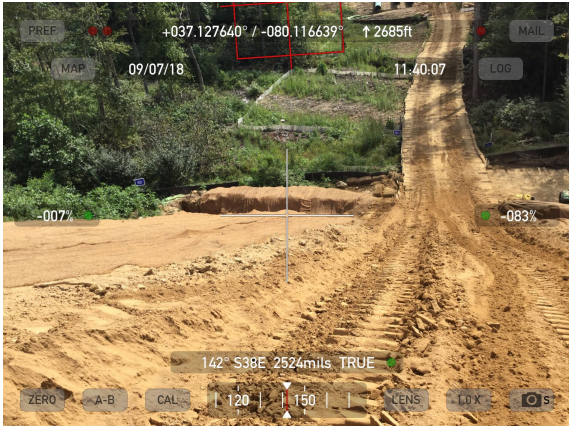
GPS Location	37.1271206299189, -80.1118227281422	GPS Location	37.1263145422909, -80.1086403709651		
Description	Substantial sized water bars and curlex on slope above S-G26	Description	Trench breaker installed near 13072+50
