Visual Site Inspection Report

| Project Name | H-600 Pipeline Spread H | AFE | 124300138 | Spread | H-600 Pipeline Spread H |
| Permit # | TBD | Inspection Type | VA SWPP | Station Begin | 12993+23 |

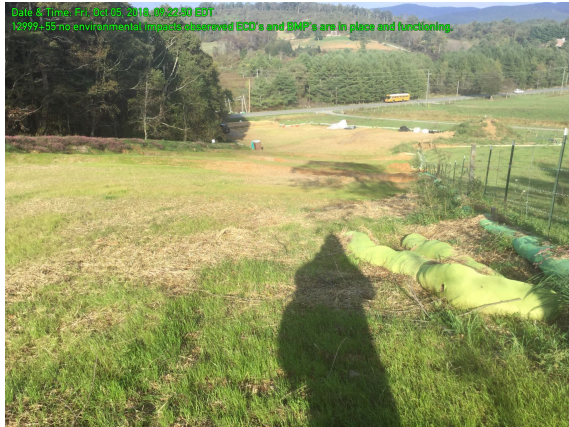
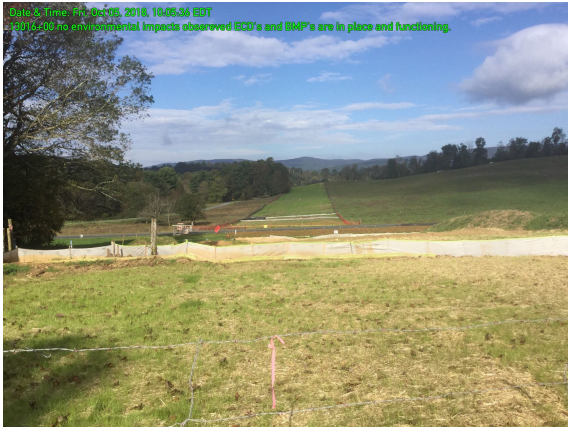
| <div><div>Date & Time: Fri, Oct 05, 2018, 09:22:30 EDT 13099+95 no environmental impacts observed ECD's and BMP's are in place and functioning.</div></div> | | <div><div>Date & Time: Fri, Oct 05, 2018, 10:05:36 EDT 13094+00 no environmental impacts observed ECD's and BMP's are in place and functioning.</div></div> | | | |
| Description | No impacts were observed. Silt fence was damaged in a few spots and repaired immediately. | Description | ECD's and BMP's were in good shape. No impacts were observed. | | |

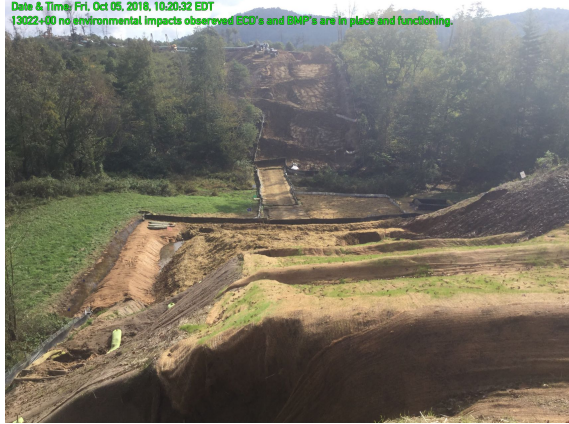
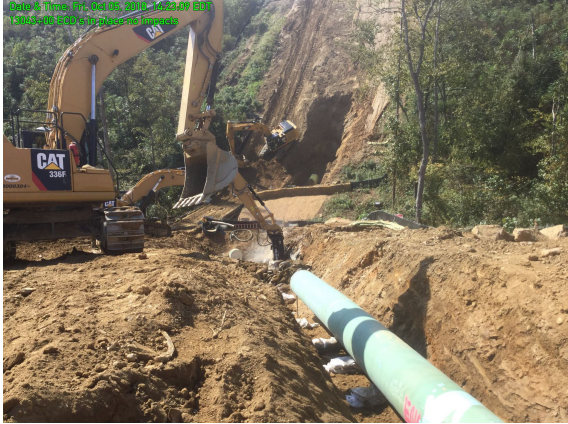
| <div><div>Date & Time: Fri, Oct 05, 2018, 10:20:32 EDT 13022+00 no environmental impacts observed ECD's and BMP's are in place and functioning.</div></div> | | <div><div>Date & Time: Fri, Oct 05, 2018, 10:23:49 EDT 13043+00 no environmental impacts observed ECD's and BMP's are in place and functioning.</div></div> | | | |
| Description | No impacts were observed and noted deficiencies were immediately addressed. | Description | Ditch was being widened here to allow pipe to fit. ECD's were in good shape and no impacts were observed. | | |

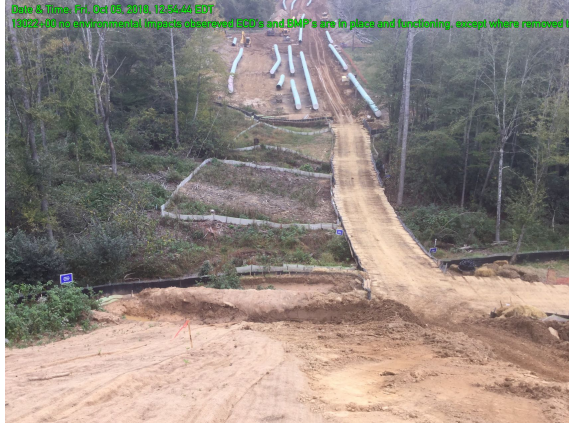
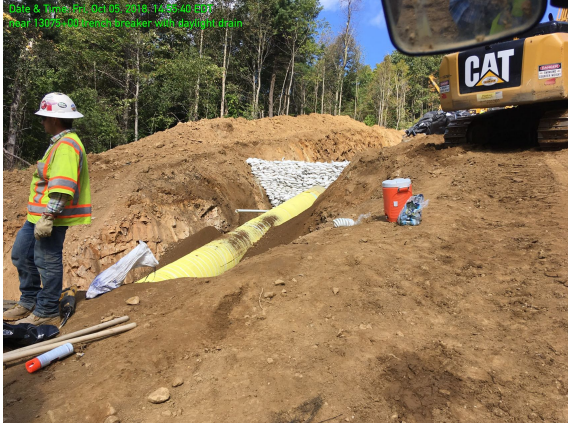
| <div><div>Date & Time: Fri, Oct 05, 2018, 12:55:44 EDT 13022+00 no environmental impacts observed ECD's and BMP's are in place and functioning, except where removed.</div></div> | | <div><div>Date & Time: Fri, Oct 05, 2018, 1:05:40 EDT 13075+00 daylight drain type trench breaker installed near daylight drain.</div></div> | | | |
| Description | Sumps in this area were being cleaned out and maintained. | Description | Daylight drain type trench breaker installed near 13075+00 | | |
