Visual Site Inspection Report

Project Name	H-600 Pipeline Spread H	AFE	124300138	Spread	H-600 Pipeline Spread H
Contractor	Precision			Report #	2341
Inspector	John Brcic			Date/Time	5/29/2018 6:38 AM
Permit #	TBD	Inspection Type	Weekly	Station Begin	12005+00
State	VA	Inspection Area	Partial	Station End	12025+00
County	Montgomery	Ground	Damp	Temperature (°F)	75.00
Municipality	N/A	Weather	Cloudy	Rain Gauge (in)	0.00
GPS Location	37.2706189798538, -80.3142738529298			Rain Accumulation Time (days)	1.00

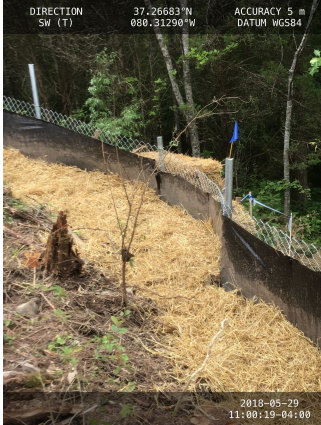
GPS Location	37.2705248929907, -80.3141346295181	GPS Location	37.3085608961142, -80.0104918423359		
Description	Super silt fence half full of sediment @ sta 12016+50, ~MP 227.6~.	Description	Env crew cleaned sediment out of super silt fence @ sta 12016+50, ~MP 227.6~. See photo for location.

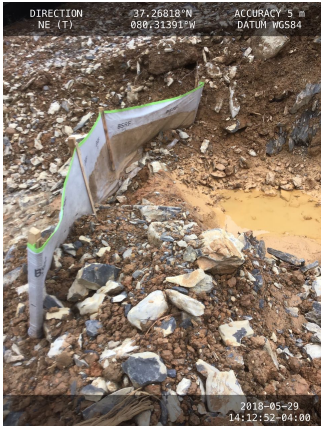
GPS Location	37.308578571744, -80.0105336502291	GPS Location	37.3085885029179, -80.0105441228787		
Description	Bottom of P1 silt fence exposed on 2 water bars on slope past S-G36, sta 12010+00 & 12011+00, ~MP 227.5~. See photo for location	Description	P1 silt fence repaired at water bars, sta 12010+00 and 12011+00, ~MP 227.5~. See photo for location.

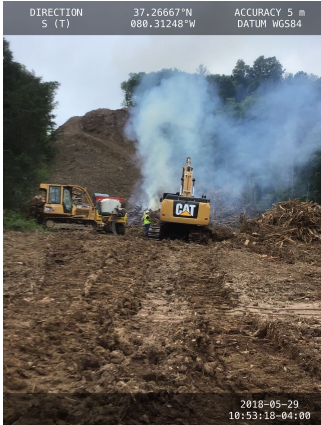
GPS Location	37.308663047138, -80.0106278792738	GPS Location	37.2687718598519, -80.3132245224717		
Description	NCI continued burning brush piles at station 12020+00, ~MP 227.7~. See photo for location.	Description	The env crew installed plywood sideboards on the 3 bridges at Catawba site. See photos for location.
