Visual Site Inspection Report

Project Name	H-600 Pipeline Spread H	AFE	124300138	Spread	H-600 Pipeline Spread H
Contractor	Precision			Report #	4841
Inspector	John Brcic			Date/Time	7/19/2018 11:22 AM
Permit #	TBD	Inspection Type	VA SWPP	Station Begin	12005+00
State	VA	Inspection Area	Partial	Station End	12071+80
County	Montgomery	Ground	Dry	Temperature (°F)	80.00
Municipality	N/A	Weather	Sunny	Rain Gauge (in)	0.00
GPS Location	37.2688045911838, -80.3146743402633			Rain Accumulation Time (days)	1.00

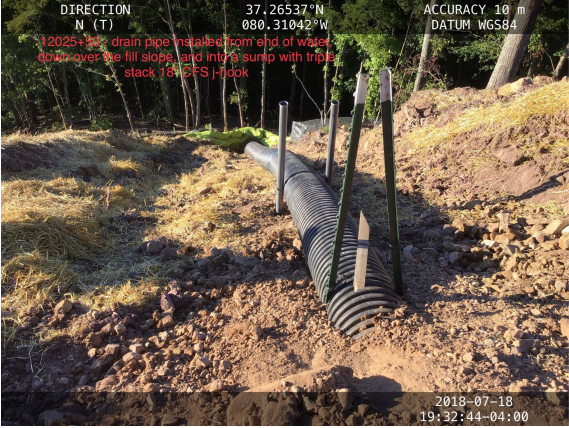
GPS Location	37.3084819224079, -80.0101383403689	GPS Location	37.3086387141179, -80.0103400224126		
Description	Timber mat retaining walls were built on the steep slopes above streams S-G39 and S-G40. See photo for location.	Description	Fill slope drains were installed per DEQ requirement for releasing area for work, station 12024+00 to 12025+50, ~MP 227.5~.

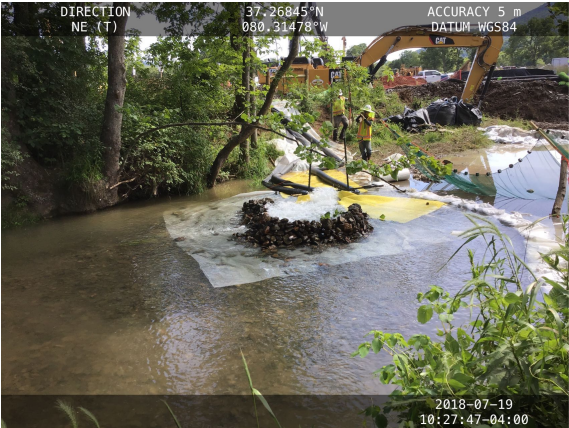
GPS Location	37.3084411025395, -80.0100311358273	GPS Location	37.3085479298954, -80.0102004502714		
Description	Operators began ditching through stream S-G36 this morning. See photo for location.	Description	A rock energy dissipater was built for the pump around outlet at stream S-G36. See photo for location.

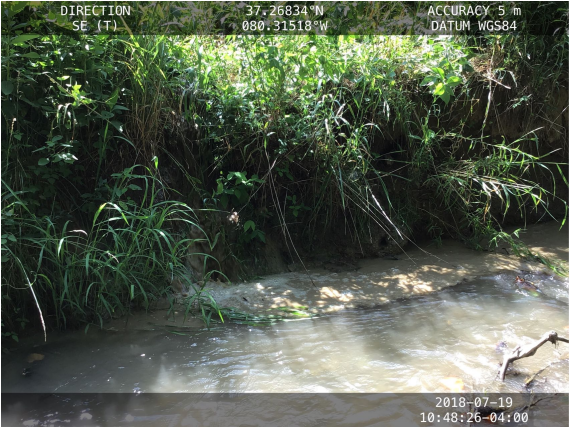
GPS Location	37.3085080320363, -80.0102908071876	GPS Location	37.3085068166603, -80.0101165474206		
Description	Stained water from the dewatering structure was entering the stream S-G36. See photo for location.	Description	The pipe section was lowered into the ditch at stream S-G36 at approximately 5:00 PM today. See photo for location.

4. E&S BMPs (List BMPs and note if installed and maintained as per the plan. If corrective action is needed, a picture is required.)					
E&S BMPs		Compliance Level	Corrective Action	Corrective Time Frame	
Dewatering Work Area		Communication	Add CFS, turbidity curtain	Addressed	
Water Deflector		Communication	Add one at pump around outflow	Addressed	
Water Deflector		Communication	Build one at pump around outflow	Addressed
