Visual Site Inspection Report

Project Name	H-600 Pipeline Spread H	AFE	124300138	Spread	H-600 Pipeline Spread H
Contractor	Precision			Report #	5184
Inspector	John Brcic			Date/Time	7/25/2018 3:14 PM
Permit #	TBD	Inspection Type	VA SWPP	Station Begin	12005+00
State	VA	Inspection Area	Partial	Station End	12102+69
County	Montgomery	Ground	Wet	Temperature (°F)	75.00
Municipality	N/A	Weather	Thunderstorms	Rain Gauge (in)	0.00
GPS Location	37.2583916271452, -80.2874642518165			Rain Accumulation Time (days)	1.00

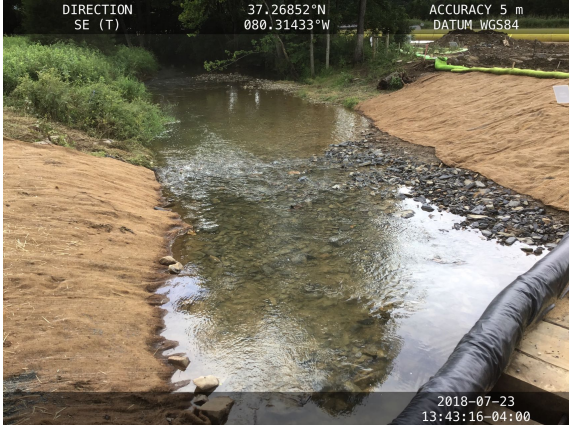
GPS Location	37.22601274, -80.25957059		GPS Location	37.22601274, -80.25957059	
Description	Stream S-G36 needs to be reshaped as post-construction contours do not match pre-construction. See photo for location.		Description	Stream S-G38 was open cut on Friday, 7/20, restored and stabilized by Saturday, 7/21. See photo for location.

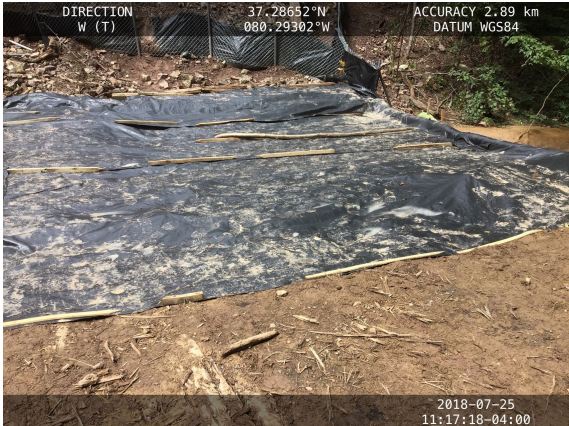
GPS Location	37.22601274, -80.25957059		GPS Location	37.2583795991142, -80.2872131299975	
Description	The bridge @ S-G40 was wrapped with geotech until equipment can be used to reinstall geotech. See photo for location.		Description	Sumps need maintenance between station 12056+00, ~MP 228.2, and AR 270. See photo for location.

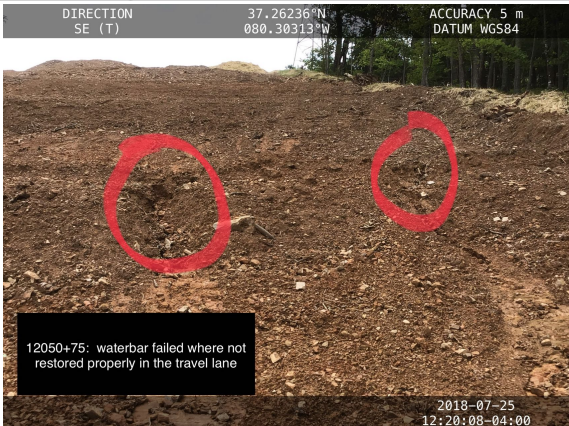
GPS Location	37.2583868913699, -80.2875318937751		GPS Location	37.2584098996942, -80.2875560336563	
Description	Station 12050+75, ~MP 228.0~: waterbar failed where travel lane not properly restored. See photo for location.		Description	Station 12052+75: waterbar not restored properly in travel lane. See photo for location.

4. E&S BMPs (List BMPs and note if installed and maintained as per the plan. If corrective action is needed, a picture is required.)					
E&S BMPs		Compliance Level	Corrective Action	Corrective Time Frame	
Waterbar		Communication	12050+75, repair in travel lane	24 Hours	
Waterbar		Communication	12052+75, repair in travel lane	24 Hours	
Sump Pit		Communication	12056+00 to AR 270, clean sumps	24 Hours
