Visual Site Inspection Report

Project Name	H-600 Pipeline Spread H	AFE	124300138	Spread	H-600 Pipeline Spread H
Contractor	Precision			Report #	7507
Inspector	John Brcic			Date/Time	9/7/2018 10:18 AM
Permit #	TBD	Inspection Type	VA SWPP	Station Begin	12071+00
State	VA	Inspection Area	Partial	Station End	12190+85
County	Montgomery	Ground	Dry	Temperature (°F)	88.00
Municipality	N/A	Weather	Sunny	Rain Gauge (in)	0.00
GPS Location	37.3086889524664, -80.0101761789431			Rain Accumulation Time (days)	1.00

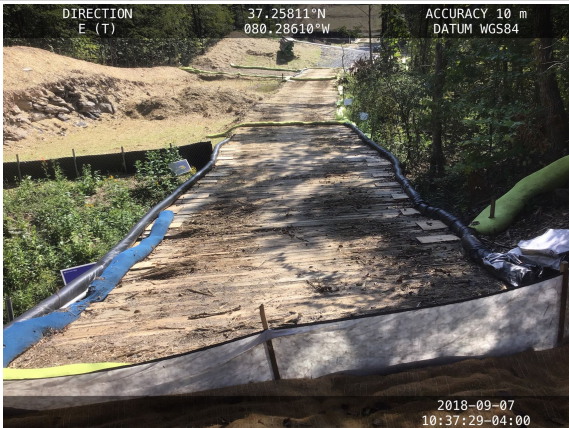
GPS Location	37.2583245719199, -80.2889257204535		GPS Location	37.2583137592648, -80.2880593669417	
Description	Bridge and ECDs in good condition at stream S-MM13.		Description	CFS was replaced at station 12102+55 per PL item #1129.
