Visual Site Inspection Report

Project Name	H-600 Pipeline Spread H	AFE	124300138	Spread	H-600 Pipeline Spread H
Contractor	Precision			Report #	8336
Inspector	John Brcic			Date/Time	9/24/2018 9:09 AM
Permit #	TBD	Inspection Type	VA SWPP	Station Begin	12071+00
State	VA	Inspection Area	Partial	Station End	12195+50
County	Montgomery	Ground	Muddy	Temperature (°F)	65.00
Municipality	N/A	Weather	Light Rain	Rain Gauge (in)	0.00
GPS Location	37.3087045680071, -80.0101706752458			Rain Accumulation Time (days)	1.00

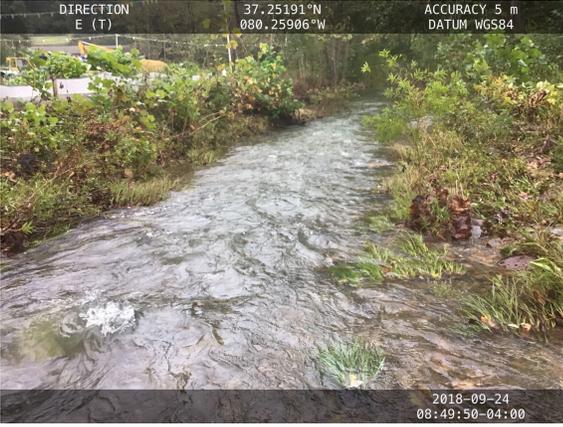
<p>DIRECTION NE (T) 37.25172°N 080.25907°W ACCURACY 10 m DATUM WGS84 2018-09-24 09:08:11-04:00</p>			
GPS Location 37.251708693837, -80.2590753325077		GPS Location 37.2517850948845, -80.2590119653198			
Description Water level was too high on stream S-C21, Bradshaw Creek, for fish removal to take place.		Description Tie-in crew was welding pipe section for the S-C21 stream crossing.

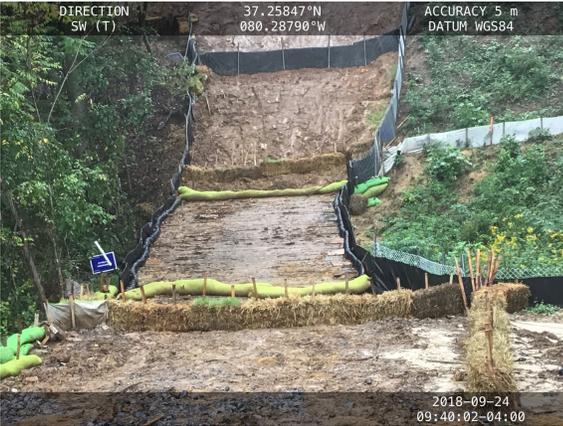
<p>DIRECTION W (T) 37.25817°N 080.28578°W ACCURACY 5 m DATUM WGS84 2018-09-24 10:17:53-04:00</p>			
GPS Location 37.2583643859599, -80.2876535151902		GPS Location 37.2581288125713, -80.2855429519716			
Description Bridge and ECDs in good condition and no impacts observed on stream S-MM11 after rain events this past weekend.		Description No issues observed at stream S-F15.

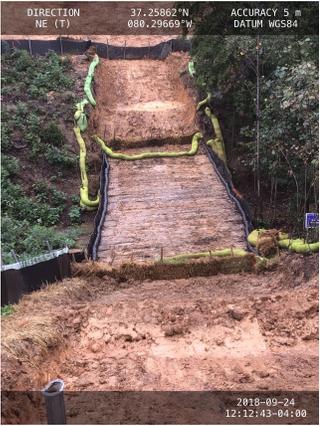
<p>DIRECTION SE (T) 37.25873°N 080.29434°W ACCURACY 5 m DATUM WGS84 2018-09-24 12:29:44-04:00</p>			
GPS Location 37.2586118197416, -80.2966647316518		GPS Location 37.3087820788644, -80.0103311295872			
Description No new impacts observed on stream S-MM15 and bridge and ECDs in satisfactory condition.		Description Sump pits will need to be cleaned out between AR 270 and AR 270.01 when accessible by equipment.
