Visual Site Inspection Report

Project Name	H-600 Pipeline Spread H	AFE	124300138	Spread	H-600 Pipeline Spread H
Contractor	Precision			Report #	8941
Inspector	John Brcic			Date/Time	10/5/2018 9:54 AM
Permit #	TBD	Inspection Type	VA SWPP	Station Begin	12071+00
State	VA	Inspection Area	Partial	Station End	12195+50
County	Montgomery	Ground	Dry	Temperature (°F)	80.00
Municipality	N/A	Weather	Cloudy	Rain Gauge (in)	0.00
GPS Location	37.2583930520688, -80.2980565466735			Rain Accumulation Time (days)	1.00

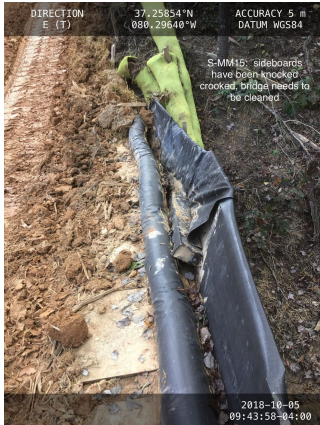
GPS Location	37.2588921524931, -80.2943425253781		GPS Location	37.2586583393042, -80.2937164810303	
Description	Repair side boards and clean bridge @ stream S-MM15. (Addressed)		Description	No clear flow path and waterbar needs to be compacted in the travel lane @ station 12085+00, ~MP 12085+00.
