# Visual Site Inspection Report

| <b>Project Name</b> | H-600 Pipeline Spread H | <b>AFE</b> | 124300138 | <b>Spread</b> | H-600 Pipeline Spread H |
| <b>Contractor</b> | Precision | | | <b>Report #</b> | 1782 |
| <b>Inspector</b> | Pat Davis | | | <b>Date/Time</b> | 5/15/2018 6:54 AM |

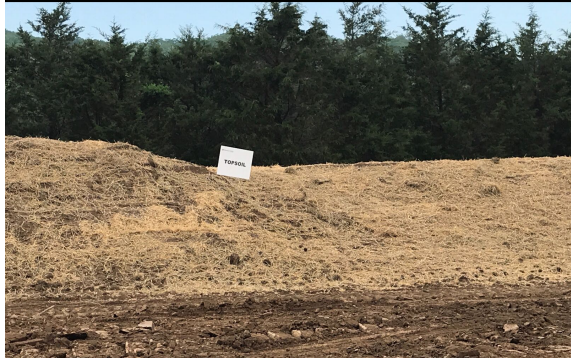
| Description | MVP-ATWS-473_051518 installed topsoil signage. Looking N. See photo for gps data. | | Description | 12017+00_051518 Stacking logs along the edge of LOD, cut travel lane. Looking SE. See photo for gps data. | |

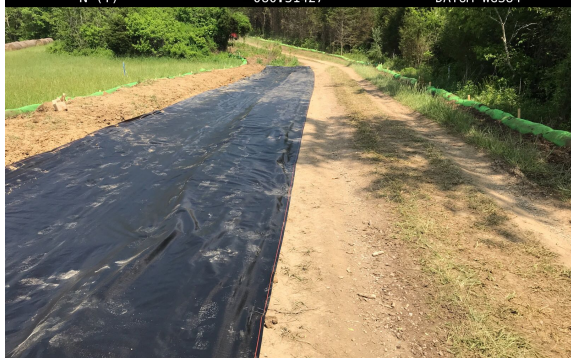
| Description | MVP-MN-268_051518 crew topsoiled and installed geotech on access road. Looking N. See photo for gps data. | | Description | MVP-MN-268_051518 crew place rock on geotech. Looking N. See photo for gps data. | |

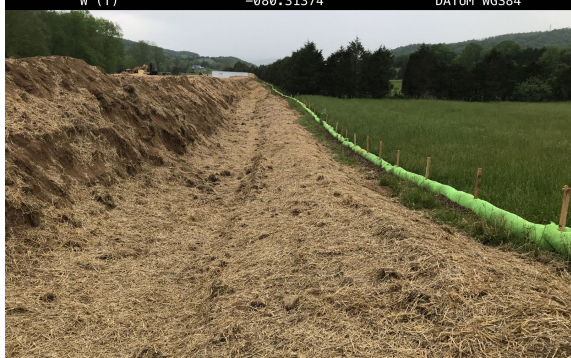
| Description | MVP-ATWS-473_051518 Clean Water Diversion Berm re-worked seeded, and straw mulch. Looking W. See photo for gps data. | | Description | 12008+53_051518 closed bridge and slope breakers over feature S-G36. Looking SE. See photo for gps data. | |
