Visual Site Inspection Report

Project Name	H-600 Pipeline Spread H	AFE	124300138	Spread	H-600 Pipeline Spread H
Contractor	Precision			Report #	2177
Inspector	Pat Davis			Date/Time	5/24/2018 6:22 PM
Permit #	TBD	Inspection Type	VA SWPP	Station Begin	12994+02
State	VA	Inspection Area	Partial	Station End	13197+55
County	Franklin	Ground	Wet	Temperature (°F)	75.00
Municipality	N/A	Weather	Sunny	Rain Gauge (in)	0.00
GPS Location	37.1269309474501, -80.1178551000358			Rain Accumulation Time (days)	0.00

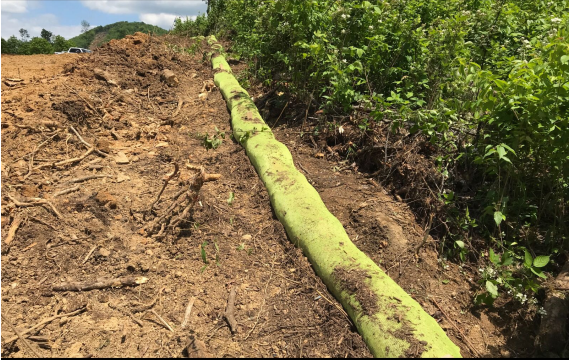
2018-05-24 12:52:21-04:00			
GPS Location	37.1268687956381, -80.1178754680604		GPS Location	37.1268687956381, -80.1178754680604	
Description	13026+00_052418 Single 12 inch filter sock installed. Looking E. See photo for gps data.		Description	13047+29_052418 crew installing super silt fence. Looking SE. See photo for gps data.	
DIRECTION W (T) +37.12526° -080.12094° ACCURACY 16 ft DATUM WGS84   2018-05-24 14:42:21-04:00		DIRECTION W (T) +37.12445° -080.12127° ACCURACY 33 ft DATUM WGS84   2018-05-24 10:03:27-04:00			
GPS Location	37.1269423468384, -80.1177184750141		GPS Location	37.1268351003873, -80.117744710371	
Description	13025+00_052418 crew installing super silt fence. Looking W. See photo for gps data.		Description	MVP-FR-289_052418 waterbar outlet cleaned out. Looking W. See photo for gps data.

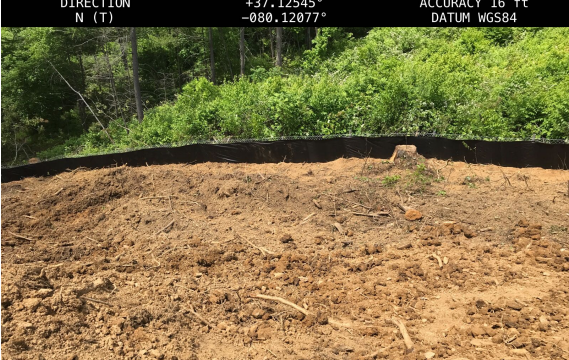
2018-05-24 10:03:50-04:00			
GPS Location	37.1267612558204, -80.1180126798154		GPS Location	37.1269783471125, -80.1178245899082	
Description	13026+00_052418 super silt fence installed. Looking N. See photo for gps data.		Description	MVP-FR-289_052418 waterbar outlet cleaned out. Looking NE. See photo for gps data.
