# Visual Site Inspection Report

<b>Project Name</b>	H-600 Pipeline Spread H		<b>AFE</b>	124300138	<b>Spread</b>	H-600 Pipeline Spread H	
<b>Contractor</b>	Precision				<b>Report #</b>	3404	
<b>Inspector</b>	Pat Davis				<b>Date/Time</b>	6/21/2018 8:11 PM	
<b>Permit #</b>	TBD	<b>Inspection Type</b>	VA SWPP		<b>Station Begin</b>	13197+75	
<b>State</b>	VA	<b>Inspection Area</b>	Partial		<b>Station End</b>	13415+00	
<b>County</b>	Franklin	<b>Ground</b>	Dry		<b>Temperature (°F)</b>	88.00	
<b>Municipality</b>	N/A	<b>Weather</b>	Sunny		<b>Rain Gauge (in)</b>	0.00	
<b>GPS Location</b>	37.2790255956908, -80.029409652983				<b>Rain Accumulation Time (days)</b>	0.00

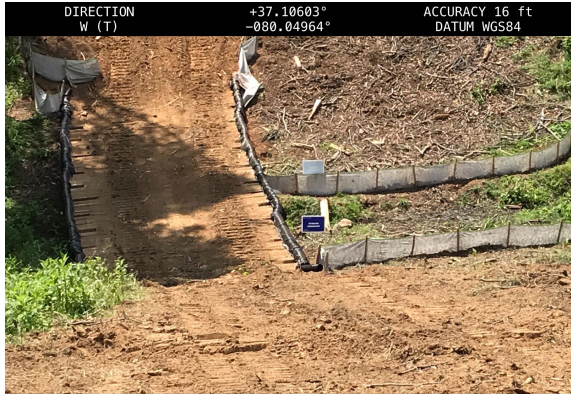
<div>2018-06-19 08:44:54-04:00</div>		
GPS Location	37.2793068189315, -80.0279277189612		GPS Location	37.2787580010233, -80.0289134636924	
Description	13321+47_061918 S-GH15 mat bridge installed over feature. Looking W. See photo for gps data.		Description	13197+55_061918 two porta toilets placed on ROW. Looking S. See photo for gps data.	
<div>DIRECTION W (T)</div> <div>+37.10647° -080.05153°</div> <div>ACCURACY 16 ft DATUM WGS84</div>

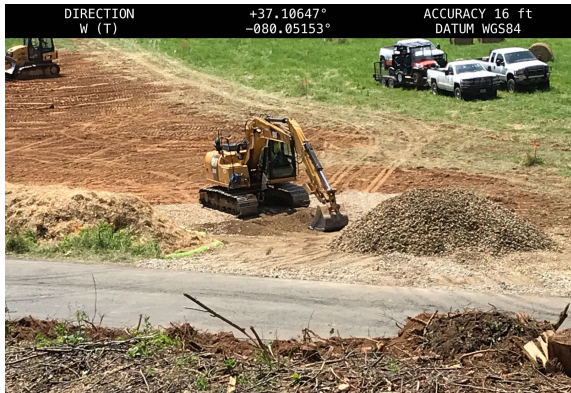
GPS Location	37.2789274668473, -80.0287873318017		GPS Location	37.2789923334841, -80.0286616758257	
Description	13316+06_061918 rock approach installed on west side of Wades Gap Road. Looking W. See photo for gps data.		Description	13325+30_061918 S-GH14 mat bridge installed over feature. Looking E. See photo for gps data.	
<div>DIRECTION W (T)</div> <div>+37.11544° -080.06150°</div> <div>ACCURACY 16 ft DATUM WGS84</div>

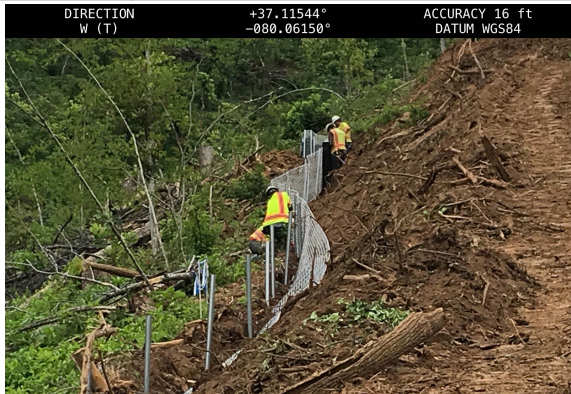
<div>2018-06-21 17:19:43-04:00</div>		
GPS Location	37.2789463969118, -80.0282614761201		GPS Location	37.278895584325, -80.0285613813064	
Description	13258+74_062118 crew installing super silt fence. Looking W. See photo for gps data.		Description	13348+46_062118 S-RR08 crew installing ECD's on on bridge. Looking N. See photo for gps data.
