# Visual Site Inspection Report

| <b>Project Name</b> | H-600 Pipeline Spread H | <b>AFE</b> | 124300138 | <b>Spread</b> | H-600 Pipeline Spread H |
| <b>Contractor</b> | Precision | | | <b>Report #</b> | 5121 |
| <b>Inspector</b> | Pat Davis | | | <b>Date/Time</b> | 7/25/2018 5:25 PM |

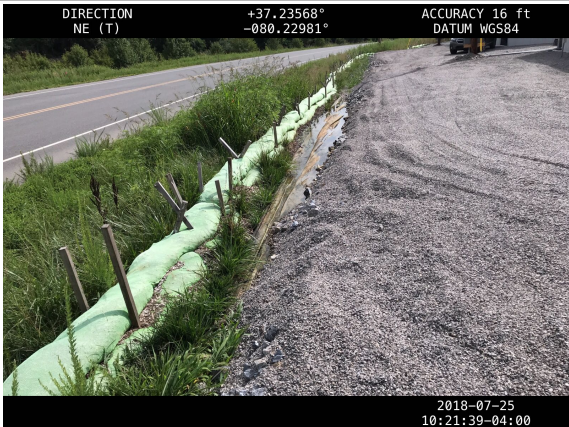
| <b>Description</b> | MVP-PY-006_072518 compost filter sock in good condition. Looking NE. See photo for gps data. | <b>Description</b> | MVP-PY-006_072518 secondary containment around light plant no liquid. Looking S. See photo for gps data. | | |

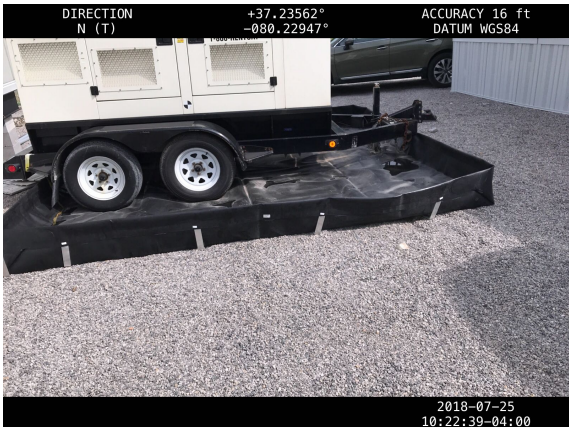
| <b>Description</b> | MVP-PY-006_072518 secondary containment under generator no liquid. Looking N. See photo for gps data. | <b>Description</b> | MVP-PY-006_072518 hoses and nozzles inside containment at bulk fuel storage. Looking E. See photo for gps data. | | |

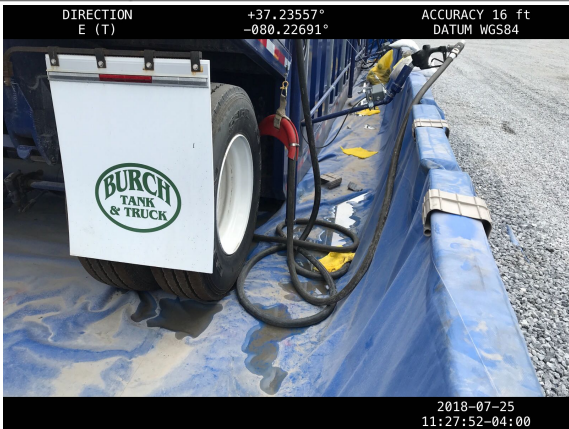
| <b>Description</b> | MVP-PY-006_072518 secondary containment at bulk fuel storage no liquid in containment. Looking E. See photo for gps data. | <b>Description</b> | MVP-PY-006_072518 sideboom leaking fluid on track. Looking SW. See photo for gps data. | | |

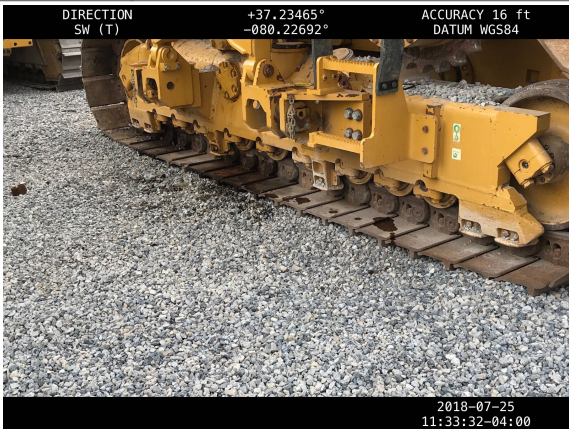
| EI performed SWPPP Inspection on the MVP-PY-006. EI observed the compost filter sock around the boundary was installed and in good condition. EI observed the secondary containments under the generators and light plants had no ov very small amounts of water from the rain events. EI observed four areas in the yard with small amounts oil and fuel on the stone. The fluids were on the top layer of stone. These areas were report to the contractor for cleanup. Two of the areas were on the south side of the bulk fuel tanks, one area was in the parking area, and one area where the equipment was park. A side boom had a fluid leak onto the left track and onto the top layer of stone. No other environmental issues were noted during today's inspection. | | | | | |

| Other | | Communication | Clean up and remove effected stone | Immediate | |
