Visual Site Inspection Report

Project Name	H-600 Pipeline Spread H		AFE	124300138	Spread	H-600 Pipeline Spread H	
Contractor	Precision				Report #	5860	
Inspector	Pat Davis				Date/Time	8/6/2018 5:50 PM	
Permit #	TBD	Inspection Type	VA SWPP		Station Begin	+0	
State	VA	Inspection Area	Partial		Station End	+0	
County	Montgomery	Ground	Muddy		Temperature (°F)	91.00	
Municipality	N/A	Weather	Cloudy		Rain Gauge (in)	0.30	
GPS Location	37.2789729788962, -80.0288253895407				Rain Accumulation Time (days)	0.00

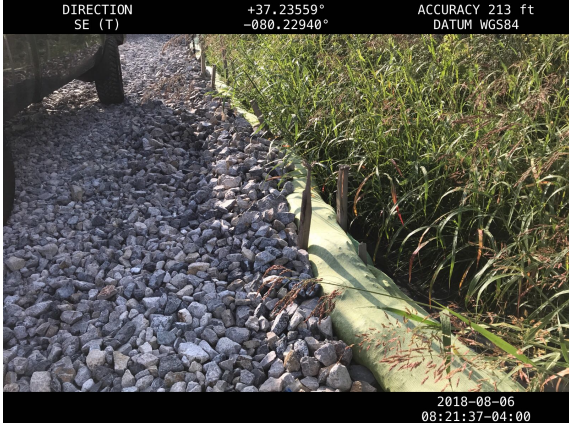
2018-08-06 08:37:30-04:00			
GPS Location	37.278830068897, -80.0289336573632	GPS Location	37.2787547065292, -80.0290748198331		
Description	MVP-PY-006_080618 stone pushed onto compost filter sock. Looking SE. See photo for gps data.	Description	MVP-PY-006_080618 lumber pushed onto compost filter sock. Looking S. See photo for gps data.		
DIRECTION E (T) +37.23442° -080.22571° ACCURACY 16 ft DATUM WGS84

4. E&S BMPs (List BMPs and note if installed and maintained as per the plan. If corrective action is needed, a picture is required.)							
E&S BMPs		Compliance Level		Corrective Action		Corrective Time Frame	
Compost Filter Sock		Communication		Remove rock from CFS		24 Hours	
Housekeeping		Communication		Pick up trash along boundary of yard		24 Hours	
Rock Construction Entrance		Acceptable					
Sensitive Resource Signage		Acceptable

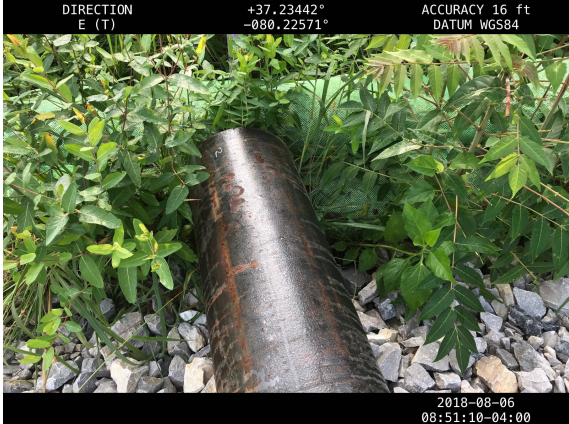
2018-08-06 08:51:10-04:00		DIRECTION SW (T) +37.23568° -080.22674° ACCURACY 16 ft DATUM WGS84   2018-08-06 08:58:02-04:00			
GPS Location	37.2788107814614, -80.0289748237282	GPS Location	37.2788150018966, -80.029021076287		
Description	MVP-PY-006_080618 pipe resting on compost filter sock. Looking E. See photo for gps data.	Description	MVP-PY-006_080618 fluid deposits on stone surface. North side of bulk fuel tanks. Looking SW. see photo for gps data.

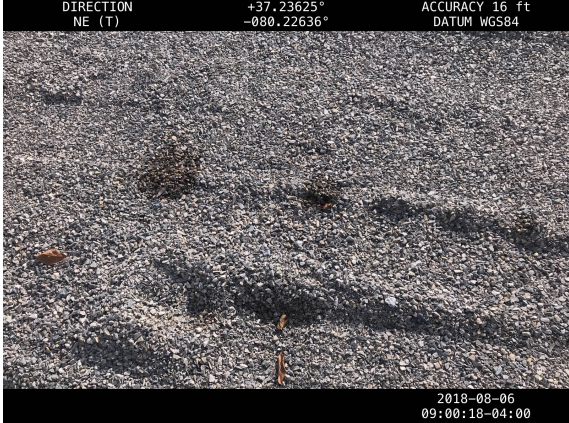
2018-08-06 08:47:34-04:00			
GPS Location	37.2788366543592, -80.028970451135	GPS Location	37.278858353605, -80.0290073969761		
Description	MVP-PY-006_080618 fluid deposit northeast corner. Looking NE. See photo for gps data.	Description	MVP-PY-006_080618 skid on corner of secondary containment. Looking SW. See photo for gps data.
