Visual Site Inspection Report

Project Name	H-600 Pipeline Spread H	AFE	124300138	Spread	H-600 Pipeline Spread H
Contractor	Precision			Report #	6438
Inspector	Pat Davis			Date/Time	8/16/2018 5:02 PM
Permit #	TBD	Inspection Type	VA SWPP	Station Begin	+0
State	VA	Inspection Area	Partial	Station End	+0
County	Roanoke	Ground	Dry	Temperature (°F)	90.00
Municipality	N/A	Weather	Sunny	Rain Gauge (in)	0.00
GPS Location	37.2788301985478, -80.02908413878			Rain Accumulation Time (days)	0.00

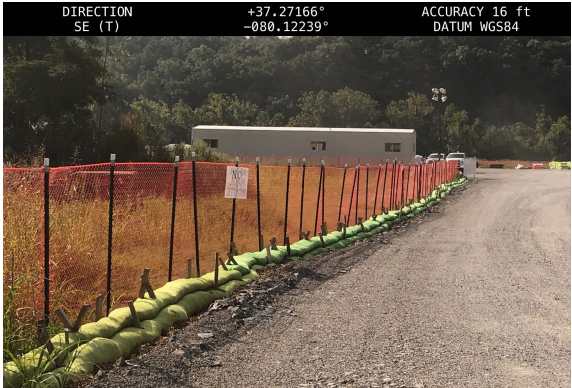
<div>2018-08-16 09:41:08-04:00</div>		
GPS Location	37.2788067042603, -80.0291980924512		GPS Location	37.2788520940685, -80.02896575914	
Description	MVP-LY-049_081618 compost filter sock along the drive. Looking SE. See photo for gps data.		Description	MVP-LY-049_081618 secondary containment under light plant. Looking NE. See photo for gps data.	
<div>DIRECTION N (T)</div> <div>+37.27157° -080.12050°</div> <div>ACCURACY 16 ft DATUM WGS84</div>

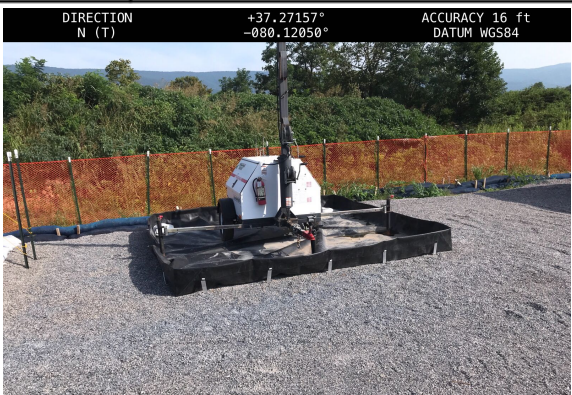
GPS Location	37.2788694317189, -80.0289196262585		GPS Location	37.2788462107984, -80.0287597675109	
Description	MVP-LY-049_081618 secondary containment under light plant. Looking N. See photo for gps data.		Description	MVP-LY-049_081618 trash dumpsters not over flowing. Looking NE. See photo for gps data.	
<div>DIRECTION SE (T)</div> <div>+37.26992° -080.12180°</div> <div>ACCURACY 16 ft DATUM WGS84</div>

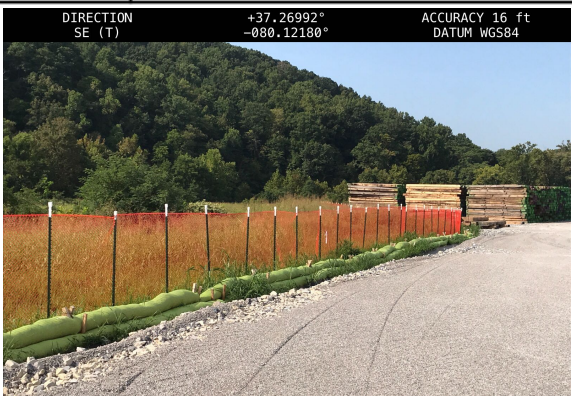
<div>2018-08-16 09:46:50-04:00</div>		
GPS Location	37.278952751463, -80.0286360767683		GPS Location	37.2788681755289, -80.0288848036245	
Description	MVP-LY-049_081618 composted filter sock along south boundary. Looking SE. See photo for gps data.		Description	MVP-LY-049_081618 compost filter sock along the south boundary. Looking E. See photo for gps data.
