# Visual Site Inspection Report

| <b>Project Name</b> | H-600 Pipeline Spread H | <b>AFE</b> | 124300138 | <b>Spread</b> | H-600 Pipeline Spread H | |
| <b>Contractor</b> | Precision | | | <b>Report #</b> | 8080 | |

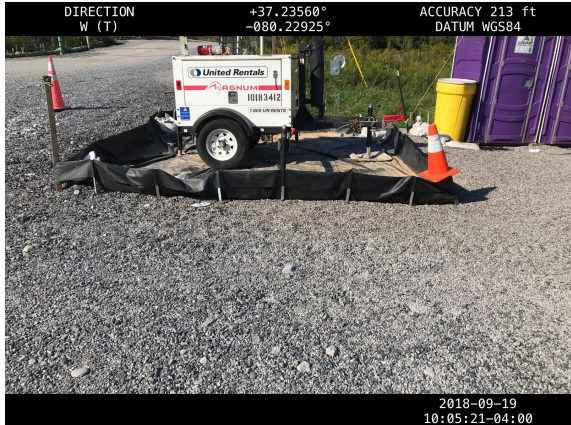
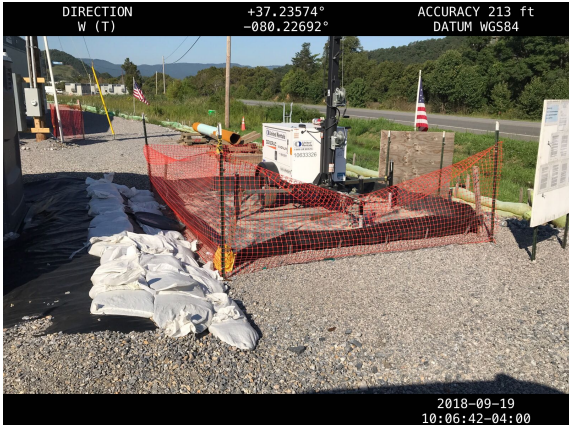
| Description | MVP-PY-006_091918 containment under light plant. Looking W. See photo for gps data. | | Description | MVP-PY-006_091918 containment under light plant. Looking W. See photo for gps data. | |

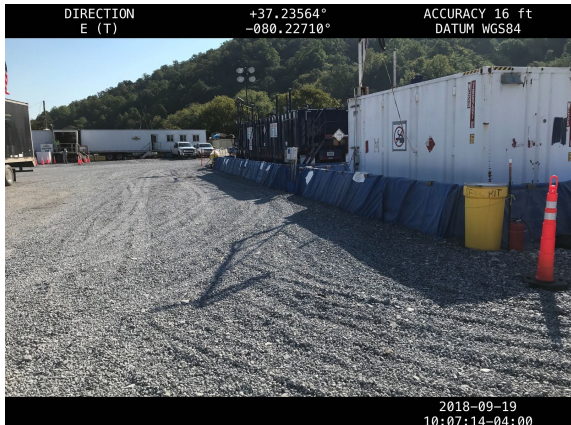
| Description | MVP-PY-006_091918 no fluid deposits on the north side of the bulk fuel tanks. Looking E. See photo for gps data. | | Description | MVP-PY-006_091918 dumpster area free of loose trash. Looking E. See photo for gps data. | |

| <b>7. Identify all remedial measures that have been taken since the previous inspection was conducted.</b><br>Crews have cleaned up the fluid deposits around the bulk fuel tanks. Crews have picked up and removed loose trash in the yard. The secondary containment's have been pumped out after the last rain event. | | | | | |

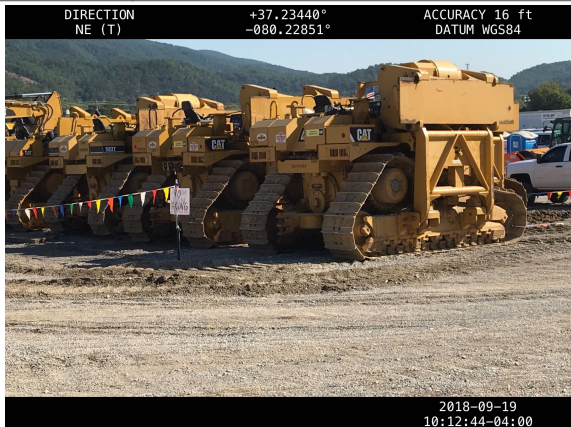
| Description | MVP-PY-006_091918 inspect newly arrived equipment. Looking NE. See photo for gps data. | | Description | MVP-PY-006_091918 no fluid deposits on the south side of the bulk fuel tanks. Looking E. See photo for gps data. | |
