# Visual Site Inspection Report

<b>Project Name</b>	H-600 Pipeline Spread H	<b>AFE</b>	124300138	<b>Spread</b>	H-600 Pipeline Spread H
<b>Contractor</b>	Precision			<b>Report #</b>	8338
<b>Inspector</b>	Pat Davis			<b>Date/Time</b>	9/24/2018 3:07 PM
<b>Permit #</b>	TBD	<b>Inspection Type</b>	VA SWPP	<b>Station Begin</b>	+0
<b>State</b>	VA	<b>Inspection Area</b>	Partial	<b>Station End</b>	+0
<b>County</b>	Roanoke	<b>Ground</b>	Muddy	<b>Temperature (°F)</b>	65.00
<b>Municipality</b>	N/A	<b>Weather</b>	Light Rain	<b>Rain Gauge (in)</b>	0.30
<b>GPS Location</b>	37.115715835278, -80.0596157927811			<b>Rain Accumulation Time (days)</b>	0.00

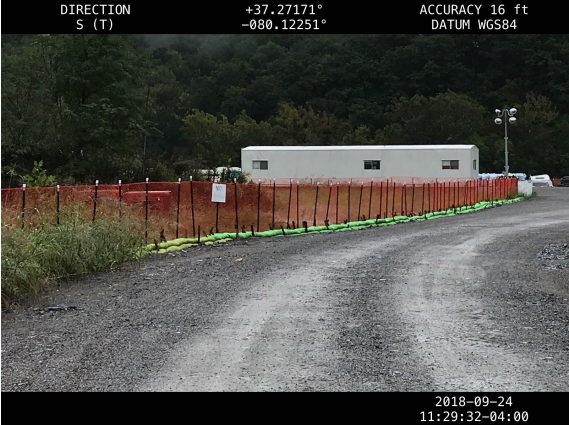
2018-09-24 11:31:38-04:00			
<b>GPS Location</b>	37.1156777395281, -80.0595981069655		<b>GPS Location</b>	37.1156777395281, -80.0595981069655	
<b>Description</b>	MVP-LY-049_092418 Filter sock and safety fence along drive. Looking S. See photo for gps data.		<b>Description</b>	MVP-LY-049_092418 containment under light plant. Looking E. See photo for gps data.	
DIRECTION N (T) +37.27103° -080.12165° ACCURACY 16 ft DATUM WGS84

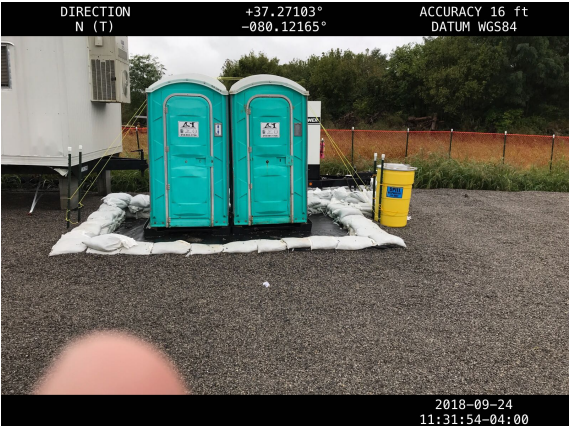
<b>Description</b>	MVP-LY-049_092418 containment under porta toilets. Looking N. See photo for gps data.		<b>Description</b>	MVP-LY-049_092418 containment being used by Northern Clearing. Looking NE. See photo for gps data.	
DIRECTION N (T) +37.27151° -080.12048° ACCURACY 16 ft DATUM WGS84

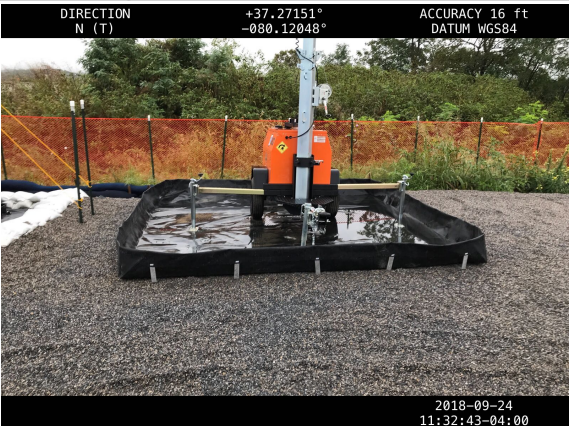
2018-09-24 11:36:38-04:00			
<b>GPS Location</b>	37.1157149551782, -80.0596164633334		<b>GPS Location</b>	37.1157149551782, -80.0596164633334	
<b>Description</b>	MVP-LY-049_092418 containment under light plant. Looking N. See photo for gps data.		<b>Description</b>	MVP-LY-049_092418 dumpster area clear of loose trash. Looking NE. See photo for gps data.
