# Visual Site Inspection Report

<b>Project Name</b>	H-600 Pipeline Spread H	<b>AFE</b>	124300138	<b>Spread</b>	H-600 Pipeline Spread H	
<b>Contractor</b>	Precision			<b>Report #</b>	8678	
<b>Inspector</b>	Pat Davis			<b>Date/Time</b>	10/1/2018 5:38 AM	
<b>Permit #</b>	TBD	<b>Inspection Type</b>	VA SWPP	<b>Station Begin</b>	+0	
<b>State</b>	VA	<b>Inspection Area</b>	Partial	<b>Station End</b>	+0	
<b>County</b>	Roanoke	<b>Ground</b>	Muddy	<b>Temperature (°F)</b>	82.00	
<b>Municipality</b>	N/A	<b>Weather</b>	Sunny	<b>Rain Gauge (in)</b>	0.00	
<b>GPS Location</b>	37.2787867029286, -80.028717432538			<b>Rain Accumulation Time (days)</b>	0.00

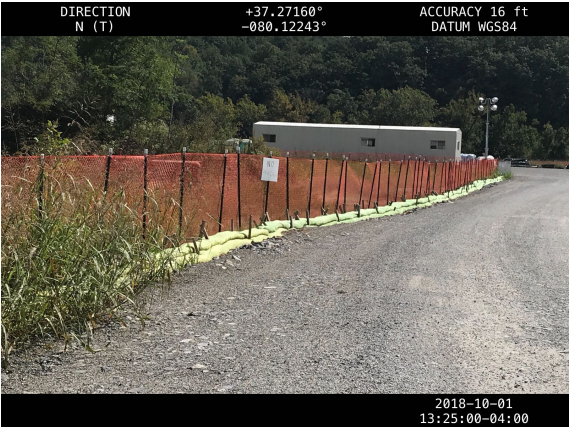
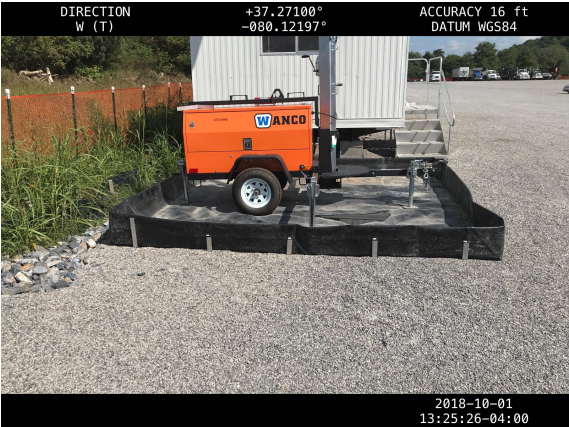
<b>GPS Location</b>	37.2790183758564, -80.0282201172986	<b>GPS Location</b>	37.2788463875627, -80.0285889130778		
<b>Description</b>	MVP-LY-049_100118 Compost filter sock and safety fence along drive. Looking S. See photo for gps location.	<b>Description</b>	MVP-LY-049_100118 containment under light plant. Looking E. See photo for gps data.

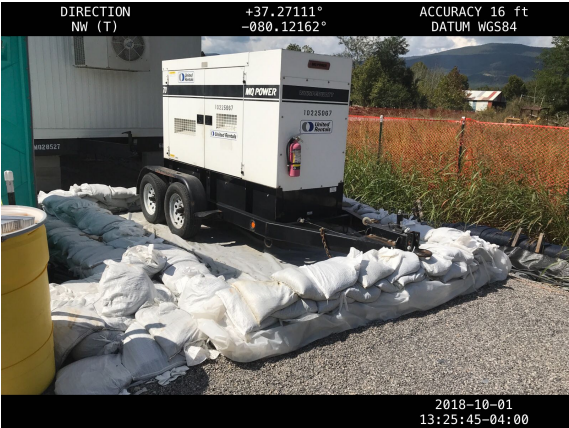
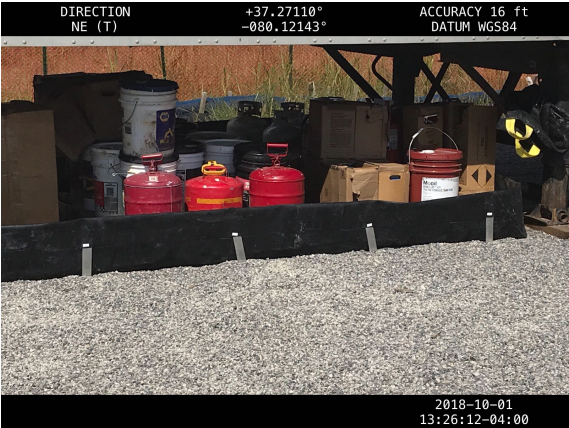
<b>GPS Location</b>	37.2788421206394, -80.028479084979	<b>GPS Location</b>	37.2788300939672, -80.0286135374639		
<b>Description</b>	MVP-LY-049_100118 containment under generator. Looking NW. See photo for gps data.	<b>Description</b>	MVP-LY-049_100118 containment for supplies. Looking NE. See photo for gps data.

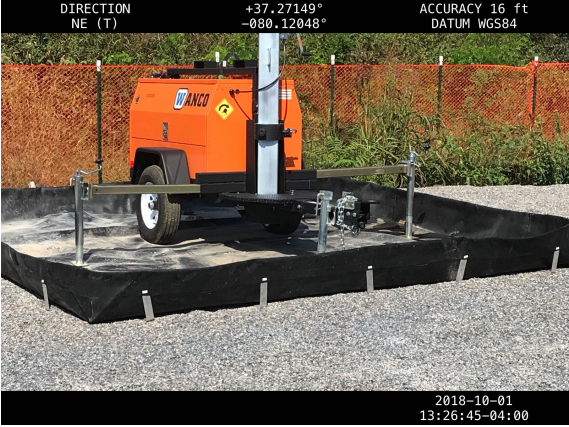
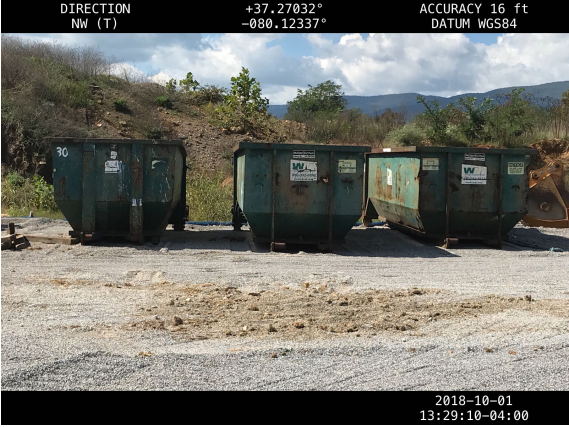
<b>GPS Location</b>	37.2788530246139, -80.0285573990874	<b>GPS Location</b>	37.2788930077327, -80.0284495318313		
<b>Description</b>	MVP-LY-049_100118 containment under light plant. Looking NE. See photo for gps data.	<b>Description</b>	MVP-LY-049_100118 dumpster area free of trash. Looking NW. See photo for gps data.
