Visual Site Inspection Report

Project Name	H-600 Pipeline Spread H	AFE	124300138	Spread	H-600 Pipeline Spread H
Contractor	Precision			Report #	8904
Inspector	Pat Davis			Date/Time	10/5/2018 11:51 AM
Permit #	TBD	Inspection Type	VA SWPP	Station Begin	13315+70
State	VA	Inspection Area	Partial	Station End	13415+51
County	Franklin	Ground	Dry	Temperature (°F)	83.00
Municipality	N/A	Weather	Cloudy	Rain Gauge (in)	0.00
GPS Location	37.2788801579719, -80.0286986383663			Rain Accumulation Time (days)	0.00

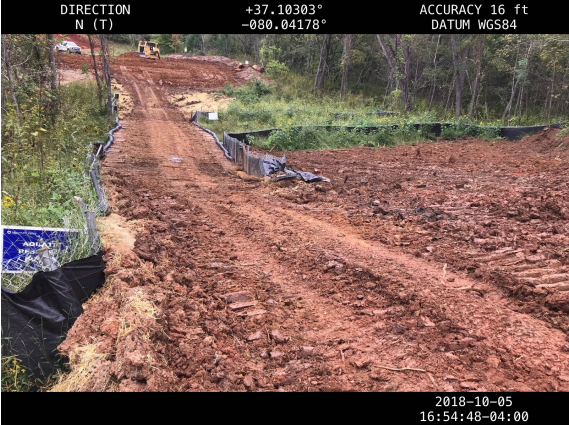
GPS Location	37.2788388804893, -80.0286594370974	GPS Location	37.2788214335809, -80.0286551805525		
Description	13348+50_100518 S-RR08 vegetation buffer graded. Looking N. See photo for gps data.	Description	13348+50_100518 S-RR08 buffer area seeded, erosion control blanket installed. Looking NE. See photo for gps data.

4. E&S BMPs (List BMPs and note if installed and maintained as per the plan. If corrective action is needed, a picture is required.)					
E&S BMPs	Compliance Level	Corrective Action		Corrective Time Frame	Date Repaired
Compost Filter Sock	Acceptable				
Housekeeping	Acceptable				
Rock Construction Entrance	Problem Area				
Sensitive Resource Buffer	Problem Area	Stabilize buffer area		Immediate	10/5/2018
Sensitive Resource Buffer	Problem Area	Stabilize buffer area		Immediate	10/5/2018
Sensitive Resource Buffer	Problem Area	Stabilize buffer area		Immediate	10/5/2018

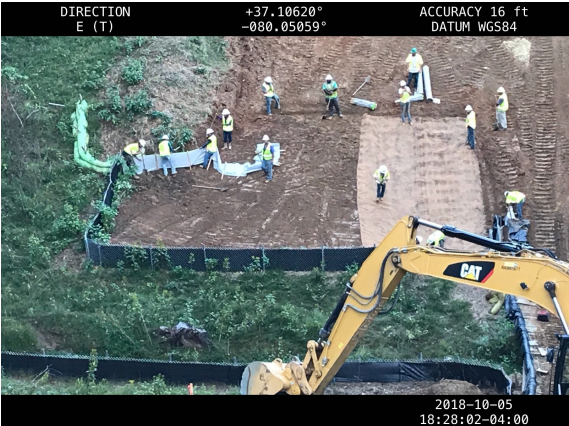
GPS Location	37.2789081372668, -80.0285732467473	GPS Location	37.2789037367676, -80.0286565628648		
Description	13321+47_100518 S-GH15 buffer area graded. Looking E. See photo for gps data.	Description	13321+47_100518 S-GH-15 buffer area stabilized. Looking N. See photo for gps data.

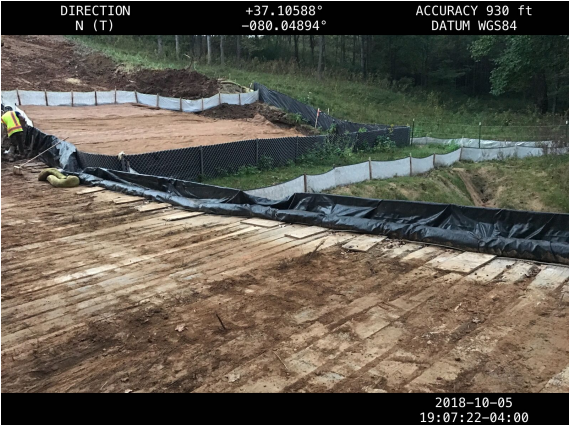
GPS Location	37.2790477797736, -80.0286912639439	GPS Location	37.279072506388, -80.0286708959192		
Description	13325+30_100518 S-GH14 west buffer stabilized. Looking N. See photo for gps data.	Description	13325+30_100518 S-GH14 east buffer stabilized. Looking E. See photo for gps data.
