Visual Site Inspection Report

Project Name	H-600 Pipeline Spread H	AFE	124300138	Spread	H-600 Pipeline Spread H
Contractor	Precision			Report #	1140
Inspector	Randy Clark			Date/Time	4/21/2018 7:20 PM
Permit #	TBD	Inspection Type	Weekly	Station Begin	13415+51
State	VA	Inspection Area	Full	Station End	13541+66
County	Montgomery	Ground	Dry	Temperature (°F)	65.00
Municipality	N/A	Weather	Sunny	Rain Gauge (in)	0.00
GPS Location	37.2691219309724, -80.0326582804588			Rain Accumulation Time (days)	4.00

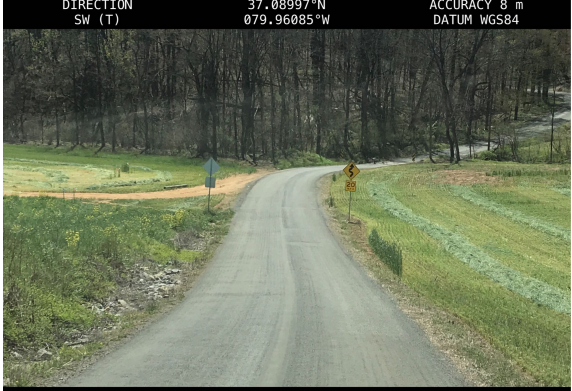
<div>Leaning Oak Road</div> <div>No activity</div> <div>2018-04-21 13:02:01-04:00</div> </div>			<div> <div>DIRECTION NE (T)</div> <div>37.08888°N 080.00523°W</div> <div>ACCURACY 6 m DATUM WGS84</div>

<div>Cahas Mountain RD. RCE installation</div> <div></div> <div>2018-04-21 12:33:42-04:00</div> </div>		
GPS Location	37.2691130302704, -80.0327303438872		GPS Location	37.2691834539788, -80.0326322716981	
Description	Leaning Oak Road pipeline crossing. (13644+82). No ground disturbance at this time. See photo for GPS data.		Description	Cahas Road crossing #2. (13496+87). Rock construction entrance in process. Temporary CFS installed. See photo for GPS data.	
<div> <div>DIRECTION S (T)</div> <div>37.09216°N 079.99133°W</div> <div>ACCURACY 12 m DATUM WGS84</div>

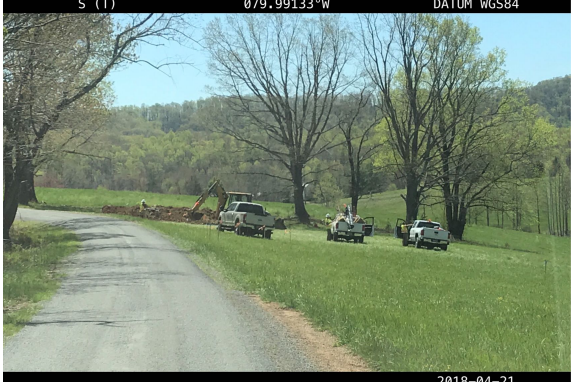
<div>House Rock Road</div> <div>RCE installation</div> <div>2018-04-21 12:46:18-04:00</div> </div>			<div> <div>DIRECTION N (T)</div> <div>37.09247°N 079.97963°W</div> <div>ACCURACY 8 m DATUM WGS84</div>

GPS Location	37.2692204174001, -80.032885568291		GPS Location	37.2693530191083, -80.0329884980619	
Description	House Rock Road. (13541+66). Rock construction entrance in process. Temporary CFS installed. See photo for GPS data.		Description	Monty Road. (13575+31). Fencing crew installing safety goalposts. See photo for GPS data.	
Insert image here			Insert image here		
GPS Location			GPS Location		
Description			Description

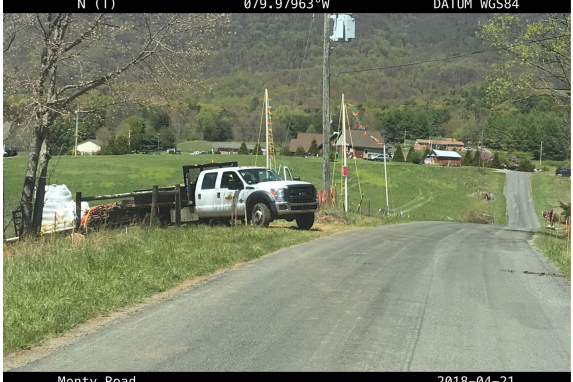
<div>Monty Road</div> <div>Fencing crew</div> <div>2018-04-21 12:55:01-04:00</div> </div>
