# Visual Site Inspection Report

<b>Project Name</b>	H-600 Pipeline Spread H	<b>AFE</b>	124300138	<b>Spread</b>	H-600 Pipeline Spread H
<b>Contractor</b>	Precision			<b>Report #</b>	2186
<b>Inspector</b>	Randy Clark			<b>Date/Time</b>	5/14/2018 5:45 PM
<b>Permit #</b>	TBD	<b>Inspection Type</b>	VA SWPP	<b>Station Begin</b>	12005+00
<b>State</b>	VA	<b>Inspection Area</b>	Full	<b>Station End</b>	12371+00
<b>County</b>	Montgomery	<b>Ground</b>	Dry	<b>Temperature (°F)</b>	87.00
<b>Municipality</b>	N/A	<b>Weather</b>	Sunny	<b>Rain Gauge (in)</b>	0.10
<b>GPS Location</b>	37.2692031542643, -80.0324699220121			<b>Rain Accumulation Time (days)</b>	4.00

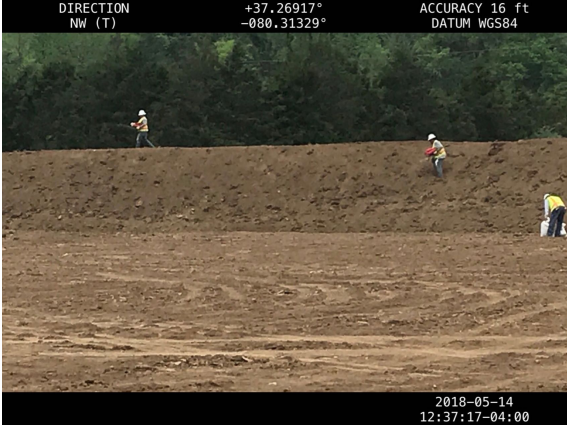
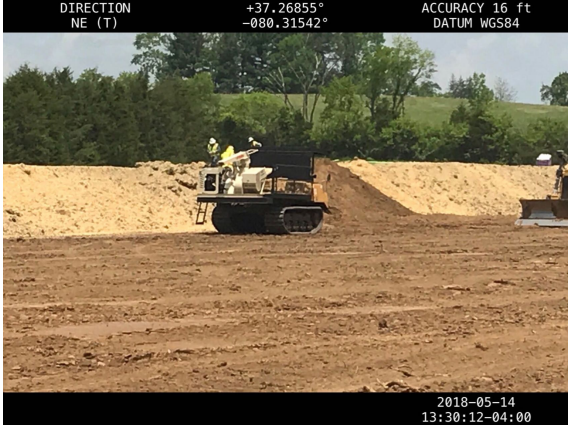
2018-05-14 13:30:12-04:00			
<b>GPS Location</b>	37.2692052778777, -80.0325726345885		<b>GPS Location</b>	37.2692026289589, -80.0325227382771	
<b>Description</b>	See photo for GPS data. MVP-ATWS-473 Crew seeding topsoil storage pile. See photo for GPS data.		<b>Description</b>	See photo for GPS data. MVP-ATWS-473 Crew mulching topsoil storage pile. See photo for GPS data.	
DIRECTION E (T)      +37.26741°      ACCURACY 16 ft -080.31333°      DATUM WGS84

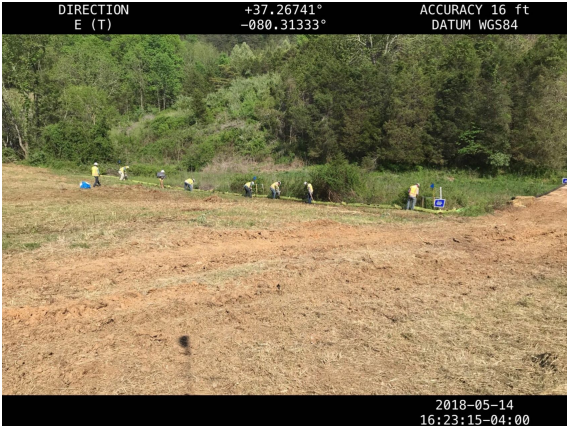
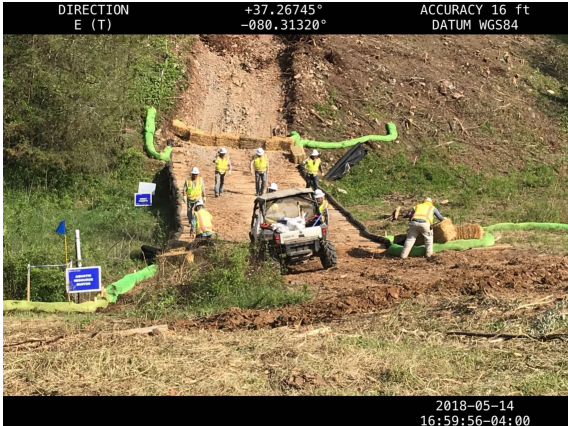
<b>Description</b>	See photo for GPS data. Perimeter erosion control devices being installed in ATWS-474A.		<b>Description</b>	Crew installing perimeter erosion control devices at stream (S-G38). See photo for GPS data.	
DIRECTION S (T)      +37.26876°      ACCURACY 16 ft -080.31435°      DATUM WGS84

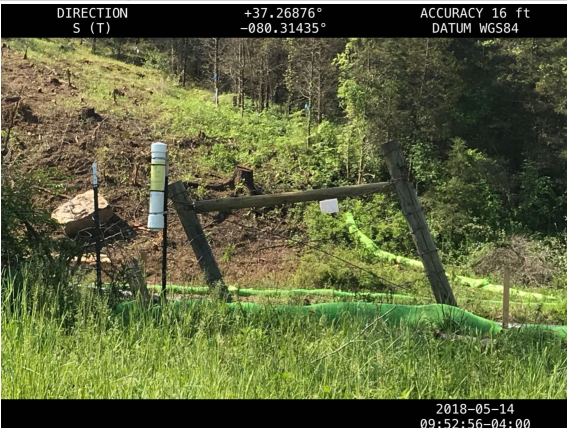
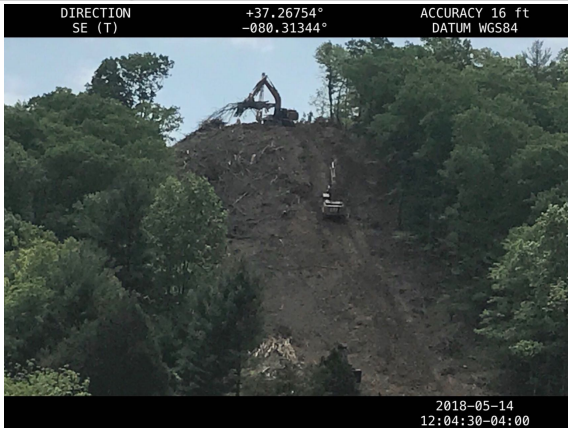
2018-05-14 12:04:30-04:00			
<b>GPS Location</b>	37.2691799747173, -80.0330905058235		<b>GPS Location</b>	37.2691332456072, -80.0328016654402	
<b>Description</b>	VMRC stream placard and associated stream crossing permits posted at stream (S-G36). See photo for GPS data.		<b>Description</b>	Crew performing mechanized clearing activity, gathering brush and processing timber. No grubbing activity. See photo for GPS data.
