# Visual Site Inspection Report

<b>Project Name</b>	H-600 Pipeline Spread H	<b>AFE</b>	124300138	<b>Spread</b>	H-600 Pipeline Spread H
<b>Contractor</b>	Precision			<b>Report #</b>	2190
<b>Inspector</b>	Randy Clark			<b>Date/Time</b>	5/14/2018 7:30 PM
<b>Permit #</b>	TBD	<b>Inspection Type</b>	VA SWPP	<b>Station Begin</b>	12371+00
<b>State</b>	VA	<b>Inspection Area</b>	Full	<b>Station End</b>	13415+00
<b>County</b>	Franklin	<b>Ground</b>	Dry	<b>Temperature (°F)</b>	84.00
<b>Municipality</b>	N/A	<b>Weather</b>	Sunny	<b>Rain Gauge (in)</b>	0.10
<b>GPS Location</b>	37.2691913670757, -80.0326987556209			<b>Rain Accumulation Time (days)</b>	4.00

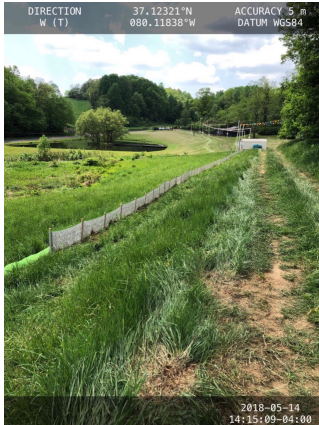
GPS Location	37.2692023946206, -80.0324963057955		GPS Location	37.2692516275132, -80.0325732667017	
Description	MVP-FR-290 erosion control devices installed. See photo for GPS data.		Description	Signage in place at stream crossing (S-G26) the next bridge crossing planned for installation. See photo for GPS data.

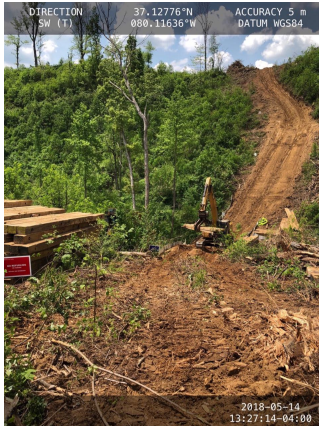
Insert image here		
GPS Location	37.2692509086445, -80.0325772082469		GPS Location		
Description	Stream crossing (S-H1) during construction. See photo for GPS data		Description		
Insert image here			Insert image here		
GPS Location			GPS Location		
Description			Description
