Visual Site Inspection Report

Project Name H-600 Pipeline Spread H		AFE 124300138	Spread H-600 Pipeline Spread H
Contractor Precision		Report # 2508	
Inspector Tracey Hilbun		Date/Time 5/30/2018 1:00 PM	
Permit # TBD	Inspection Type VA SWPP	Station Begin 13415+51	
State VA	Inspection Area Full	Station End 13670+00	
County Franklin	Ground Wet	Temperature (°F) 89.00	
Municipality N/A	Weather Cloudy	Rain Gauge (in) 0.70	
GPS Location 37.0593923193355, -79.8825644734487		Rain Accumulation Time (days) 4.00

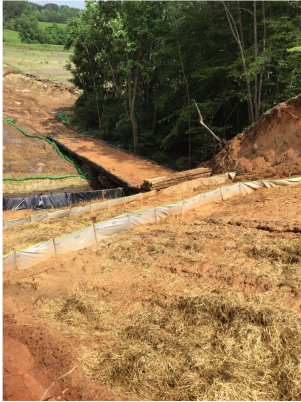
GPS Location	37.0594094787138, -79.8825511895864		GPS Location	37.0594305592003, -79.8826418817787	
Description	GA House Rock Road after rain event		Description	Grading crew working on grading operations

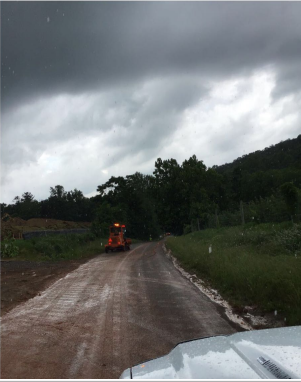
Insert image here		
GPS Location	37.059385432268, -79.8825697553662		GPS Location		
Description	Sweeper at Cahas Road #1 working on road		Description		
Insert image here			Insert image here		
GPS Location			GPS Location		
Description			Description
