# Visual Site Inspection Report

| <b>Project Name</b> | H-600 Pipeline Spread G | | <b>AFE</b> | 124300137 | <b>Spread</b> | H-600 Pipeline Spread G | |
| <b>Contractor</b> | Precision | | | | <b>Report #</b> | 9783 | |
| <b>Inspector</b> | Clinton Banks | | | | <b>Date/Time</b> | 10/22/2018 3:27 AM | |

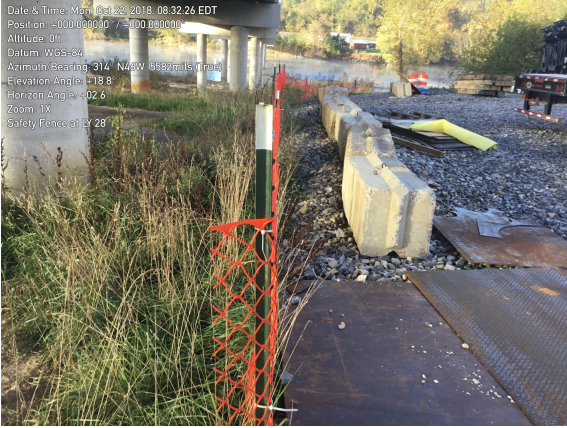
| <b>Description</b> | Safety Fence at LY 28 | <b>Description</b> | Compost Filter Sock at LY 28 | | |

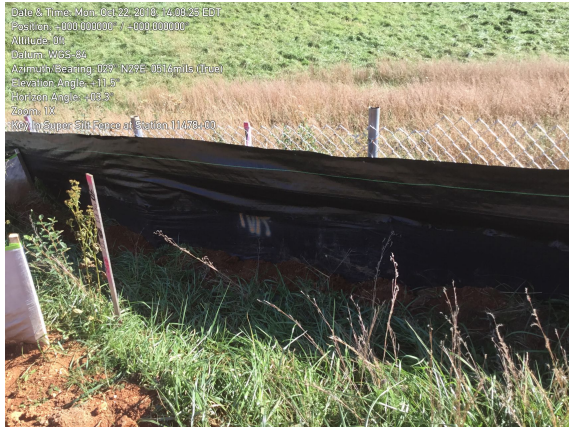
| Description | Key In Super Silt Fence at Station 11478+00 | Description | WaterBar at Station 11454+94 | | |

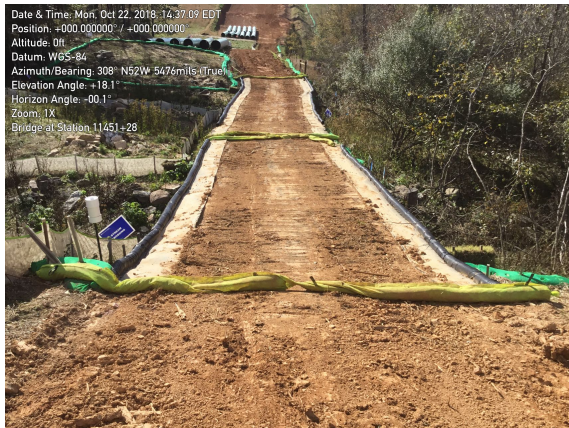
| Description | Bridge at Station 11451+28 at Stream S-0013 | Description | Top Strang of Barbwire off at Station 11500+00 | | |

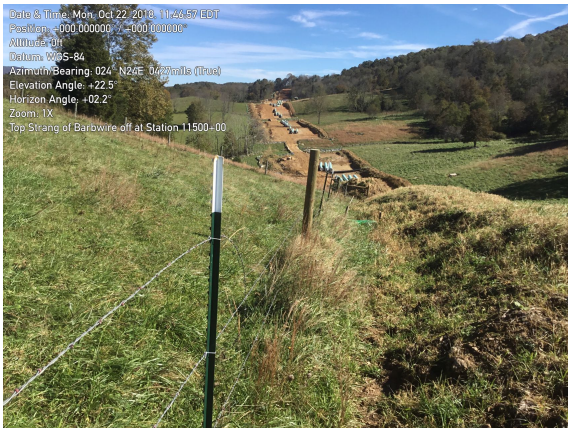
| While walking ROW observed Top Strand of Barbwire off at Station 11500+00. Crew made necessary repairs. P-1 Silt Fence at Station 11513+09 needed repaired where Cow kicked a hole in P-1. Crew addressed the issue. Crew keyed in Super Silt Fence at Station 11478+00. Part of the Crew worked on wrapping pipe on Sinking Creek for Stabilizing. Went from Station 11524+16 M.P. 218.0 To 11436+00 M.P. 216.5 | | | | | |

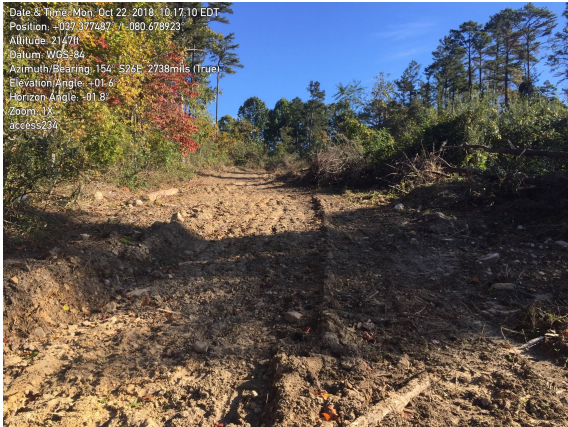
| Description | Access 234 new fence installed by land owner | | Description | Access 234 and Row 10502+00 area crew to repair | |

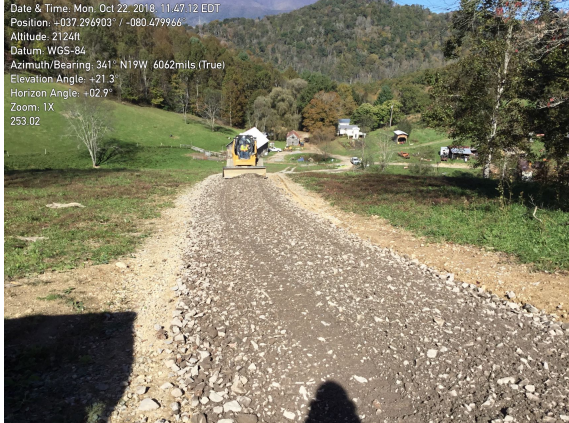
| Description | ROw conditions @ MP 213 | Description | Crews adding stone to AR 253.02 | | |

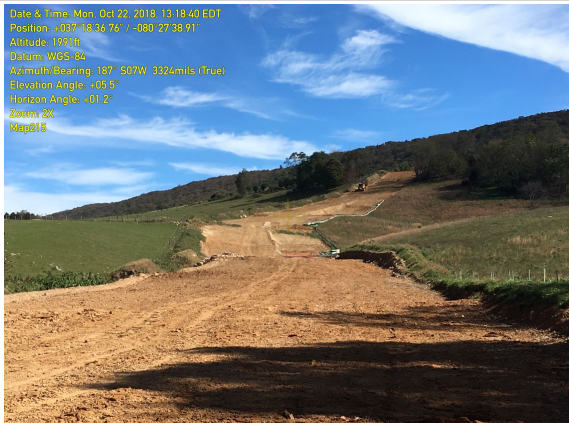
| Description | Plunge pool for CWD @ MP 215 | Description | ROW conditions and crews working on maintenance of water bars and sumps @ MP 215 | | |

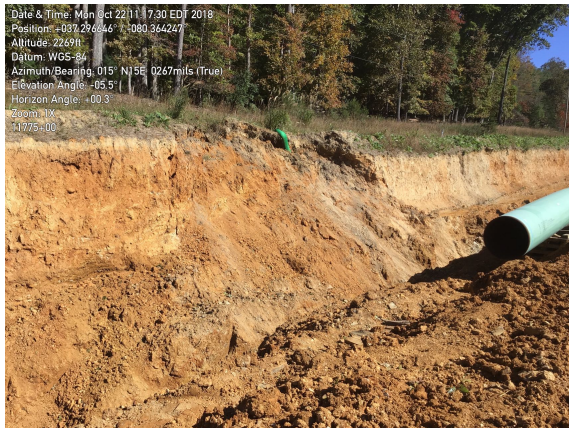
| Description | See photo for GPS location and station number. Slip that occurred along cut wall. | | Description | See photo for GPS location and station number. Top soil pile requested to have priority one silt fence installed around. | |

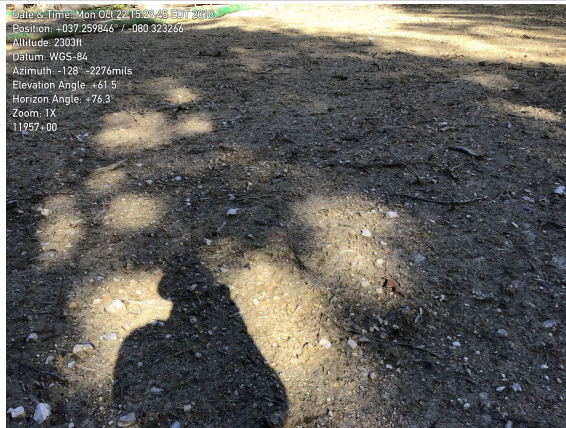
| Description | See photo for GPS location and station number. Permanent water bar and rock level spreader in place. | | Description | See photo for GPS location and station number. Area restored and hydro mulched, no vegetation growth present. | |

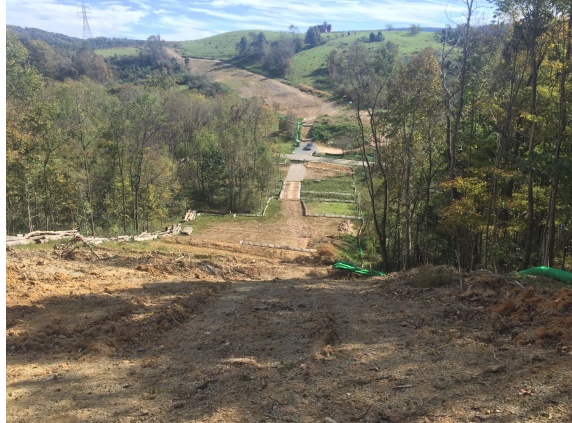
| <b>Description</b> | End treatment previous destroyed by tree upruttred no Issues | <b>Description</b> | 10916+00 looking toward Dow Creek not much growth | | |

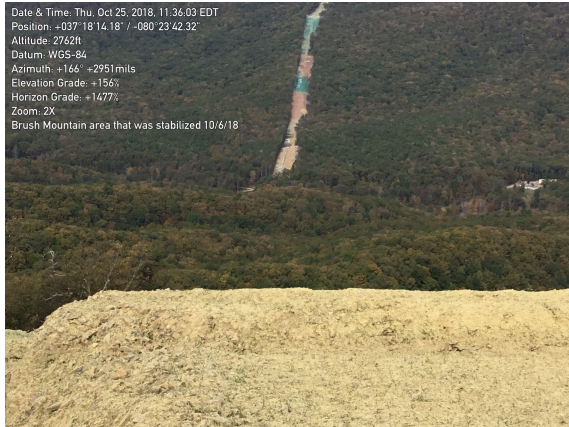
| Description | Area of little seed germination. | Description | Environmental controls in place. | | |

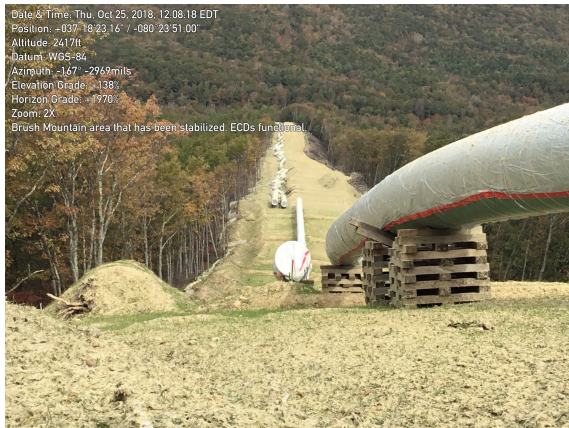
| Description | Sparse vegetation currently. | Description | Area exhibiting good germination. | | |
