# Visual Site Inspection Report

<b>Project Name</b>	H-600 Pipeline Spread G		<b>AFE</b>	124300137	<b>Spread</b>	H-600 Pipeline Spread G	
<b>Contractor</b>	Precision				<b>Report #</b>	9976	
<b>Inspector</b>	Clinton Banks				<b>Date/Time</b>	10/26/2018 4:43 AM	
<b>Permit #</b>	TBD	<b>Inspection Type</b>	VA SWPP		<b>Station Begin</b>	+28	
<b>State</b>	VA	<b>Inspection Area</b>	Full		<b>Station End</b>	+28	
<b>County</b>	Giles	<b>Ground</b>	Wet		<b>Temperature (°F)</b>	47.00	
<b>Municipality</b>	N/A	<b>Weather</b>	Light Rain		<b>Rain Gauge (in)</b>	0.00	
<b>GPS Location</b>	37.3363111296258, -80.8085777456705			<b>Rain Accumulation Time (days)</b>	1.00

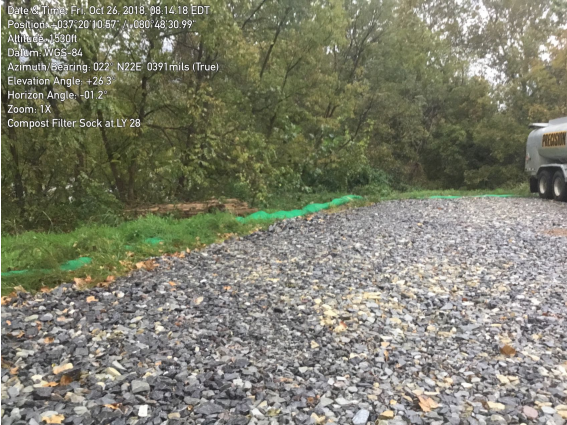
<p> Date &amp; Time: Fri, Oct 26, 2018 08:14:18 EDT  Position: +037°20'10.57" N, -080°48'30.99" W  Altitude: 189ft  Datum: WGS 84  Azimuth Bearing: 022° N22E 0391mils (True)  Elevation Angle: +26°  Horizon Angle: -01.2°  Zoom: 1X  Compost Filter Sock at LY 28 </p>

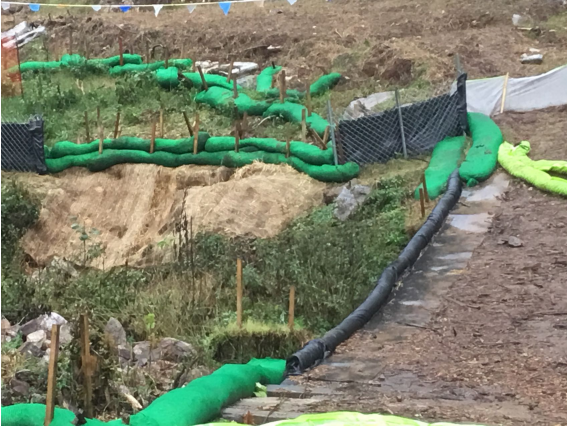
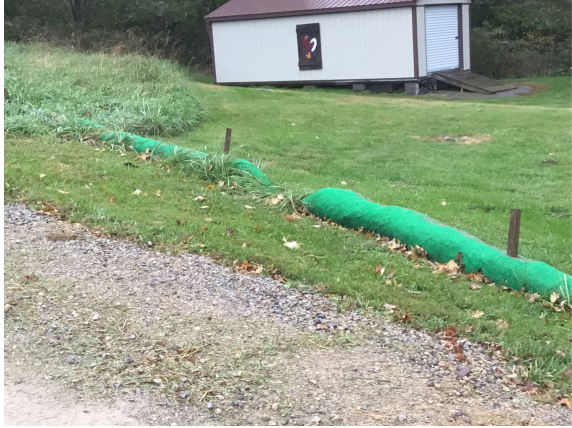
<b>GPS Location</b>	37.3491494916727, -80.6528347638255	<b>GPS Location</b>	37.3506958689888, -80.6504010782397		
<b>Description</b>	Stream S G 32 fiber in place no washing	<b>Description</b>	Buffalo Anklets 241.02 missing 2' of filter sock location

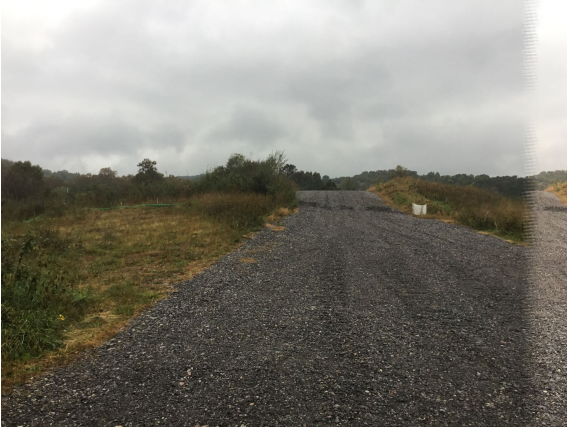
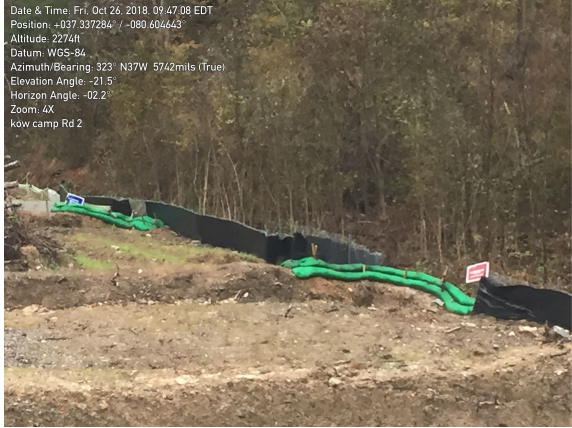
<b>GPS Location</b>	37.3706446308991, -80.6819560938335	<b>GPS Location</b>	37.3337481122415, -80.7502498730787		
<b>Description</b>	Access 235 no issues off Roger Rd	<b>Description</b>	Kow camp 2 Checked were crew cut super silt fence

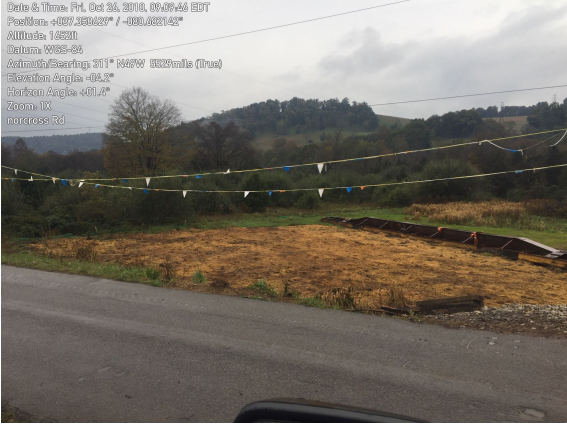
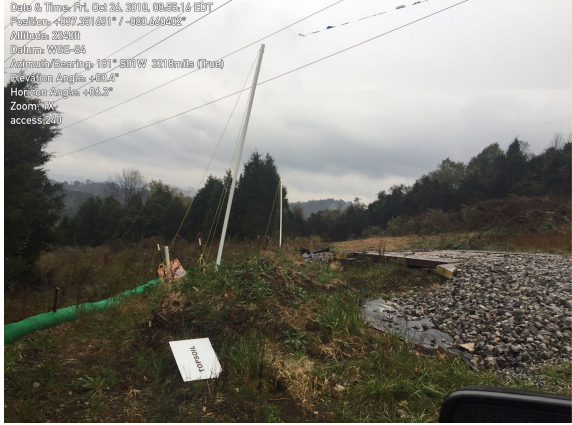
<b>GPS Location</b>	37.3337533378797, -80.7502476950833	<b>GPS Location</b>	37.3337447152655, -80.7502512889053		
<b>Description</b>	Norcross rd all mats removed area seeded and mulched	<b>Description</b>	Access 240 checked area that had material picked up all clear

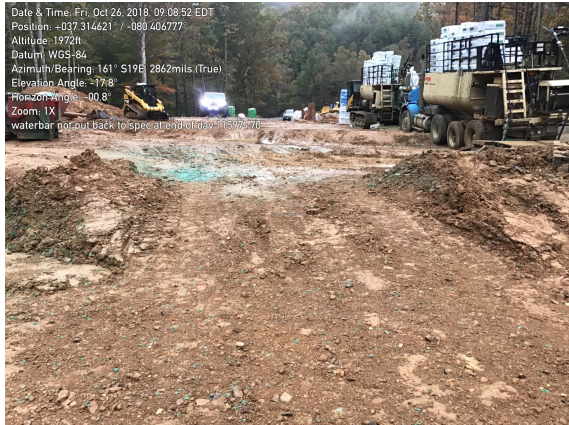
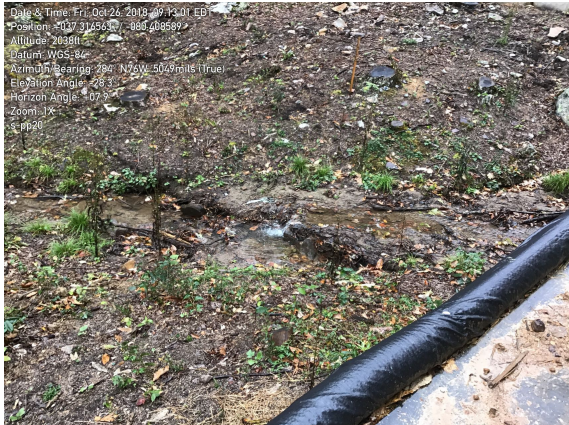
GPS Location	37.3143402859916, -80.4066238180552	GPS Location	37.3143402859916, -80.4066238180552		
Description	Waterbars above Craig creek access rd not reinstalled.	Description	Stream s-pp20 no impacts observed.		
<p>Date &amp; Time: Fri, Oct 26, 2018 09:13:14 EDT Position: +037.316553 / -080.408610 Altitude: 2031ft Datum: WGS-84 Azimuth/Bearing: 249° S69W 4427mils (True) Elevation Angle: -20.4° Horizon Angle: -06.2° Zoom: 1X s-pp20</p>

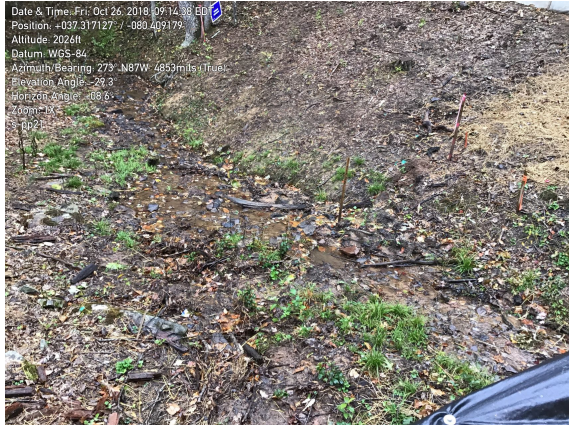
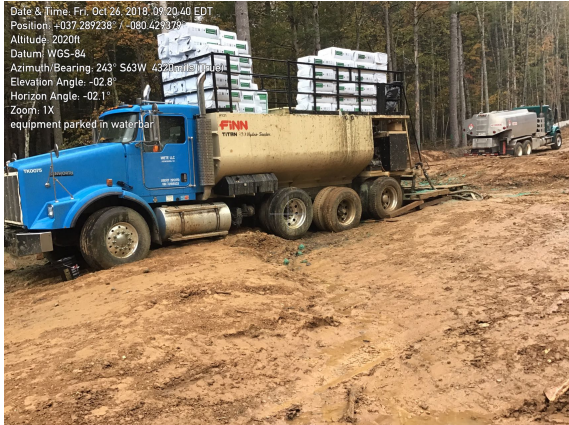
<p>Date &amp; Time: Fri, Oct 26, 2018 09:20:40 EDT Position: +037.289238 / -080.423070 Altitude: 2020ft Datum: WGS-84 Azimuth/Bearing: 243° S63W 4571mils (True) Elevation Angle: -02.8° Horizon Angle: -02.1° Zoom: 1X equipment parked in waterbar</p>

GPS Location	37.3144318163742, -80.4065476265553	GPS Location	37.314387685654, -80.4065751191977		
Description	Stream s-pp21 no impacts observed.	Description	Hydroseeding truck parked within throat of waterbar. Mike Perry and Rob Robertson notified.

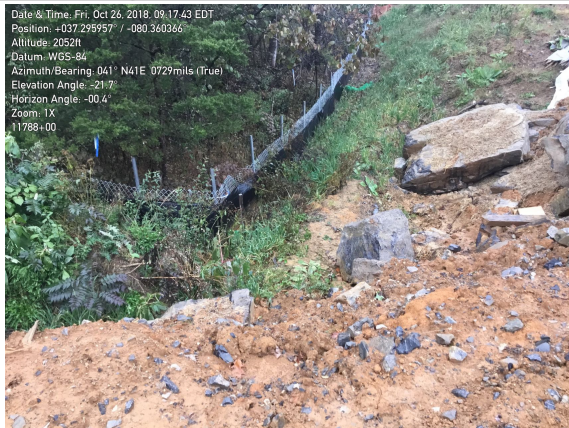
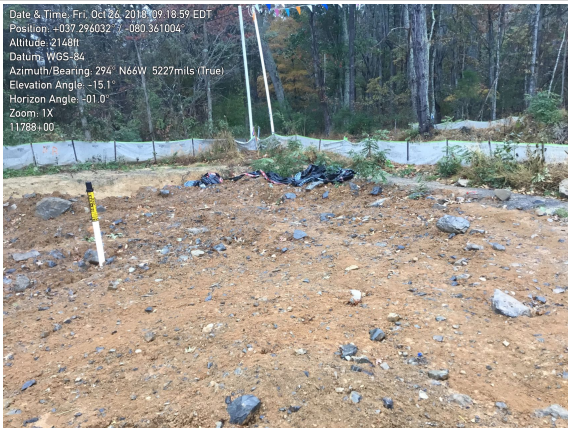
GPS Location	37.3337684066413, -80.7502450573808	GPS Location	37.3337418819765, -80.7502567190091		
Description	Super silt fence protecting karst feature 11788+00	Description	Trash observed on row 11788+00
