# Visual Site Inspection Report

<b>Project Name</b>	H-600 Pipeline Spread H	<b>AFE</b>	124300138	<b>Spread</b>	H-600 Pipeline Spread H
<b>Contractor</b>	Precision			<b>Report #</b>	9190
<b>Inspector</b>	Glenn Mike Renfro			<b>Date/Time</b>	10/10/2018 1:32 PM
<b>Permit #</b>	TBD	<b>Inspection Type</b>	VA SWPP	<b>Station Begin</b>	13415+00
<b>State</b>	VA	<b>Inspection Area</b>	Full	<b>Station End</b>	13670+00
<b>County</b>	Franklin	<b>Ground</b>	Damp	<b>Temperature (°F)</b>	72.00
<b>Municipality</b>	N/A	<b>Weather</b>	Light Rain	<b>Rain Gauge (in)</b>	0.15
<b>GPS Location</b>	36.9719008717635, -79.8701711648243			<b>Rain Accumulation Time (days)</b>	1.00

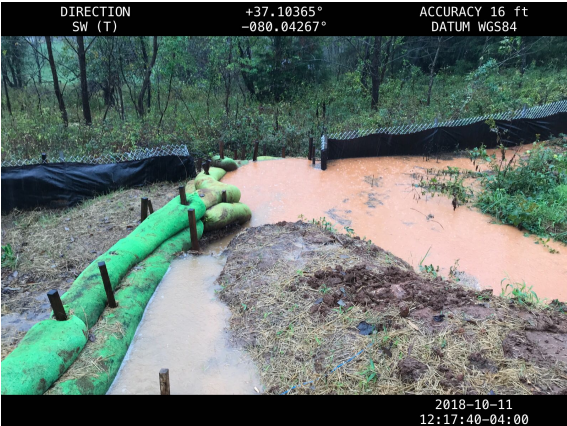
2018-10-11 12:17:40-04:00		DIRECTION S (T)      +37.10246°      ACCURACY 16 ft -080.04112°      DATUM WGS84   2018-10-11 12:28:48-04:00			
<b>GPS Location</b>	37.2788188280885, -80.028683552593	<b>GPS Location</b>	37.2789724683736, -80.0286769308895

<b>Description</b>	13349+21_101118 sump full overflowing ECD's. Looking SW. See photo for gps data.	<b>Description</b>	13352+23_101118 turbid stormwater flowing onto bridge mats. Looking S. See photo for gps data.		
DIRECTION SE (T)      +37.10115°      ACCURACY 16 ft -080.03979°      DATUM WGS84

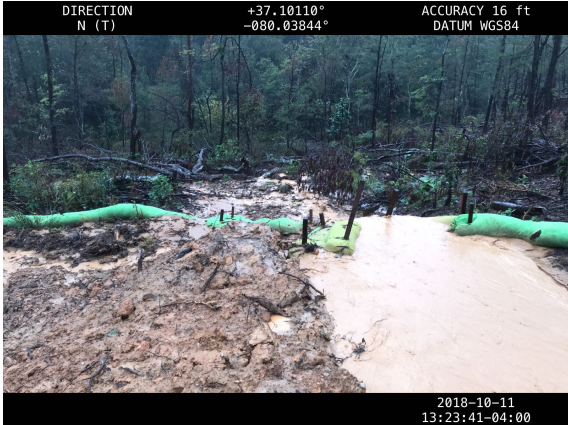
2018-10-11 13:23:41-04:00			
<b>GPS Location</b>	37.278639078175, -80.0285361987352	<b>GPS Location</b>	37.278639078175, -80.0285361987352		
<b>Description</b>	13358+64_101118 S-RR11 turbid water overflowing ECD's. Looking SE. See photo for gps data.	<b>Description</b>	13362+50_101118 sump full and overflowing turbid water. Looking N. See photo for gps data.

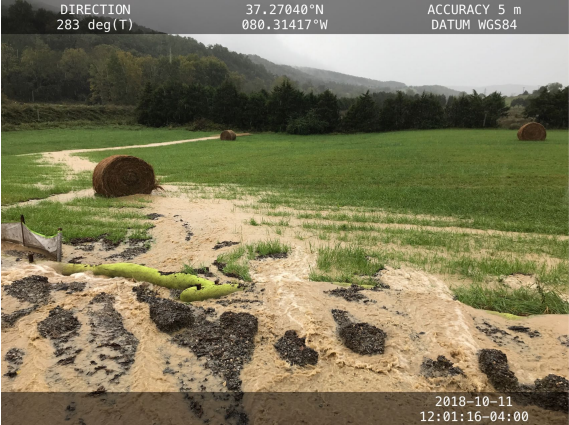
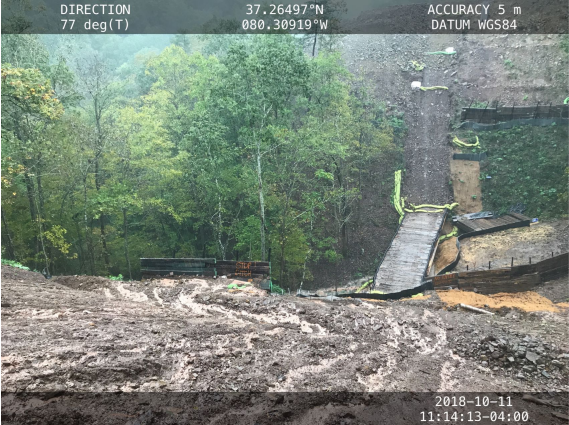
<b>GPS Location</b>	37.0697167175268, -80.6152235707647		<b>GPS Location</b>	37.0700079342696, -80.6153321173793	
<b>Description</b>	See photo for gps data. Gravel from access road 268.0 was deposited off ROW on the west side of the road.		<b>Description</b>	See photo for gps data. Soil sloughed into waterbars and water topping waterbars from 12028+50 to 12030+00.

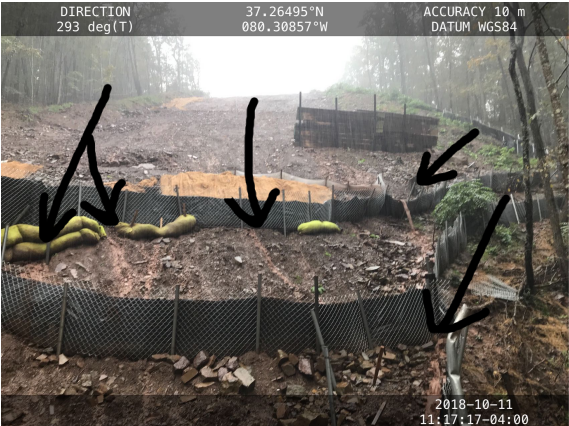
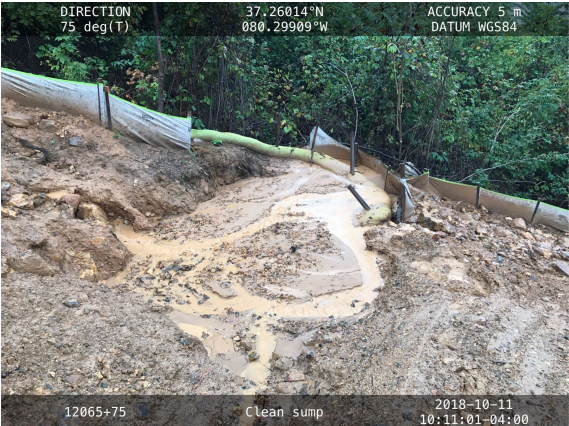
<b>GPS Location</b>	37.0698936051103, -80.6151953247195		<b>GPS Location</b>	37.0698852232071, -80.6150012836611	
<b>Description</b>	See photo for gps data. Super silt fence leaning and being topped and also being undermined at about 12030+50.		<b>Description</b>	See photo for gps data. Sump at 12065+70 is full of sediment and needs to be cleaned out.

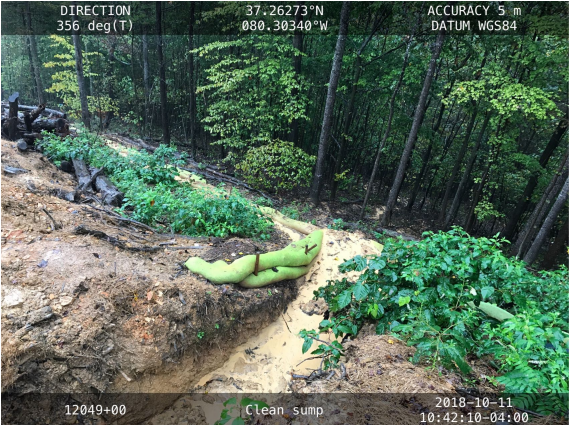
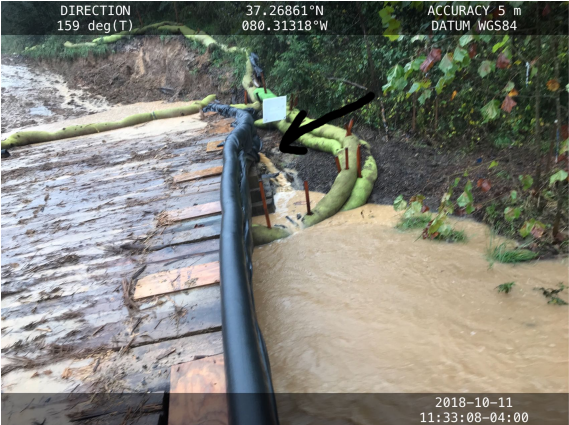
<b>Description</b>	See photo for gps data. Sump at 12049+00 is full of sediment and needs to be cleaned out.		<b>Description</b>	See photo for gps data. Hole in the geotextile lap on the AR-268.01 bridge over SG36.

<b>AFE</b>	124300138	<b>Date/Time</b>	10/11/2018 9:14 AM	<b>Report #</b>	9233
<b>6. PCSM BMPs</b> (List BMPs and note if installed and maintained as per the plan. If corrective action is needed, a picture is required.)					
<b>PCSM BMPs</b>	<b>Compliance Level</b>	<b>Corrective Action</b>	<b>Corrective Time Frame</b>	<b>Date Repaired</b>	
<b>7. Identify all remedial measures that have been taken since the previous inspection was conducted.</b> The following items were performed in this area since the last SWPPP inspection: - Reconstructed the diversion berm from 12020+00 to 12023+00. - reconstructed each of the waterbars from 12045+00 to 12055+00.					
<b>Comments</b> (Reference above questions as appropriate.) It rained about 1.75 inches since yesterday morning according to the rain gauge at Catawba Road and it rained an additional 1.5 inches between 8:00 am and 12:00 pm this morning. The rain continued the rest of the day today. Precision did not work in the area from 12005+00 to 12072+00 today due to the wet conditions. I performed a SWPPP inspection from 12005+00 to 12072+00 today. Off site impacts were observed along the west side of access road MVP-MN-268. Flow from the off-ROW drainage along the east side of the access road, topped it's banks and crossed the access road. Gravel was washed across the 12" CFS on the west side of the road and deposited just off the ROW in the grassy field on the west side of the access road. The following items were observed during this inspection and should be addressed when the ROW is dry enough to safely access: - Clean up off-ROW gravel along the west side of access road 268.0. - Soil sloughed into the waterbars from 12028+50 to 12030+00, causing the waterbars to be topped. These waterbars should be cleaned out and regraded to shed water to the sumps. - Super silt fence at about 12030+50 is leaning, being topped and undermined in places. The super silt fence should be straightened, tightened and keyed in to prevent water from freely flowing under or over it, to the bridge at SG39. - Sump at 12049+00 is full of sediment and will need to be cleaned out - Sump at 12057+50 is full of sediment and will need to be cleaned out - Sump at 12065+30 is full of sediment and will need to be cleaned out - Sump at 12065+75 is full of sediment and will need to be cleaned out - Hole was observed in the geotextile on the AR-268.01 bridge over SG36. Hole should be repaired.

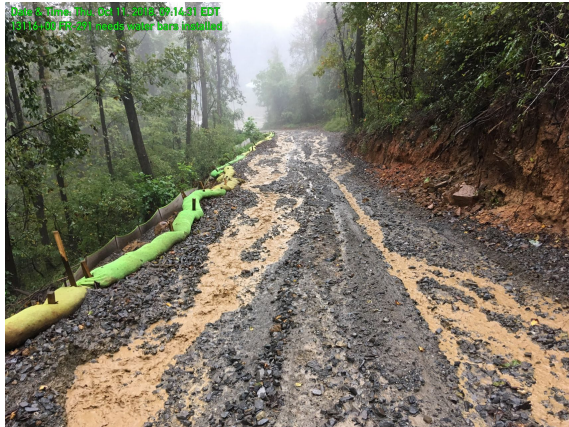
AFE	124300138	Date/Time	10/11/2018 5:30 PM	Report #	9254
Pictures					
<div><div>Date &amp; Time: Thu, Oct 11, 2018 10:14:31 EDT 10:14:31 EDT water bars installed</div>

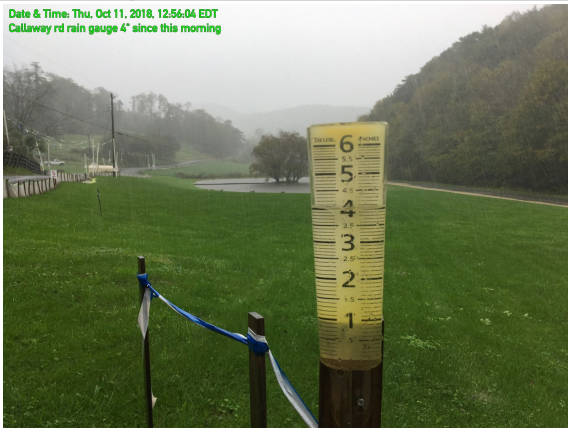
</div>		<div><div>Date &amp; Time: Thu, Oct 11, 2018, 12:56:04 EDT Callaway rd rain gauge 4" since this morning</div>

</div>			
GPS Location		37.2939445171853, -80.0226601493359		GPS Location	
Description		Silt sock slid off of access road		37.2938793827429, -80.0228776161323	
		Description		4" additional rain in 4.5 hours

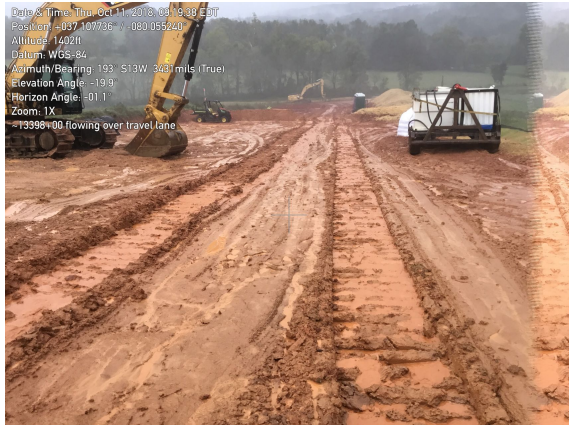
A/E	124300138	Date/Time	10/11/2018 8:28 PM	Report #	9265
Pictures					
<p>Date &amp; Time: Thu, Oct 11, 2018, 09:19:38 EDT Position: +037.107736 / -080.055240 Altitude: 1402ft Datum: WGS-84 Azimuth/Bearing: 193° S13W 323mils (True) Elevation Angle: +19.9° Horizon Angle: -01.1° Zoom: 1X ~13398+00 flowing over travel lane</p>

GPS Location	37.106542345171, -80.0519891829044		GPS Location	37.1066373540434, -80.0523618423194	
Description	Please see photo for coordinates. ~Sta. No. 13398+00, travel lane through all waterbars knocked out from equipment.		Description	Please see photo for coordinates. ~Sta. No. 13397+50, water ponding due to travel lane knocked out and obstructing flow.

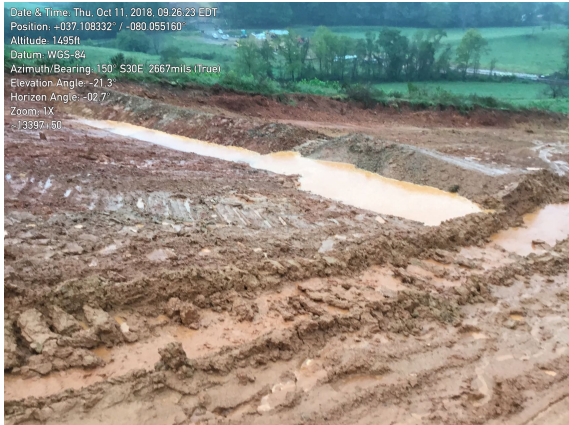
<p>Date &amp; Time: Thu, Oct 11, 2018, 09:26:23 EDT Position: +037.108332 / -080.055160 Altitude: 1495ft Datum: WGS-84 Azimuth/Bearing: 150° S30E 2667mils (True) Elevation Angle: +21.3° Horizon Angle: -02.7° Zoom: 1X ~13397+50</p>

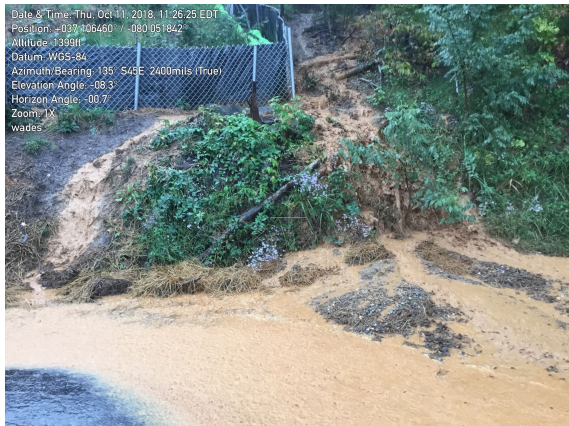
<p>Date &amp; Time: Thu, Oct 11, 2018, 11:26:25 EDT Position: +037.106460 / -080.051842 Altitude: 1399ft Datum: WGS-84 Azimuth/Bearing: 139° S45E 2400mils (True) Elevation Angle: -08.3° Horizon Angle: -00.7° Zoom: 1X wades</p>

GPS Location	37.1066471189606, -80.0522742514313		GPS Location	37.1066471189606, -80.0522742514313	
Description	Please see photo for coordinates. Sta. No. 13315+70, Wade's Gap Road crossing, sediment and gravel in public road.		Description	Please see photo for coordinates. Sta. No. 13317+02, turbid water running down from outlet impacting private drive.	
<p>Date &amp; Time: Thu, Oct 11, 2018, 11:27:06 EDT Position: +037.106112 / -080.052203 Altitude: 1438ft Datum: WGS-84 Azimuth/Bearing: 197° S17W 3502mils (True) Elevation Angle: -07.6° Horizon Angle: +00.5° Zoom: 1X wades driveway</p>

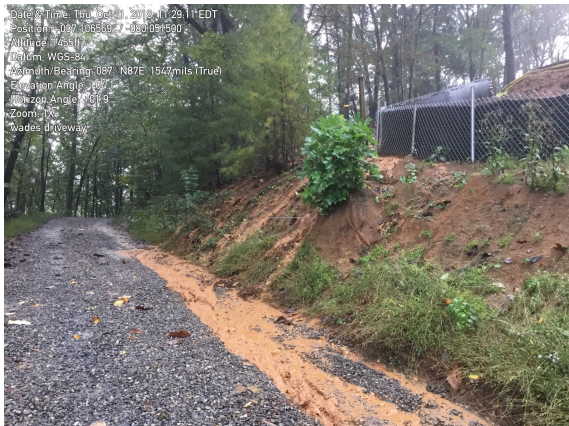
<p>Date &amp; Time: Thu, Oct 11, 2018, 11:28:17 EDT Position: +037.106686 / -080.051900 Altitude: 1431ft Datum: WGS-84 Azimuth/Bearing: 087° N87E 1542mils (True) Elevation Angle: +07.1° Horizon Angle: -00.9° Zoom: 1X wades driveway</p>

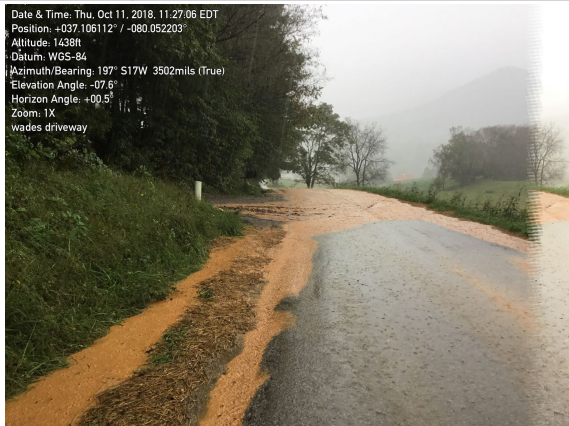
GPS Location	37.1066471189606, -80.0522742514313		GPS Location	37.1066471189606, -80.0522742514313	
Description	Please see photo for coordinates. Sta. No. 13317+02, private drive washed out onto Wade's Gap Road.		Description	Please see photo for coordinates. ~Sta. No. 13308+00, ponding in and overtopping outlet.

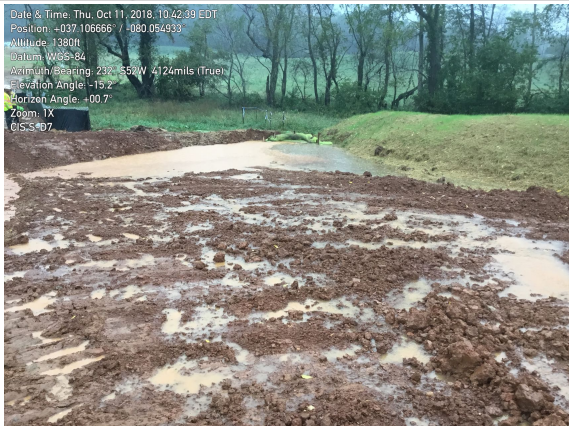
<p>Date &amp; Time: Thu, Oct 11, 2018, 10:42:39 EDT Position: +037.106666 / -080.054933 Altitude: 1380ft Datum: WGS-84 Azimuth/Bearing: 233° S50W 4124mils (True) Elevation Angle: -15.2° Horizon Angle: +00.7° Zoom: 1X GIS-07</p>

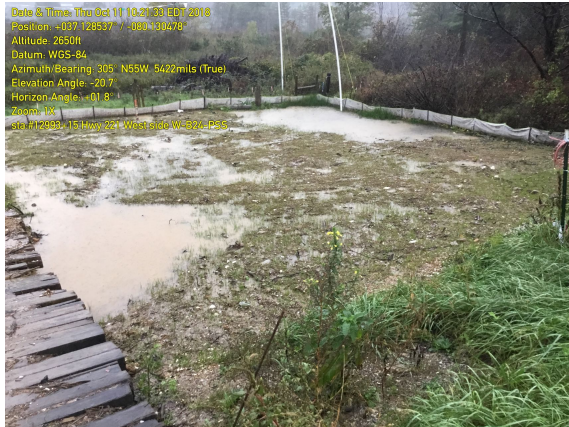
A/E	124300138	Date/Time	10/11/2018 9:05 PM	Report #	9268
Pictures					
<p><small>Date &amp; Time: Thu Oct 11 10:27:31 EDT 2018 Position: +037.128537° / -080.130276° Altitude: 2650ft Datum: WGS-84 Azimuth/Bearing: 305° N55W 5422mils (True) Elevation Angle: -20.7° Horizon Angle: -01.8° Zoom: 1X Sta.#12993+15 Hwy 221 West side W-B24-PSS</small></p>

GPS Location	37.2881973426188, -80.0394734182882	GPS Location	37.2873386973862, -80.0395697169751		
Description	Sta:#12993+15 W-B24-PSS is stabilized. See photo for accurate coordinates.	Description	Sta:#12994+02 East side of Hwy 221 RCE in compliance. See photo for accurate coordinates.

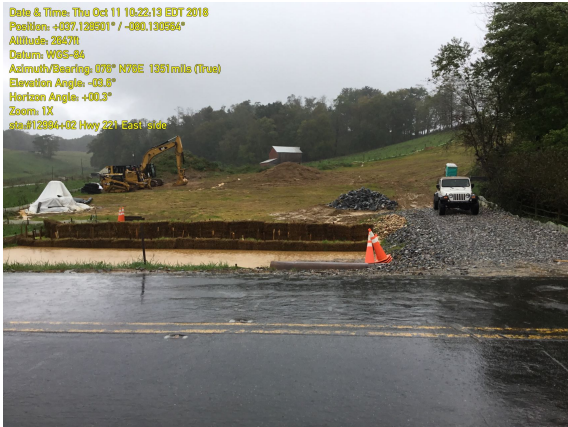
<p><small>Date &amp; Time: Thu Oct 11 10:22:19 EDT 2018 Position: +037.128601° / -080.130664° Altitude: 2647ft Datum: WGS-84 Azimuth/Bearing: 078° N78E 1361mils (True) Elevation Angle: -03.8° Horizon Angle: +00.3° Zoom: 1X Sta.#12994+02 Hwy 221 East side</small></p>

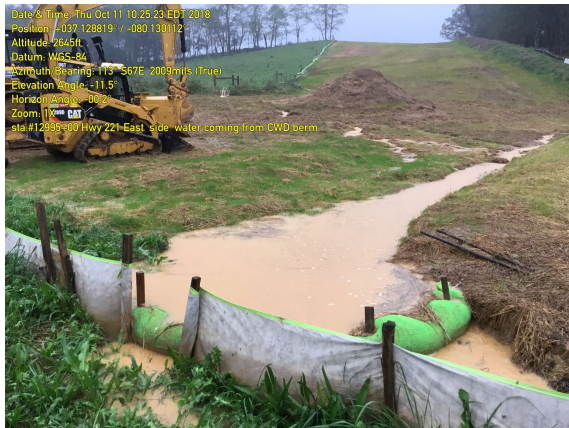
<p><small>Date &amp; Time: Thu Oct 11 10:29:23 EDT 2018 Position: +037.128819° / -080.131112° Altitude: 2646ft Datum: WGS-84 Azimuth/Bearing: 113° S67E 2009mils (True) Elevation Angle: -11.5° Horizon Angle: -00.5° Zoom: 1X Sta.#12995+00 Hwy 221 East side Water coming from CWD berm</small></p>

GPS Location	37.2873208439325, -80.0394987222553	GPS Location	37.2872756235649, -80.0396521949023		
Description	Sta:#12995+00 P1SF holding back water. See photo for accurate coordinates.	Description	Sta:#12997+00 looking West toward Hwy 221 CWD full. See photo for accurate coordinates.		
<p><small>Date &amp; Time: Thu Oct 11 13:34:16 EDT 2018 Position: +037.128500° / -080.130520° Altitude: 2644ft Datum: WGS-84 Azimuth/Bearing: 335° N35W 5653mils (True) Elevation Angle: -16.2° Horizon Angle: -01.4° Zoom: 1X Sta.#12994+20 East side Hwy 221 too much water</small></p>

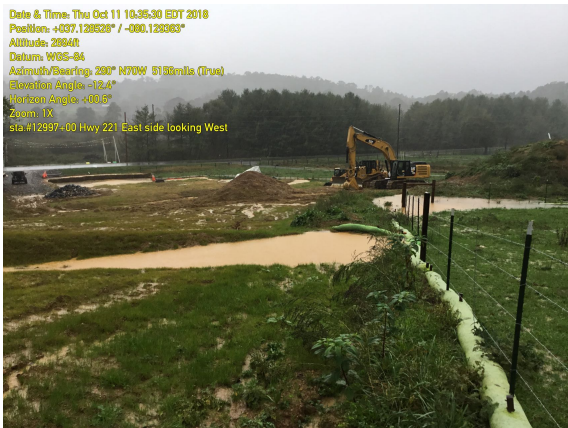
<p><small>Date &amp; Time: Thu Oct 11 10:35:30 EDT 2018 Position: +037.128822° / -080.128303° Altitude: 2644ft Datum: WGS-84 Azimuth/Bearing: 200° N70W 5130mils (True) Elevation Angle: -12.4° Horizon Angle: +00.5° Zoom: 1X Sta.#12997+00 Hwy 221 East side looking West</small></p>

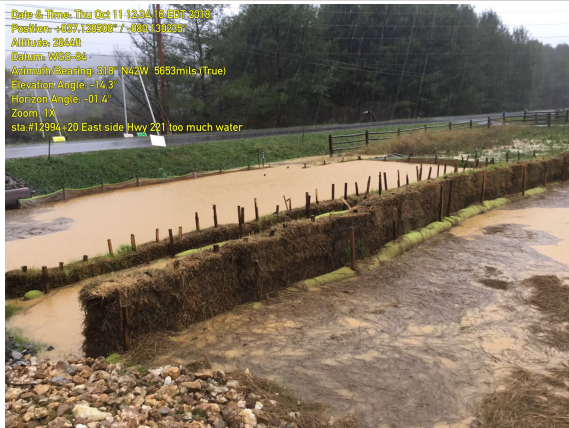
GPS Location	37.287287819234, -80.0396189187467	GPS Location	37.2872850532059, -80.0396079384536		
Description	Sta:#12994+02 East side Hwy 221. Flood water over whelming P1SF. See photo for accurate coordinates.	Description	Sta:#13009+00 CWD on the BRP. Flood water over powering SSF. See photo for accurate coordinates.

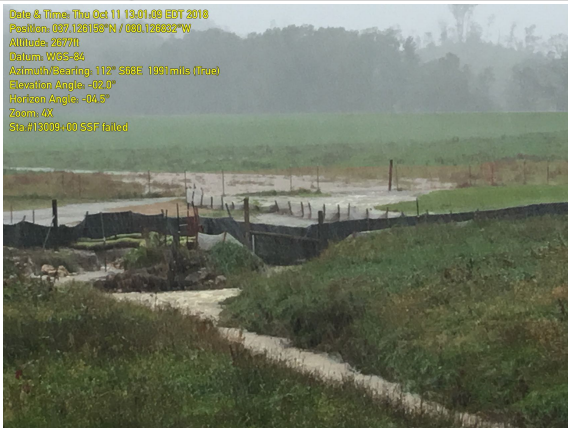
<p><small>Date &amp; Time: Thu Oct 11 13:41:09 EDT 2018 Position: +037.128158°N / -080.128832°W Altitude: 2627ft Datum: WGS-84 Azimuth/Bearing: 110° S88E 1001mils (True) Elevation Angle: -03.1° Horizon Angle: -00.3° Zoom: 2X Sta.#13009+00 CWD filled</small></p>
