Visual Site Inspection Report

Project Name	H-600 Pipeline Spread H	AFE	124300138	Spread	H-600 Pipeline Spread H
Contractor	Precision			Report #	9493
Inspector	Glenn Mike Renfro			Date/Time	10/16/2018 1:12 PM
Permit #	TBD	Inspection Type	VA SWPP	Station Begin	13415+00
State	VA	Inspection Area	Full	Station End	13670+00
County	Franklin	Ground	Wet	Temperature (°F)	64.00
Municipality	N/A	Weather	Cloudy	Rain Gauge (in)	5.00
GPS Location	36.9719343955377, -79.8701934131976			Rain Accumulation Time (days)	4.00

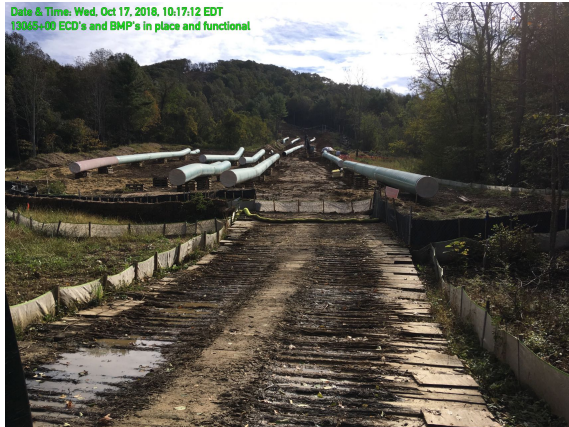
AFE	124300138	Date/Time	10/17/2018 11:12 AM	Report #	9573		
Pictures							
<div><div>Date & Time: Wed, Oct 17, 2018, 10:17:12 EDT 13065+00 ECD's and BMP's in place and functional</div>

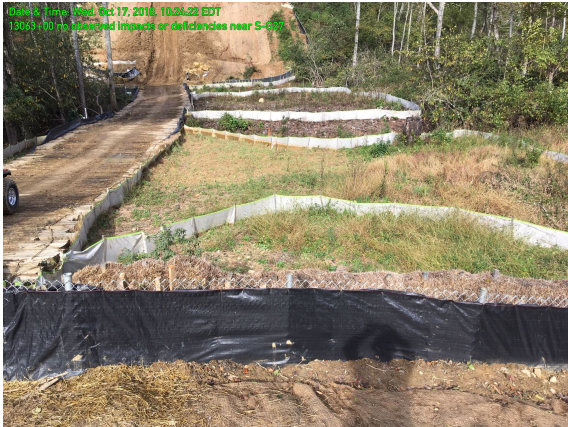
</div>			<div><div>Date & Time: Wed, Oct 17, 2018, 10:24:22 EDT 13069+00 no observed impacts or deficiencies near S-G27</div>

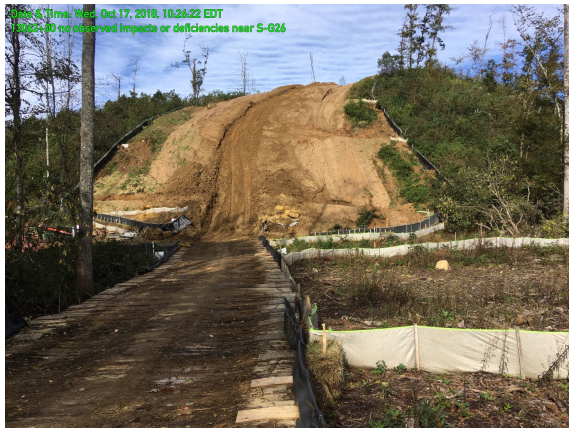
</div>				
GPS Location		37.1269023232508, -80.1179285255076		GPS Location		37.1267944900665, -80.1179079898448	
Description		All ECD's and water bars appeared to be within specification and no impacts were observed.		Description		No impacts were observed near S-G27	
<div><div>Date & Time: Wed, Oct 17, 2018, 10:26:22 EDT 13066+00 no observed impacts or deficiencies near S-G26</div>

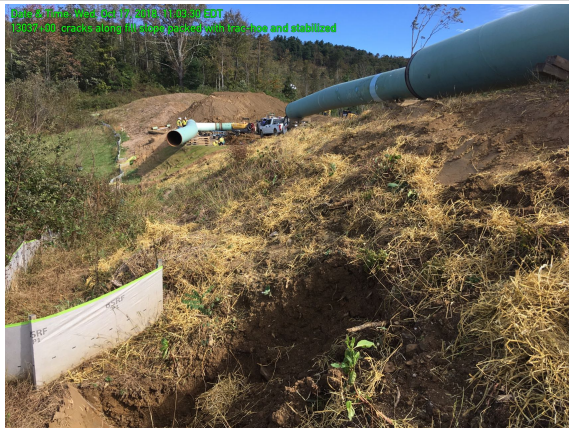
Description		No impacts and no deficiencies were observed near S-G26 13062+00		Description		Tie-in crew working on tie-in to creek section. No deficiencies were observed here.	
<div><div>Date & Time: Wed, Oct 17, 2018, 10:26:22 EDT 13064+00 cracks along fill slope caused by equipment track close to the edge, were compacted with a trac-hoe and then the area</div>

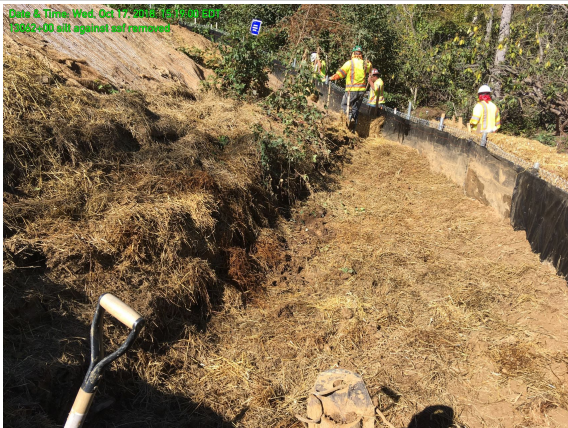
</div>			<div><div>Date & Time: Wed, Oct 17, 2018, 10:26:22 EDT 13062+00 silt against soil removed</div>

</div>				
GPS Location		37.1268410934481, -80.1179224067182		GPS Location		37.1269109147015, -80.1113843546064	
Description		Cracks on edge of fill slope caused by equipment track close to the edge, were compacted with a trac-hoe and then the area		Description		SSF was damaged while cleaning silt away and was replaced today.

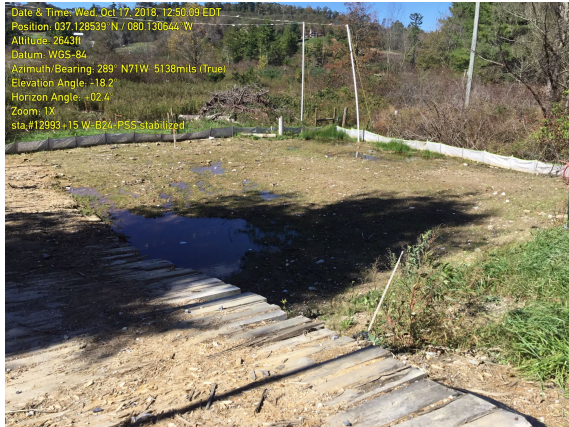
A/E	124300138	Date/Time	10/17/2018 5:10 PM	Report #	9578
Pictures					
<p>Date & Time: Wed, Oct 17, 2018, 12:50:09 EDT Position: 037.128539° N / 080.130645° W Altitude: 2643ft Datum: WGS-84 Azimuth/Bearing: 289° N71W 5138mils (True) Elevation Angle: +18.2 Horizon Angle: +02.4 Zoom: 1X Sta:#12993+15 W-B24-PSS stabilized</p>

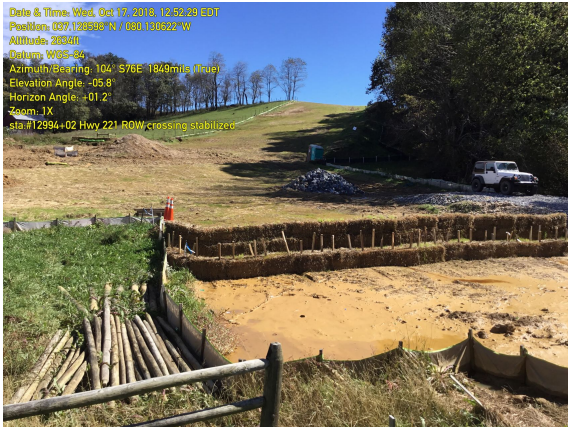
<p>Date & Time: Wed, Oct 17, 2018, 12:55:29 EDT Position: 037.128656° N / 080.130622° W Altitude: 2650ft Datum: WGS-84 Azimuth/Bearing: 102° S76E 1820mils (True) Elevation Angle: -05.8 Horizon Angle: +01.2 Zoom: 1X Sta:#12994+02 Hwy 221 ROW crossing stabilized</p>

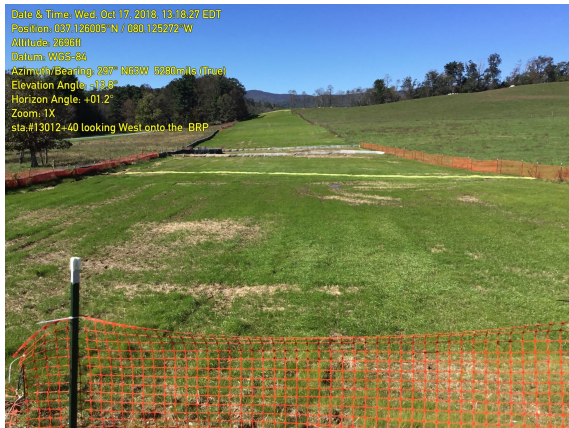
GPS Location	37.1285725431863, -80.1306057349594	GPS Location	37.1286526741806, -80.1305992808939		
Description	Sta:#12993+15 W-B24-PSS stabilized	Description	Sta:#12994+02 Hwy 221 ROW crossing stabilized		
<p>Date & Time: Wed, Oct 17, 2018, 13:43:27 EDT Position: 037.126000° N / 080.125032° W Altitude: 2010ft Datum: WGS-84 Azimuth/Bearing: 302° M33W 2380mils (True) Elevation Angle: +13.5 Horizon Angle: +01.2 Zoom: 1X Sta:#13012+40 looking West onto the BRP</p>

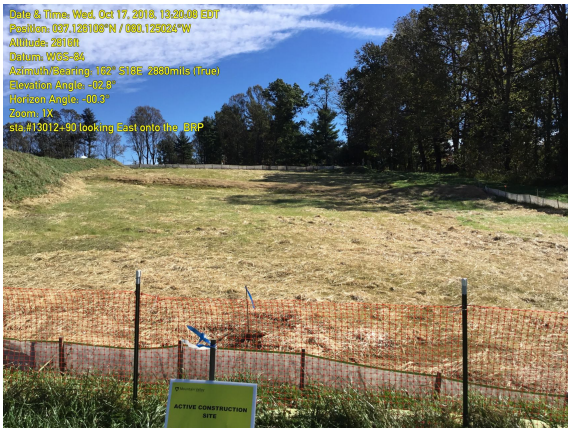
<p>Date & Time: Wed, Oct 17, 2018, 13:50:00 EDT Position: 037.126108° N / 080.125034° W Altitude: 2010ft Datum: WGS-84 Azimuth/Bearing: 102° S10E 2880mils (True) Elevation Angle: -05.5 Horizon Angle: +00.3 Zoom: 1X Sta:#13012+90 looking East onto the BRP</p>

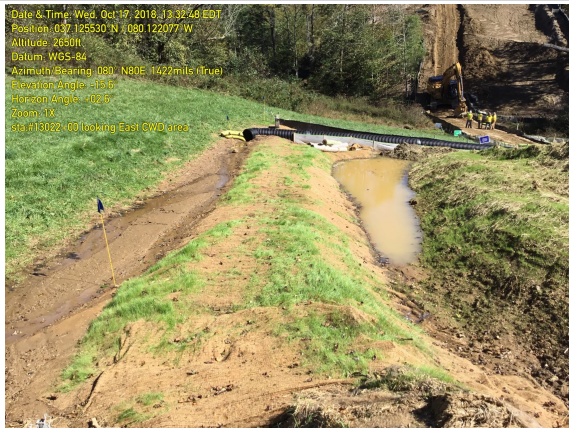
GPS Location	37.1260040765974, -80.1252574101837	GPS Location	37.126088943367, -80.1250466053189		
Description	Sta:#13012+40 looking West onto the BRP	Description	Sta:#13012+90 looking East onto the BRP		
<p>Date & Time: Wed, Oct 17, 2018, 13:32:46 EDT Position: 037.125530° N / 080.122077° W Altitude: 2650ft Datum: WGS-84 Azimuth/Bearing: 089° N80E 1922mils (True) Elevation Angle: +14.7 Horizon Angle: +02.5 Zoom: 1X Sta:#13022+00 looking East CWD inlet</p>

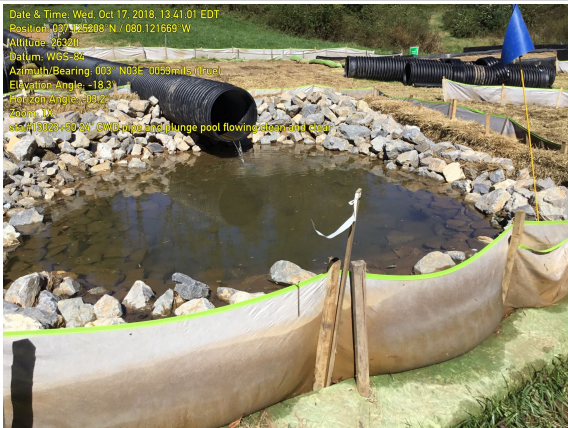
<p>Date & Time: Wed, Oct 17, 2018, 13:41:01 EDT Position: 037.125588° N / 080.121669° W Altitude: 2650ft Datum: WGS-84 Azimuth/Bearing: 093° N83E 0699mils (True) Elevation Angle: +16.31 Horizon Angle: +01.7 Zoom: 1X Sta:#13023+50 CWD plunge pool flowing along with CWD</p>

GPS Location	37.2801077367923, -80.0284782776667	GPS Location	37.2801077367923, -80.0284782776667		
Description	Sta:#13022+00 CWD berm and 24" CWD inlet. See photo for accurate coordinates.	Description	Sta:#13023+50 CWD plunge pool outlet. See photo for accurate coordinates.

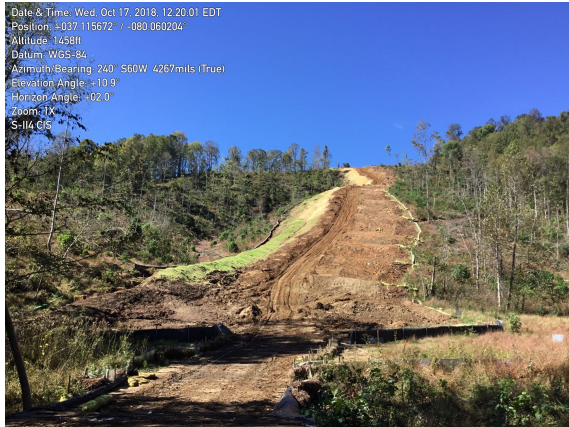
A/E	124300138	Date/Time	10/17/2018 6:41 PM	Report #	9615
Pictures					
<p>Date & Time: Wed, Oct 17, 2018, 12:20:01 EDT Position: +037.115672 / -080.060204 Altitude: 1458ft Datum: WGS-84 Azimuth/Bearing: 249.560W 4267mils (True) Elevation Angle: +10.9° Horizon Angle: +02.0° Zoom: 1X S-II4 CIS</p>

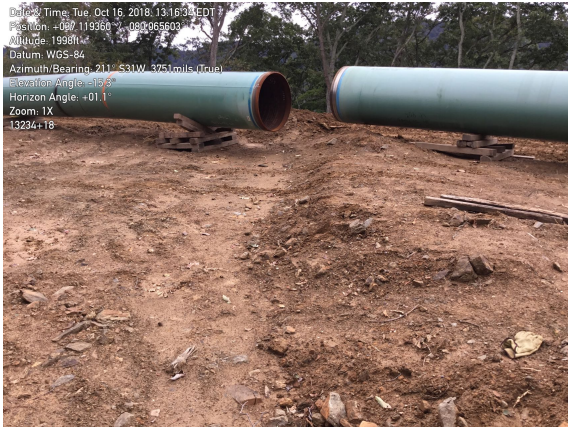
<p>Date & Time: Tue, Oct 16, 2018, 13:16:33 EDT Position: +037.119368 / -080.065603 Altitude: 1998ft Datum: WGS-84 Azimuth/Bearing: 211.531W 1251mils (True) Elevation Angle: +01.1° Horizon Angle: +01.1° Zoom: 1X 13236+18</p>

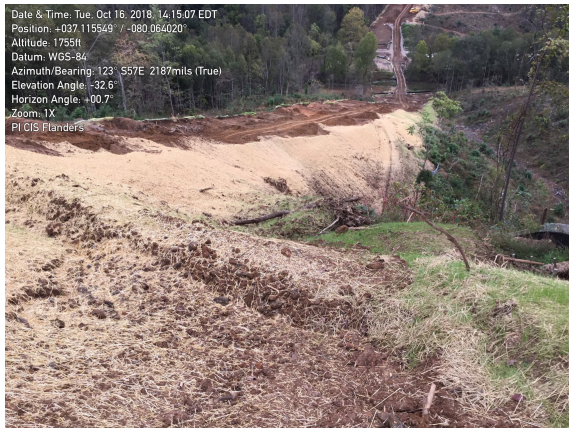
GPS Location	37.326114676331, -80.028565905646		GPS Location	37.2356177866806, -80.2295810916277	
Description	Please see photo for coordinates. Sta. No. 13285+74, CIS of S-II4.		Description	Please see photo for coordinates. ~Sta. No. 13233+18, waterbar needs repair.	
<p>Date & Time: Tue, Oct 16, 2018, 14:15:07 EDT Position: +037.115549 / -080.064020 Altitude: 1755ft Datum: WGS-84 Azimuth/Bearing: 123.557E 2187mils (True) Elevation Angle: -32.6° Horizon Angle: +00.7° Zoom: 1X P1 CIS Flanders</p>

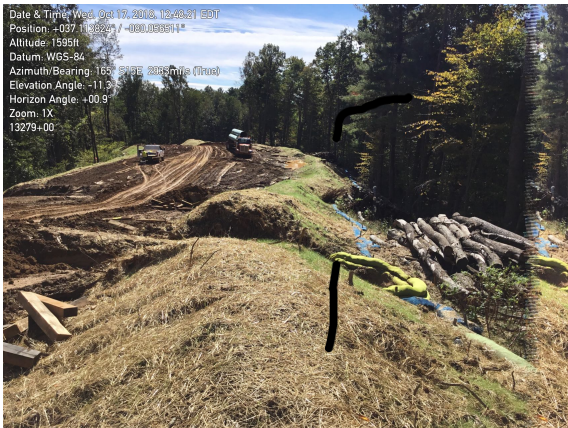
<p>Date & Time: Wed, Oct 17, 2018, 12:26:01 EDT Position: +037.115949 / -080.063914 Altitude: 1595ft Datum: WGS-84 Azimuth/Bearing: 163.518E 2083mils (True) Elevation Angle: -11.3° Horizon Angle: +00.9° Zoom: 1X 13279+00</p>

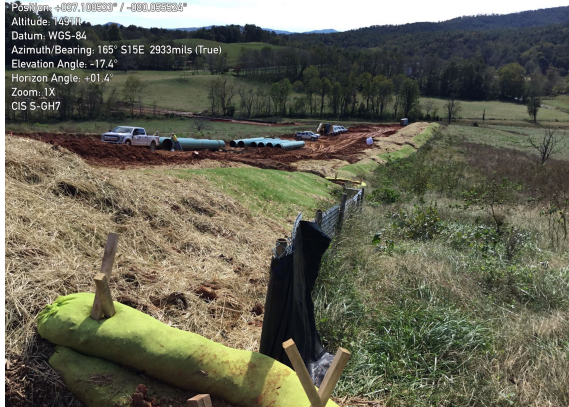
GPS Location	37.2356177866806, -80.2295810916277		GPS Location	37.2356177866806, -80.2295810916277	
Description	Please see photo for coordinates. Sta. No. 13250+00, CIS of S-II4, soil piles stabilized.		Description	Please see photo for coordinates. ~Sta. No. 13279+00, soil piles stabilized, outlets functioning acceptably.	
<p>Date & Time: Wed, Oct 17, 2018, 13:14:00 EDT Position: +037.108233 / -080.052204 Altitude: 1491ft Datum: WGS-84 Azimuth/Bearing: 165.515E 2933mils (True) Elevation Angle: -17.4° Horizon Angle: +01.4° Zoom: 1X CIS S-GH7</p>

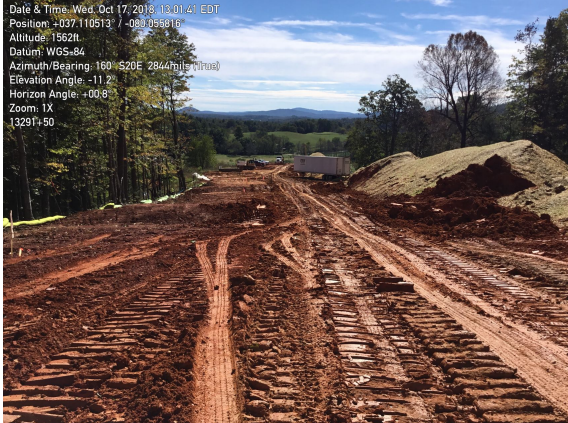
<p>Date & Time: Wed, Oct 17, 2018, 13:01:41 EDT Position: +037.110513 / -080.053816 Altitude: 1562ft Datum: WGS-84 Azimuth/Bearing: 160.520E 2844mils (True) Elevation Angle: -11.2° Horizon Angle: +00.8° Zoom: 1X 13291+50</p>

GPS Location	37.2356177866806, -80.2295810916277		GPS Location	37.2356177866806, -80.2295810916277	
Description	Please see photo for coordinates. ~Sta. No. 13300+00, soil piles stabilized, outlets functioning acceptably.		Description	Please see photo for coordinates. ~Sta. No. 13291+50, waterbars installed acceptably, with travel lane out for daytime activities.

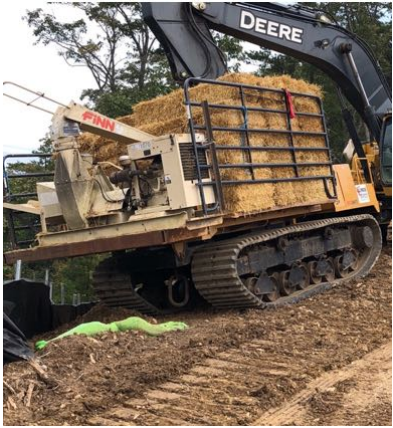
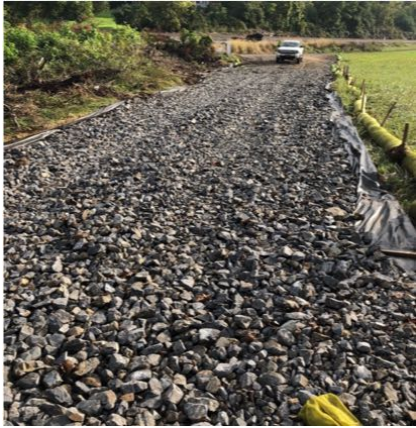
GPS Location	37.2357106871062, -80.2296034696044	GPS Location	37.2357104809615, -80.2296042665625		
Description	12234+06 buggy preparing for topsoil stabilization.	Description	12430+72 Rock construction entrance

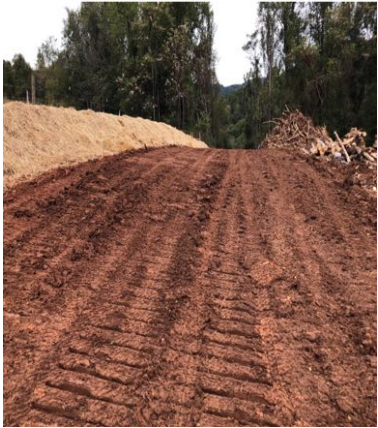
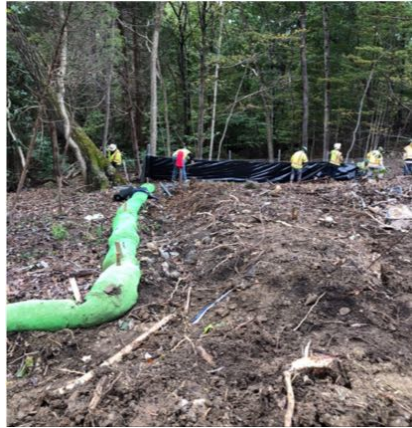
GPS Location	37.2357314452876, -80.2296847757699	GPS Location	37.2357314452876, -80.2296847757699		
Description	MVP-MLV-27 top soiled travel lane on access road and performed stabilization.	Description	12378+84 crew installing super silt fence erosion control devices.

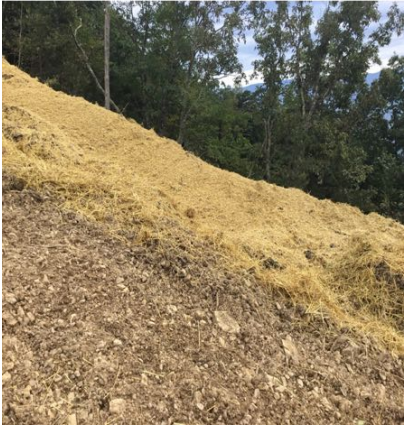
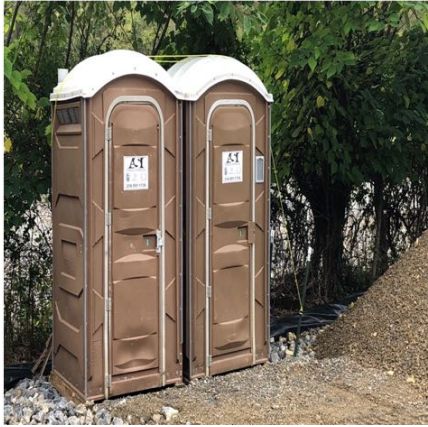
GPS Location	37.2357065929447, -80.2295888029786	GPS Location	37.2357093876505, -80.2296029029034		
Description	12236+71 stabilized topsoil pile.	Description	MVP-MN-277.03 port-o-potty location.
