Visual Site Inspection Report

Project Name	H-600 Pipeline Spread H	AFE	124300138	Spread	H-600 Pipeline Spread H
Contractor	Precision			Report #	9811
Inspector	Glenn Mike Renfro			Date/Time	10/22/2018 4:02 PM
Permit #	TBD	Inspection Type	VA SWPP	Station Begin	13415+00
State	VA	Inspection Area	Full	Station End	13670+00
County	Franklin	Ground	Dry	Temperature (°F)	61.00
Municipality	N/A	Weather	Sunny	Rain Gauge (in)	0.00
GPS Location	37.0912620518702, -79.9916268233955			Rain Accumulation Time (days)	6.00

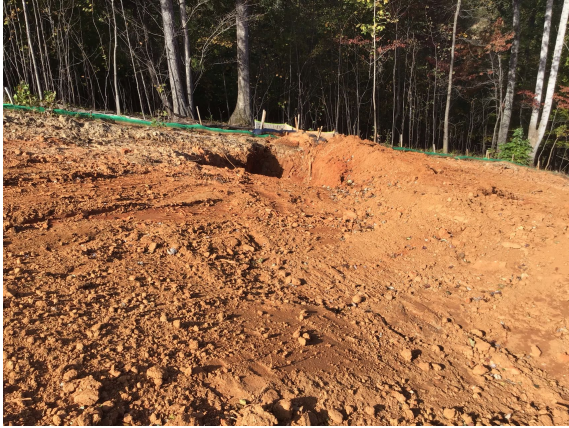
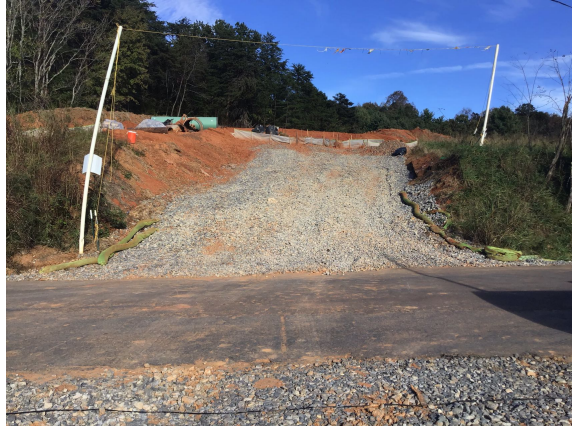
GPS Location	37.0906901127073, -79.9910689239204	GPS Location	37.0907200780111, -79.9907328934222		
Description	Waterbar and end treatment in good condition at approximately 13620+00	Description	RCE in good condition at GAS Monty Rd

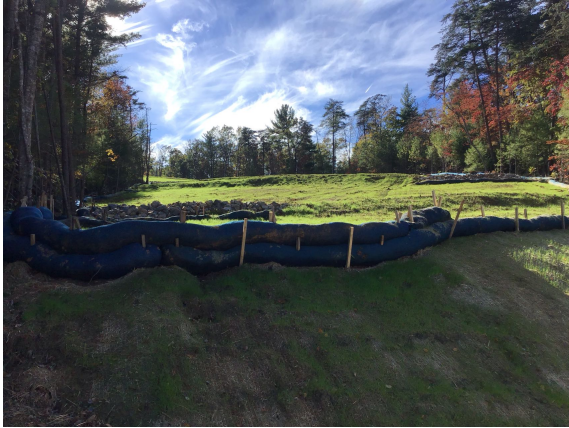
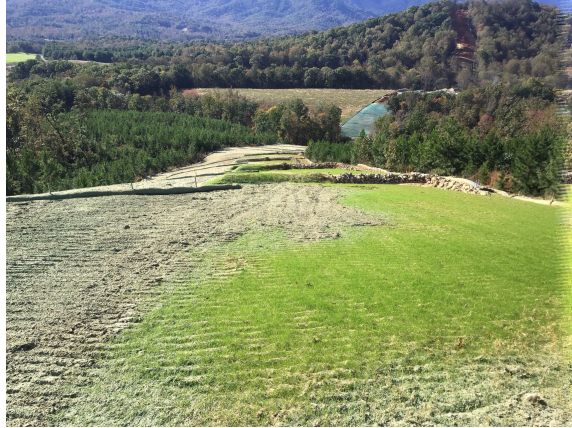
GPS Location	37.0906901127073, -79.9910689239204	GPS Location	37.0906901127073, -79.9910689239204		
Description	CIS of Cahas Mt #2 reclamation completed.	Description	CIS of 13437+00 permanent waterbar end treatments reworked and RoW reseeded.

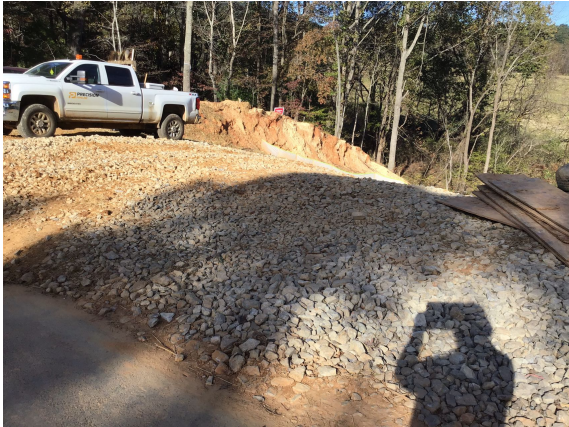
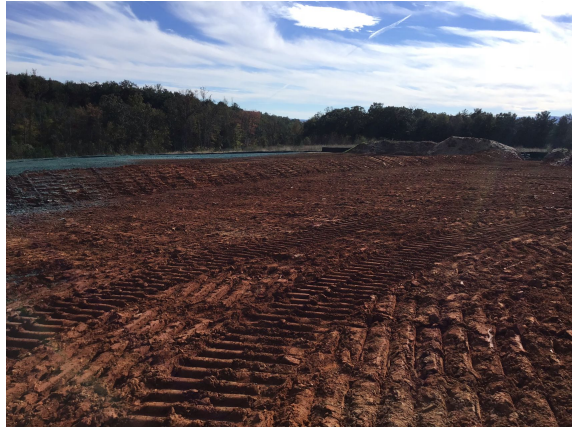
GPS Location	37.0908824354756, -79.9909323827177	GPS Location	37.0908824354756, -79.9909323827177		
Description	REC on the GAS of House Rock in good condition.	Description	Reclamation crew hydromulching area near kickoff.

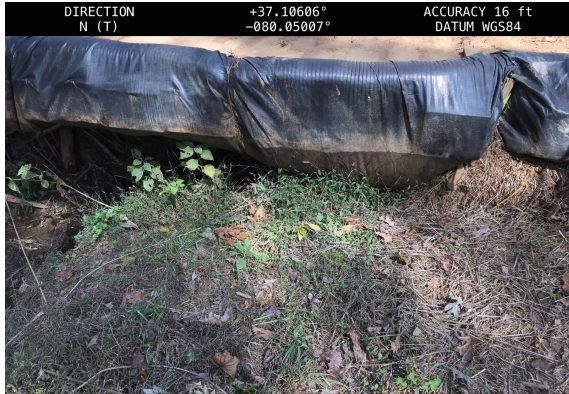
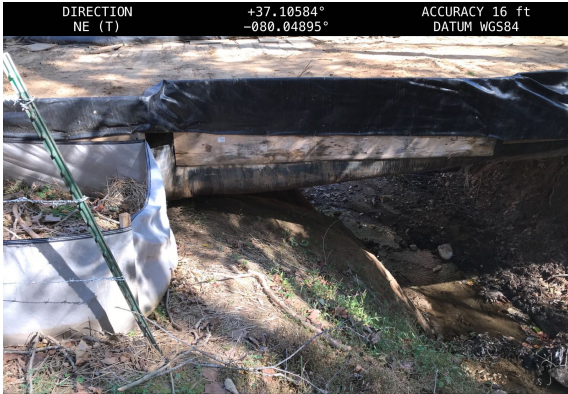
<div>2018-10-23 11:59:51-04:00</div>		
GPS Location	37.0942302514213, -80.0309333392233		GPS Location	37.09425719924, -80.0314277876914	
Description	13321+47_102318 geotech full and sagging. Looking N. See photo for gps data.		Description	13325+30_102318 geotech full and sagging. Looking N. See photo for gps data.	
<div>DIRECTION E (T)</div> <div>+37.10592° -080.04909°</div> <div>ACCURACY 16 ft DATUM WGS84</div>

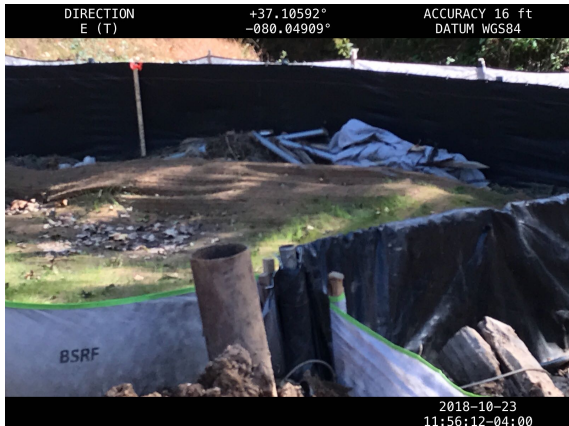
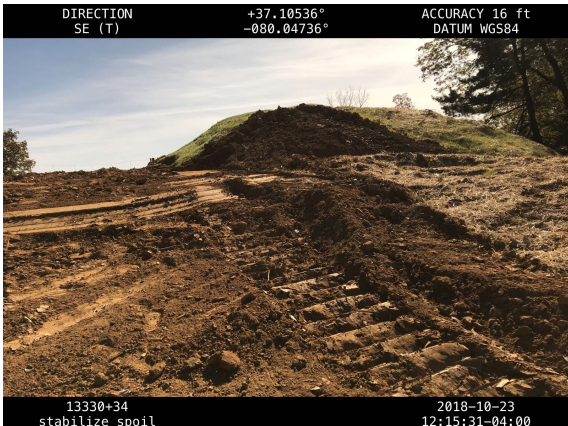
GPS Location	37.0941140782434, -80.0310405437649		GPS Location	37.0941140782434, -80.0310405437649	
Description	13325+32_102318 discarded ECD's to be removed. Looking E. See photo for gps data.		Description	13330+00_102318 spoil pile needs stabilized after spoil has been added. Looking SE. See photo for gps data.	
<div>DIRECTION NE (T)</div> <div>+37.10457° -080.04618°</div> <div>ACCURACY 33 ft DATUM WGS84</div>

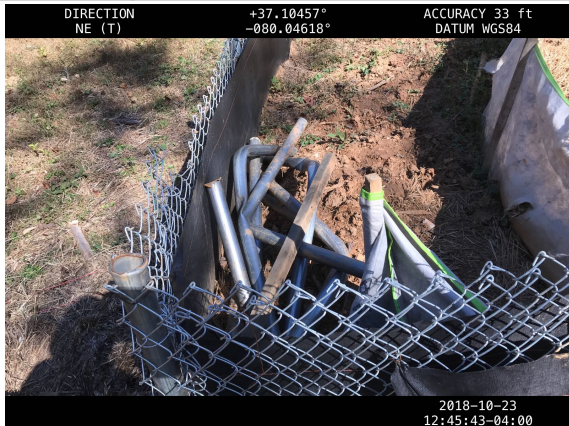
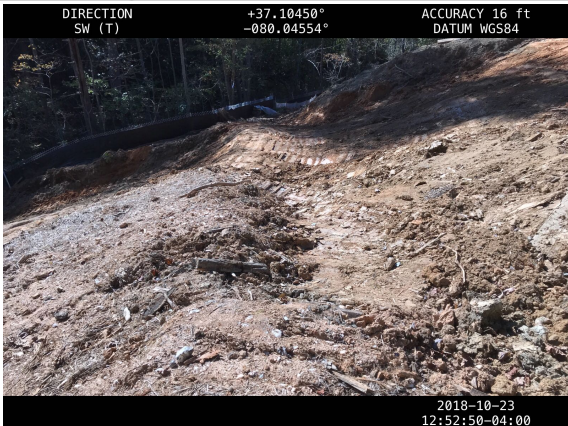
<div>2018-10-23 12:52:50-04:00</div>		
GPS Location	37.094069444609, -80.0310305693001		GPS Location	37.094069444609, -80.0310305693001	
Description	13334+17_102318 S-GH11 discarded ECD's to be removed. Looking NE. See photo for gos data.		Description	13336+38_102328 waterbar channel needs regraded behind Blasting Crew. Looking SW. See photo for gps data.

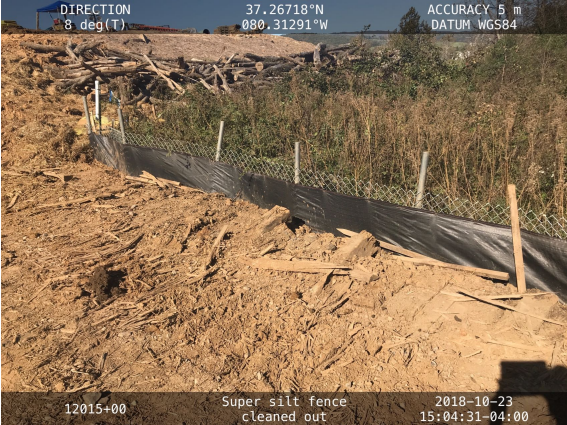
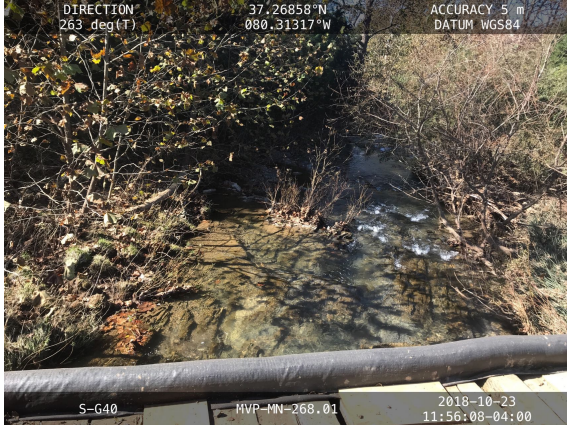
GPS Location	37.28893826, -80.28737379		GPS Location	37.28893826, -80.28737379	
Description	See photo for gps data. Photo shows the super silt fence at 12015+00 after it was cleaned out today.		Description	See photo for gps data. Photo shows the general condition of stream SG40 below the bridge on MVP-MN-268.01.

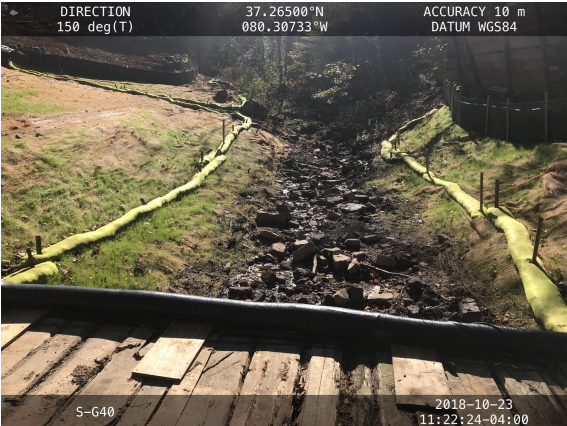
GPS Location	37.2677594516773, -80.3131339140984		GPS Location	37.2677594516773, -80.3131339140984	
Description	See photo for gps data. Photo shows the general condition of stream S-G40. Vegetation growing on stream banks.		Description	See photo for gps data. Photo shows the construction debris located between 12036+00 and 12038+00.

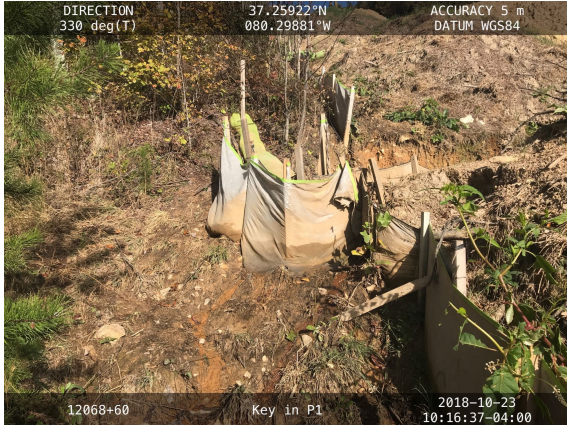
GPS Location	37.2677594516773, -80.3131339140984		GPS Location	37.2677594516773, -80.3131339140984	
Description	See photo for gps data. Photo shows the damaged P1 silt fence at 12065+45.		Description	See photo for gps data. Photo shows the undermined P1 silt fence at 12068+60.

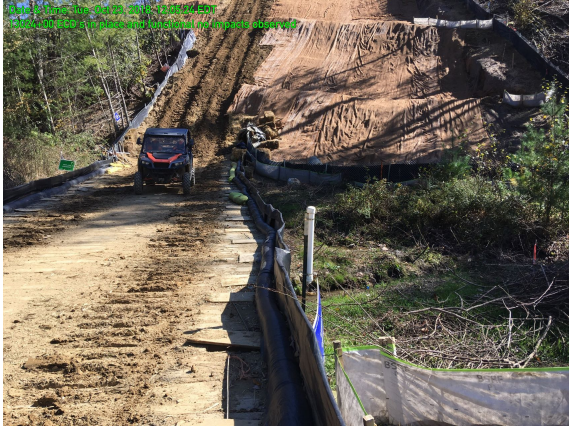
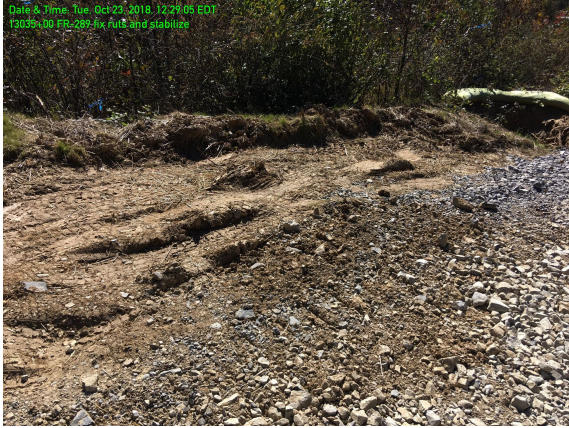
GPS Location	37.1367788873959, -80.112102096975	GPS Location	37.1367788873959, -80.112102096975		
Description	S-G24 and S-G25 no impacts and cleanup crew removed water bars to access the Blue Ridge Parkway.	Description	Vehicles pulling off the edge of the access road have made ruts and need to be fixed and stabilized

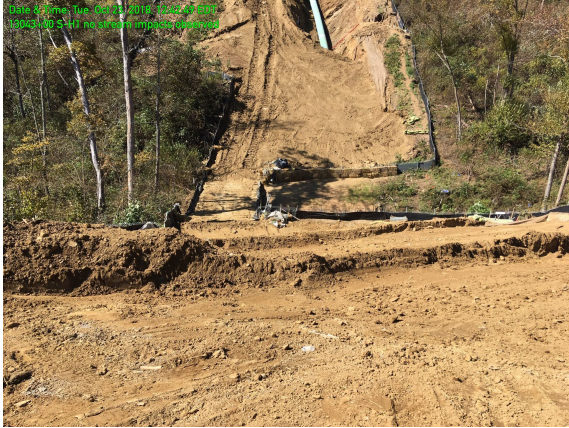
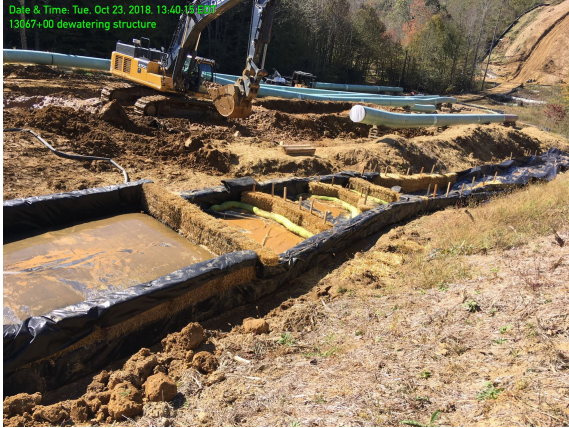
GPS Location	37.1367788873959, -80.112102096975	GPS Location	37.1367788873959, -80.112102096975		
Description	S-H1 no impacts to stream. Tie-in crew making last tie-in in this area.	Description	Dewatering structure functioning properly

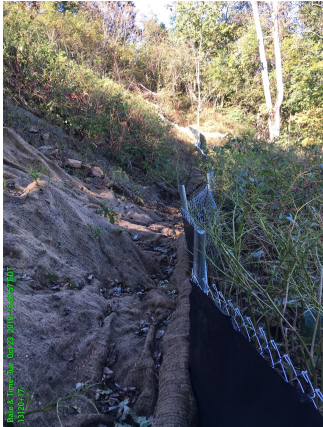
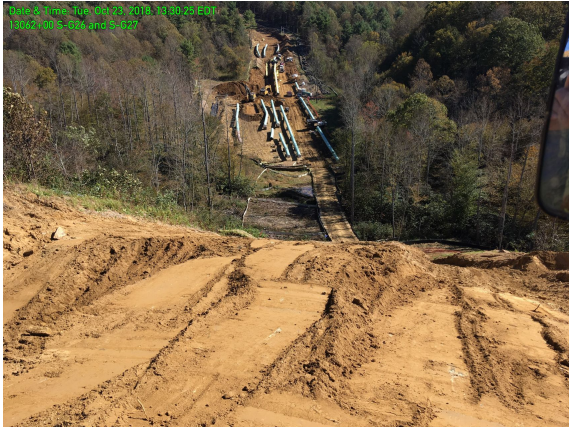
GPS Location	37.1367788873959, -80.112102096975	GPS Location	37.1367788873959, -80.112102096975		
Description	Area has been stabilized since August 17th. No impacts observed.	Description	No impacts observed at S-G26 and S-G27

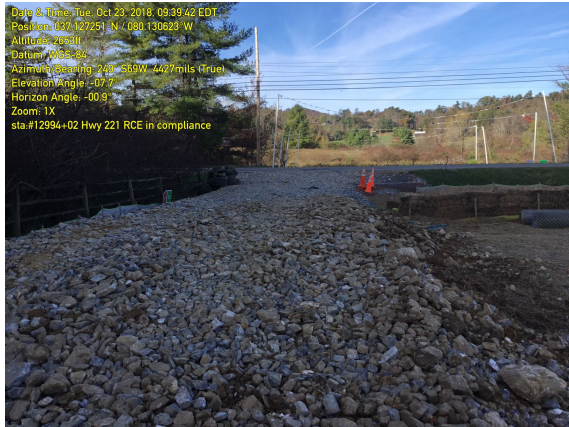
A/E	124300138	Date/Time	10/23/2018 6:55 PM	Report #	9866
Pictures					
<p>Date & Time: Tue, Oct 23, 2018, 09:39:42 EDT Position: 037.127251° N / 080.130629° W Altitude: 2634 ft Datum: WGS-84 Azimuth/Bearing: 243° S63W 4427mils (True) Elevation Angle: -07.2° Horizon Angle: -00.9° Zoom: 1X Sta: #12994+02 Hwy 221 RCE in compliance</p>

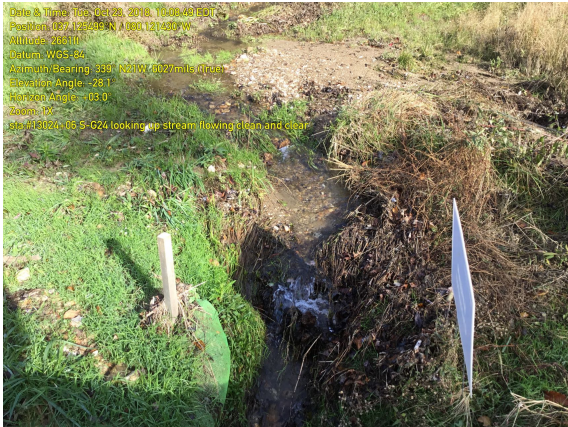
<p>Date & Time: Tue, Oct 23, 2018, 16:06:40 EDT Position: 037.1254993° N / 080.121429646° W Altitude: 2631 ft Datum: WGS-84 Azimuth/Bearing: 195.122107 4027mils (True) Elevation Angle: -26.1° Horizon Angle: -03.0° Zoom: 1X Sta: #13024+06 S-G24 looking up stream flowing clean and clear</p>

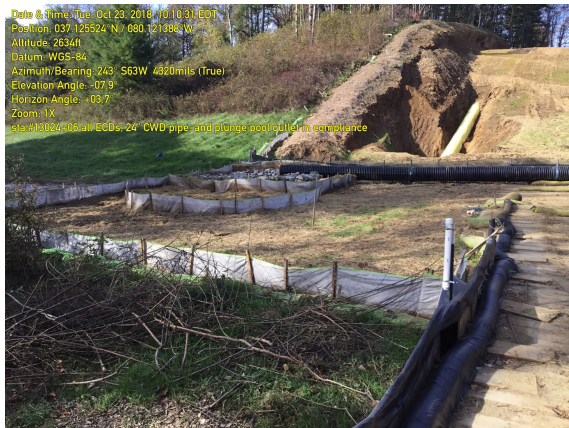
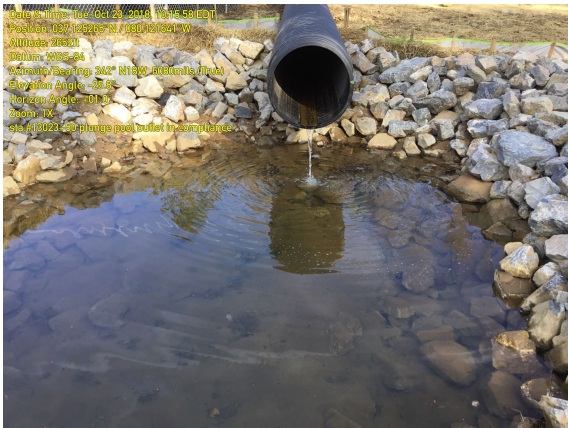
<p>Date & Time: Tue, Oct 23, 2018, 16:57:46 EDT Position: 037.1252255° N / 080.1216262020917 Altitude: 2632 ft Datum: WGS-84 Azimuth/Bearing: 242° N180W 4800mils (True) Elevation Angle: -26.5° Horizon Angle: -03.5° Zoom: 1X Sta: #13023+50 plunge pool outlet in compliance</p>

GPS Location	37.1254955046225, -80.1214126311989	GPS Location	37.1252255235213, -80.1216262020917		
Description	Sta: #13024+06 All ECDs, 24" CWD pipe, and plunge pool outlet in compliance.	Description	Sta: #13023+50 plunge pool outlet in compliance.		
<p>Date & Time: Tue, Oct 23, 2018, 15:31:10 EDT Position: 037.1285484° N / 080.1306287° W Altitude: 2701 ft Datum: WGS-84 Azimuth/Bearing: 307° N85W 5422mils (True) Elevation Angle: -07.1° Horizon Angle: -00.5° Zoom: 1X Sta: #12993+15 W-B24-PSS stabilized</p>

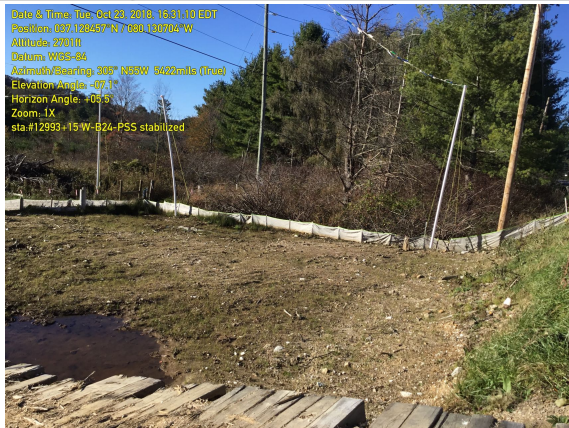
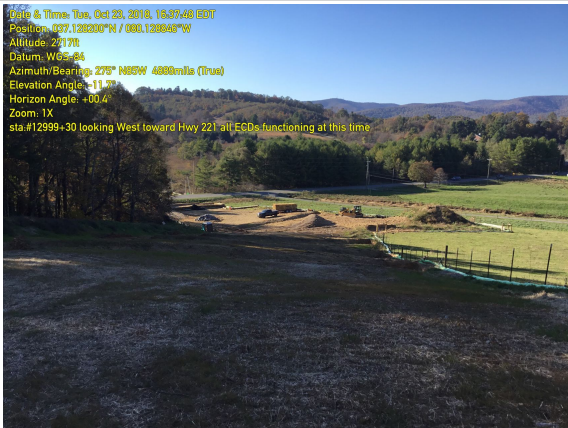
<p>Date & Time: Tue, Oct 23, 2018, 16:57:46 EDT Position: 037.1280002° N / 080.1290036615754 Altitude: 2517 ft Datum: WGS-84 Azimuth/Bearing: 275° N85W 4800mils (True) Elevation Angle: -11.7° Horizon Angle: -00.4° Zoom: 1X Sta: #12999+30 looking West toward Hwy 221. All ECDs functioning at this time</p>

Description	Sta: #12993+15 W-B24-PSS stabilized	Description	Sta: #12999+30 looking West toward Hwy 221. All ECDs functioning at this time. See photo for accurate coordinates.

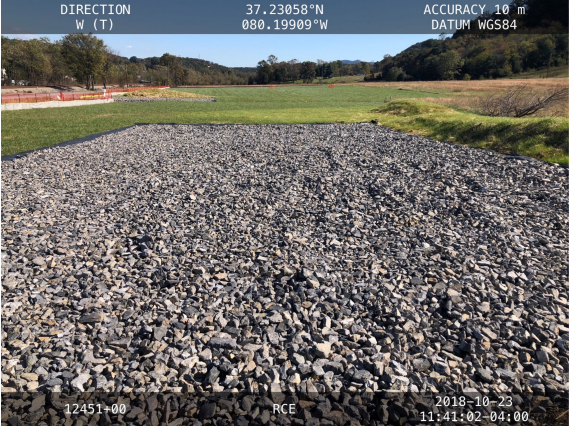
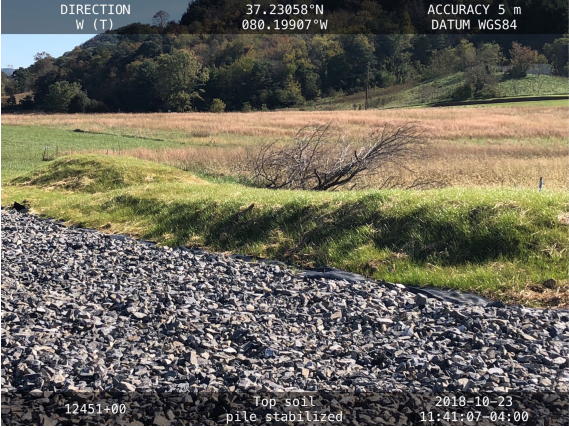
GPS Location	37.3313770616602, -79.9583372300501		GPS Location	37.3311676873098, -79.9582244424545	
Description	12451+00_102310 RCE Looking W. See picture for GPS data.		Description	12451+00_102318 top soil pile stabilized. Looking W. See picture for GPS data.

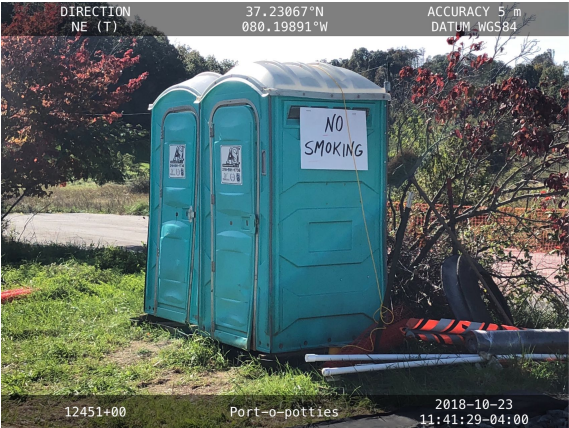
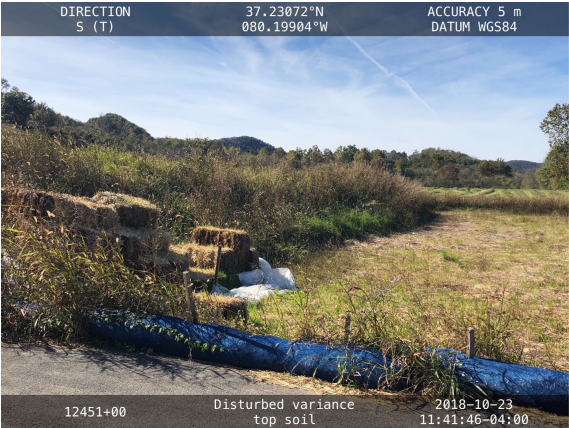
GPS Location	37.3309968458836, -79.95838914074		GPS Location	37.3311593709861, -79.9582394399494	
Description	12451+00_102318 port-o-potties. Looking NE. See picture for GPS data.		Description	12451+00_102318 Disturbed variance top soil. Looking S. See picture for GPS data.

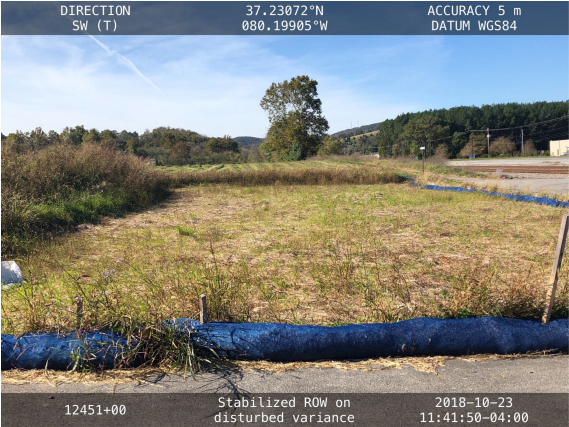
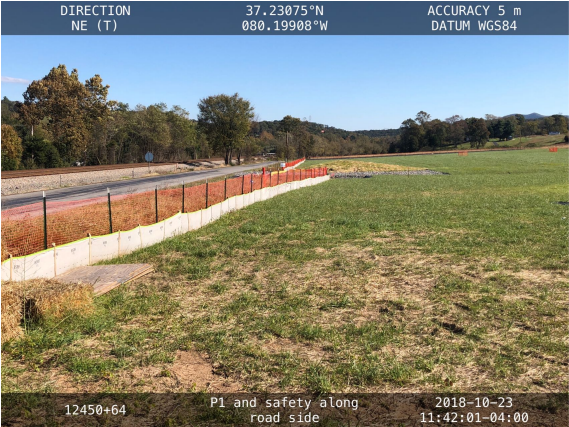
GPS Location	37.3311862349858, -79.9581637513637		GPS Location	37.3312359718881, -79.9582025699456	
Description	12451+00_102318 Stabilized ROW on disturbed variance. Looking SW. See picture for GPS data.		Description	12450+64_102318. P1 and safety fence along road side. Looking NE. See picture for GPS data.

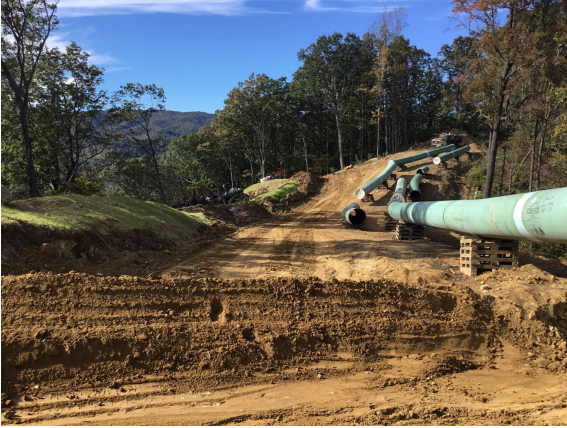
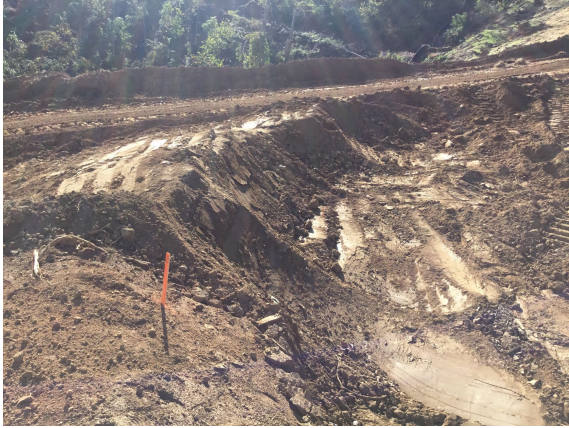
GPS Location	37.2357072748039, -80.2296099099932	GPS Location	37.2357072748039, -80.2296099099932		
Description	Please see photo for coordinates. ~Sta. No. 13220+00, soil stabilized and ECDs functioning acceptably.	Description	Please see photo for coordinates. ~Sta. No. 13252+50, waterbars need maintenance in travel land.

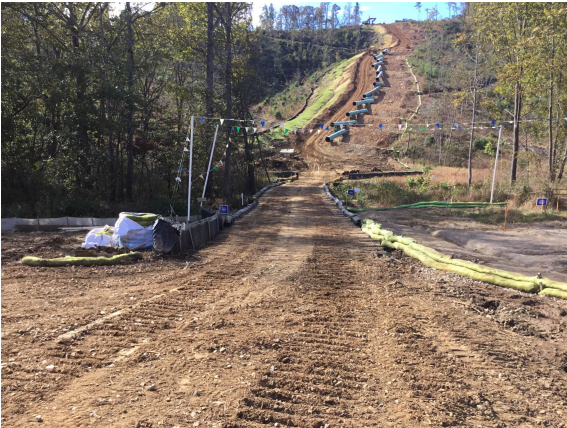
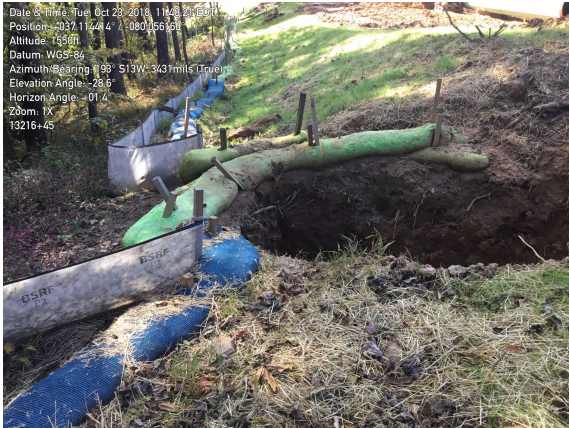
<div> Date & Time: Tue, Oct 23, 2018, 11:48:20 EDT Position: +037.112244, -80.056691 Altitude: 1530ft Datum: WGS-84 Azimuth/Bearing: 89° 51'30" 3431mils (true) Elevation Angle: -28.6° Horizon Angle: -01.4° Zoom: 1X 13216+45 </div>			
GPS Location	37.2357104936456, -80.2295897887072	GPS Location	37.2357829939921, -80.2296556067469		
Description	Please see photo for coordinates. ~Sta. No. 13261+00, GAS of S-II4, ECDs installed, bridge clean, no stream impacts noted.	Description	Please see photo for coordinates. ~Sta. No. 13216+45, CFS needs maintenance.

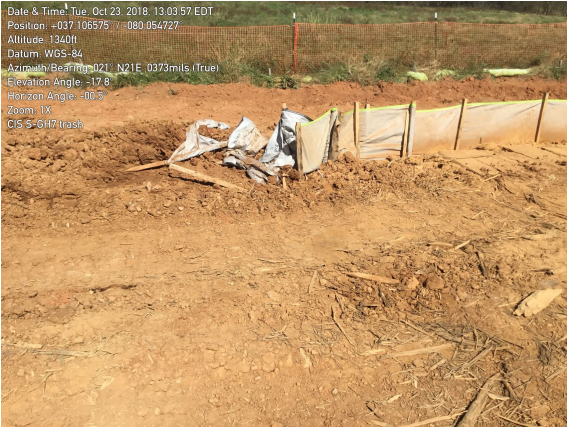
<div> Date & Time: Tue, Oct 23, 2018, 13:03:57 EDT Position: +037.106575, -80.054727 Altitude: 1320ft Datum: WGS-84 Azimuth/Bearing: 021° 22'1E 0373mils (true) Elevation Angle: -17.8° Horizon Angle: -10.5° Zoom: 1X CIS S-GH7 trash </div>

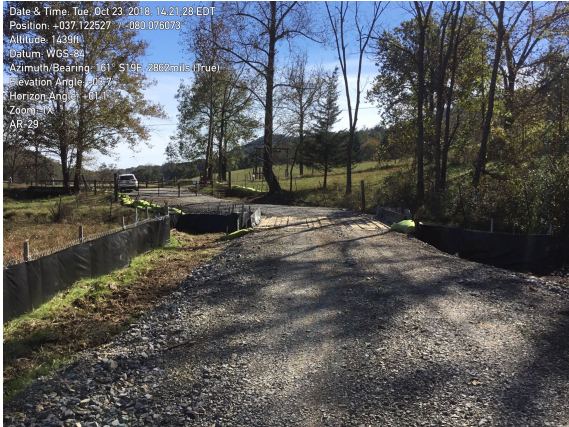
<div> Date & Time: Tue, Oct 23, 2018, 14:21:28 EDT Position: +037.122527, -80.076073 Altitude: 1439ft Datum: WGS-84 Azimuth/Bearing: 161° 51'36" 2882mils (true) Elevation Angle: -23.1° Horizon Angle: -01.1° Zoom: 1X AR-29 </div>			
GPS Location	37.2357829939921, -80.2296556067469	GPS Location	37.2357829939921, -80.2296556067469		
Description	Please see photo for coordinates. ~Sta. No. 13309+00, construction debris needs removed.	Description	Please see photo for coordinates. ~Sta. No. 13190+50, MVP-MLV-AR-29, ECDs functioning acceptably.
