# Visual Site Inspection Report

<b>Project Name</b>	H-600 Pipeline Spread H	<b>AFE</b>	124300138	<b>Spread</b>	H-600 Pipeline Spread H
<b>Contractor</b>	Precision			<b>Report #</b>	9993
<b>Inspector</b>	Glenn Mike Renfro			<b>Date/Time</b>	10/26/2018 11:18 AM
<b>Permit #</b>	TBD	<b>Inspection Type</b>	VA SWPP	<b>Station Begin</b>	13415+00
<b>State</b>	VA	<b>Inspection Area</b>	Full	<b>Station End</b>	13670+00
<b>County</b>	Franklin	<b>Ground</b>	Wet	<b>Temperature (°F)</b>	42.00
<b>Municipality</b>	N/A	<b>Weather</b>	Light Rain	<b>Rain Gauge (in)</b>	0.25
<b>GPS Location</b>	36.971845140733, -79.8700781020481			<b>Rain Accumulation Time (days)</b>	1.00

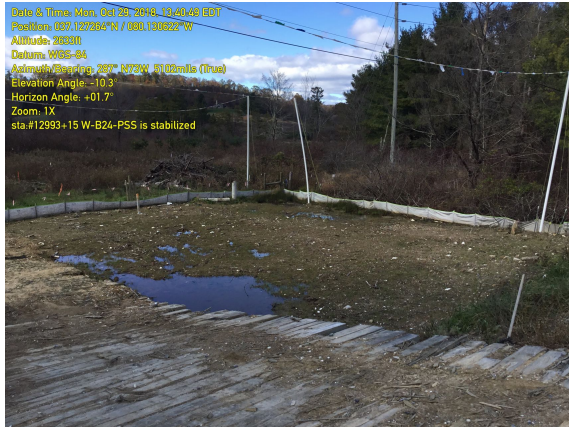
A/E	124300138	Date/Time	10/29/2018 5:35 PM	Report #	10140
Pictures					
<div><div><div>Date &amp; Time: Mon, Oct 29, 2018, 13:45:46 EDT Position: 037.129934°N / 080.130832°W Altitude: 2030ft Datum: WGS-84 Azimuth/Bearing: 287° N87E 1547mils (True) Elevation Angle: -09.2° Horizon Angle: -01.7° Zoom: 1X Sta.#12993+15 W-B24-PSS is stabilized</div>

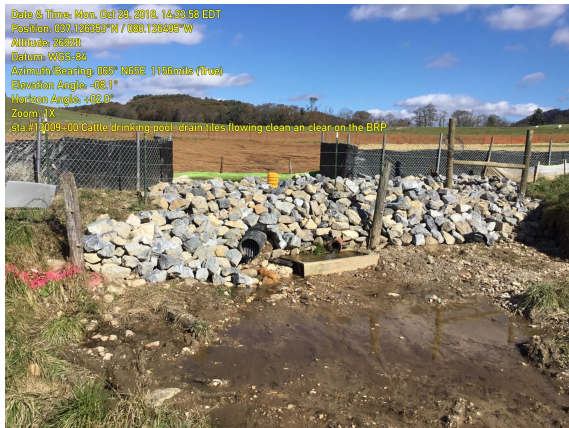
<div><div><div>Date &amp; Time: Mon, Oct 29, 2018, 14:20:43 EDT Position: 037.129905°N / 080.129469°W Altitude: 2030ft Datum: WGS-84 Azimuth/Bearing: 000° N00E 1100mils (True) Elevation Angle: -08.1° Horizon Angle: +03.6° Zoom: 1X Sta.#13009+00 Cattle drawing pool drain tiles flowing clean and clear on the BRP</div>

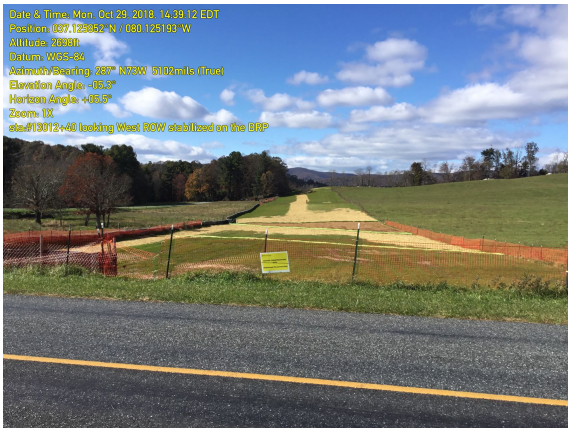
</div></div>		<div><div><div>Date &amp; Time: Mon, Oct 29, 2018, 14:30:42 EDT Position: 037.129912°N / 080.129100°W Altitude: 2030ft Datum: WGS-84 Azimuth/Bearing: 287° N87W 5100mils (True) Elevation Angle: -08.3° Horizon Angle: +05.5° Zoom: 1X Sta.#13012+40 looking West ROW stabilized on the BRP</div>

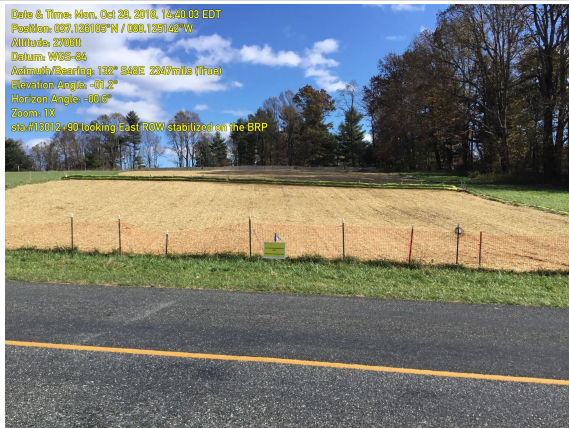
<div><div><div>Date &amp; Time: Mon, Oct 29, 2018, 14:50:03 EDT Position: 037.129105°N / 080.129142°W Altitude: 2700ft Datum: WGS-84 Azimuth/Bearing: 130° S40E 2347mils (True) Elevation Angle: -01.2° Horizon Angle: -00.5° Zoom: 1X Sta.#13012+90 looking East ROW stabilized on the BRP</div>

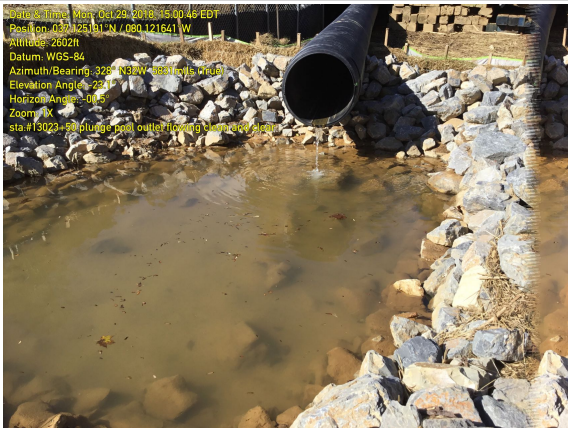
</div></div>		<div><div><div>Date &amp; Time: Mon, Oct 29, 2018, 15:00:46 EDT Position: 037.125181°N / 080.121641°W Altitude: 2652ft Datum: WGS-84 Azimuth/Bearing: 325° N35W 4081mils (True) Elevation Angle: -02.1° Horizon Angle: -00.5° Zoom: 1X Sta.#13023+50 plunge pool outlet flowing clean and clear</div>

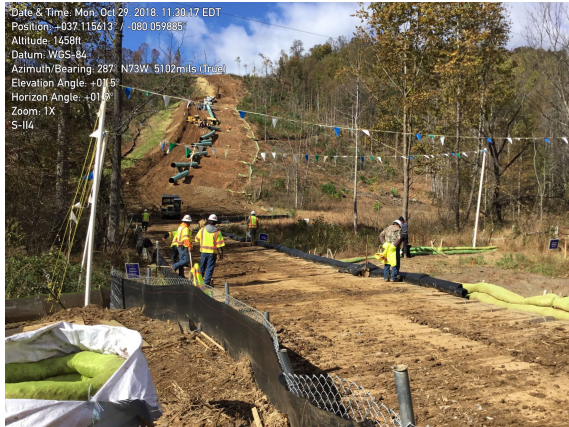
A/E	124300138	Date/Time	10/29/2018 7:42 PM	Report #	10152
Pictures					
<p>Date &amp; Time: Mon, Oct 29, 2018, 11:30:17 EDT Position: +037.115613° / -080.059885° Altitude: 1458ft Datum: WGS-84 Azimuth/Bearing: 287° N73W 5102mils (True) Elevation Angle: +01.8° Horizon Angle: -01.8° Zoom: 1X S-II4</p>

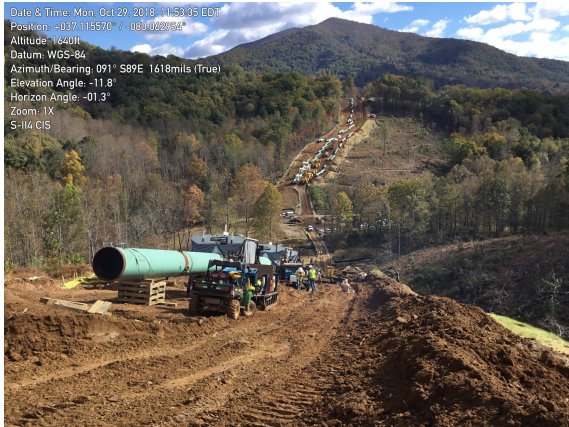
<p>Date &amp; Time: Mon, Oct 29, 2018, 11:33:35 EDT Position: +037.115570° / -080.062958° Altitude: 1340ft Datum: WGS-84 Azimuth/Bearing: 091° S89E 1618mils (True) Elevation Angle: -11.8° Horizon Angle: -01.3° Zoom: 1X S-II4 CIS</p>

GPS Location	37.3331011286241, -80.0123496135824	GPS Location	37.3331011286241, -80.0123496135824		
Description	Please see photo for coordinates. S-II4, bridge maintained over stream crossing. No environmental impacts noted.	Description	Please see photo for coordinates. ~Sta. No. 13252+00, waterbars installed and functioning acceptably, outlets maintained.

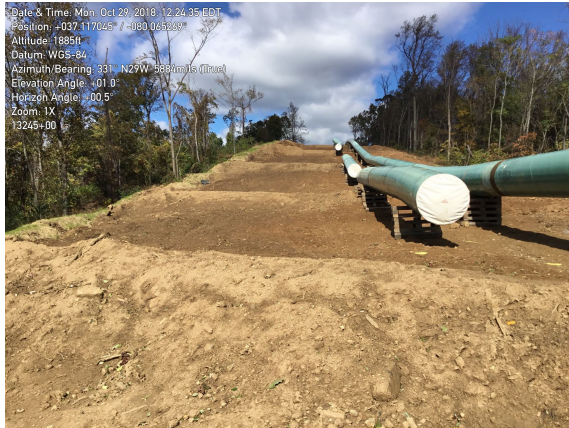
<p>Date &amp; Time: Mon, Oct 29, 2018, 12:24:35 EDT Position: +037.117025° / -080.063457° Altitude: 1885ft Datum: WGS-84 Azimuth/Bearing: 331° N29W 388mils (True) Elevation Angle: -01.0° Horizon Angle: -00.5° Zoom: 1X 13245+00</p>

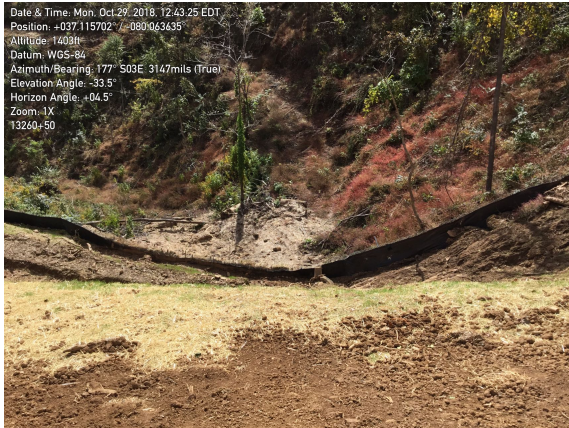
<p>Date &amp; Time: Mon, Oct 29, 2018, 12:43:25 EDT Position: +037.115702° / -080.063635° Altitude: 1403ft Datum: WGS-84 Azimuth/Bearing: 177° S03E 3147mils (True) Elevation Angle: -33.5° Horizon Angle: +04.5° Zoom: 1X 13260+50</p>

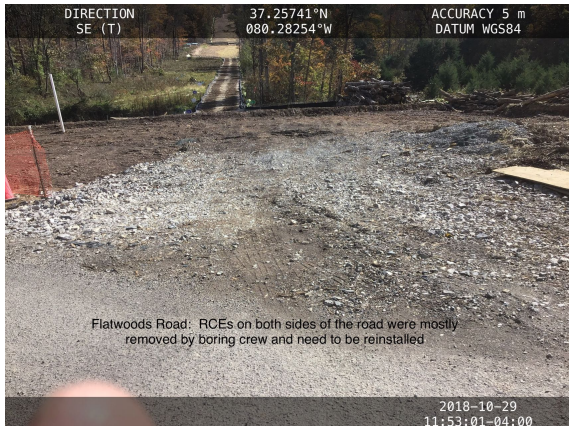
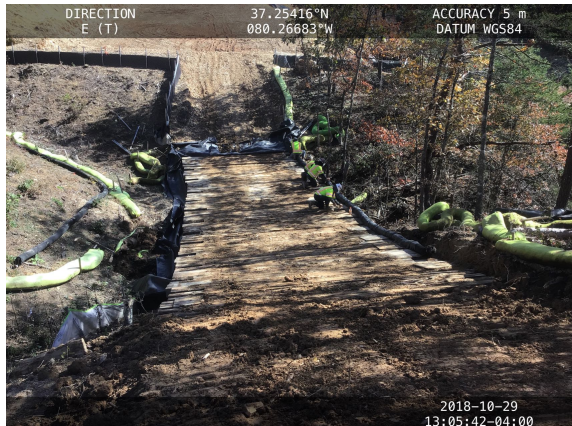
<b>GPS Location</b>	37.2586206207399, -80.2965961676839		<b>GPS Location</b>	37.2581298183997, -80.2890679613504	
<b>Description</b>	SSF next to travel lane on coming in side of stream S-MM15 needs repair and maintenance.		<b>Description</b>	Replace damaged CFS across bridge @ stream S-MM13.

E&S BMPs	Compliance Level	Corrective Action	Corrective Time Frame	Date Repaired
Silt Fence (Reinforced Filter Fabric Fence)	Communication	12076+25: straighten SSF	24 Hours	
Rock Construction Entrance	Communication	Fix RCEs on Flatwoods Road	24 Hours	
Compost Filter Sock	Communication	S-MM13: replace CFS on bridge	24 Hours	
Silt Fence (Filter Fabric Fence)	Acceptable			
Waterbar	Acceptable			
Sump Pit	Acceptable

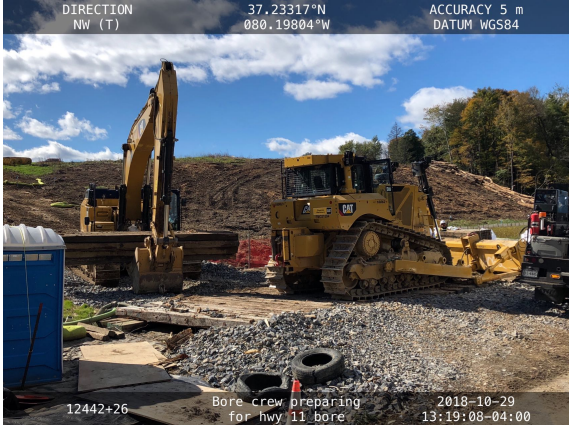
<p>DIRECTION NW (T) 37.23317°N 080.19804°W ACCURACY 5 m DATUM WGS84</p> <p>12442+26 Bore crew preparing for hwy 11 bore 2018-10-29 13:19:08-04:00</p>

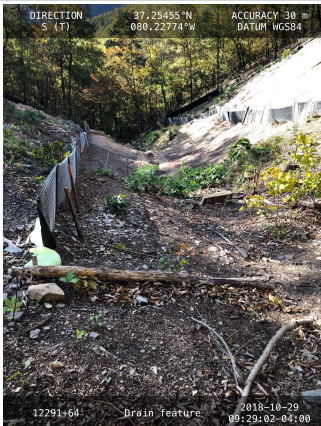
<p>DIRECTION S (T) 37.25455°N 080.22774°W ACCURACY 30 m DATUM WGS84</p> <p>12291+64 Drain feature 2018-10-29 09:29:02-04:00</p>

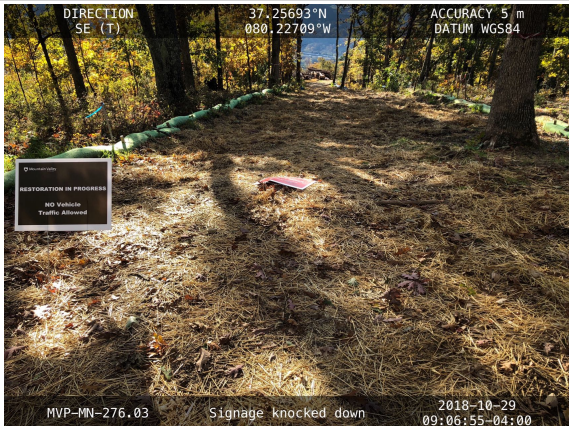
<p>DIRECTION SE (T) 37.25693°N 080.22709°W ACCURACY 5 m DATUM WGS84</p> <p>MVP-MN-276.03 Signage knocked down 2018-10-29 09:06:55-04:00</p>		<b>GPS Location</b> 37.3313431861227, -79.95808789514	
<b>Description</b>		<b>Description</b>		12291+64_102918 Drainage feature. Looking S. See picture for GPS data.	
<b>Description</b>		<b>Description</b>		MVP-MN-276.03 Signage that had been ran over. Looking SE. See picture for GPS data.
