Visual Site Inspection Report

| Project Name | Transco Interconnect Station | | AFE | 124300113 | Spread | Transco Interconnect Station | |

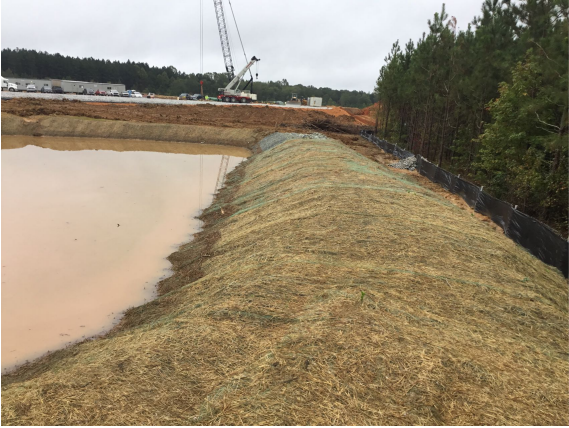
| Description | ST1 | Description | SSF along west LOD downslope of ST2 | | |

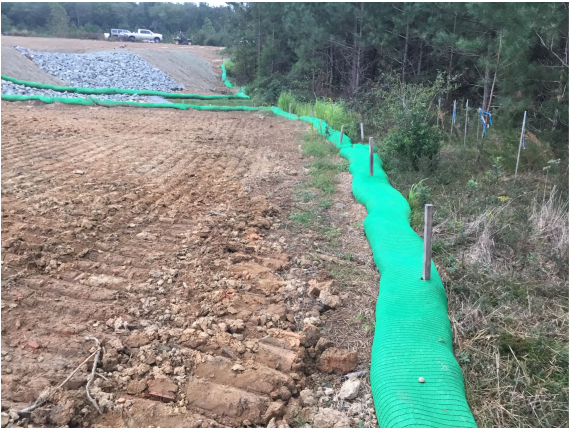
| Description | 18 inch CFS along west LOD | Description | Plunge pool and spreader for SB1 | | |

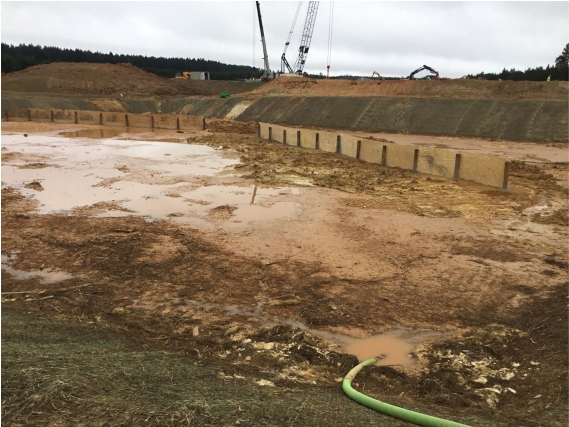
| Description | Completed baffle in SB1 | Description | Damaged 12 in CFS near station of 11+00 of access road | | |

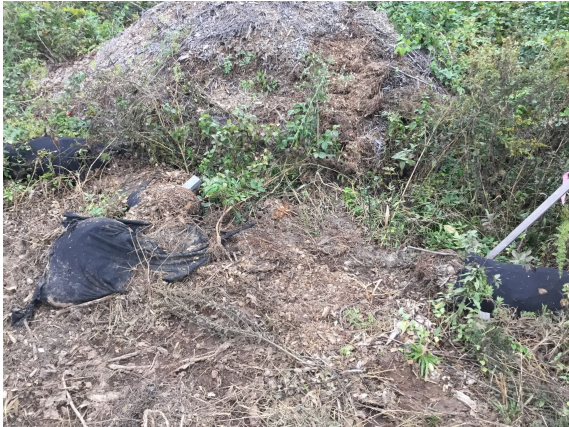
| Performed a VADEQ 4-day SWPPP inspection.... No measurable rainfall in last 11 days. Inspected all installed 12 inch CFS along LOD.... no sediment build up. Damage discovered next to inlet for CC2 near road side ditch for access road. nspected all 18 inch CFS. No sediment build up or damage Inspected installed Super Silt Fence... NO sediment build up or damage Inspected rock filter outlets along SSF. No sediment build up Inspected rock check outlets along SSF. No sediment build up Inspected containment structures for fuel tank and fuel/lube truck. Inspected all eqpt for leaks. Inspected the RCE at Transco Road. No sediment or dirt on the roadway. Signs and permits posted. Inspected inlet, outlet and rock checks for culvert and roadside ditch near site entrance. | | | | | |

| Compost Filter Sock | | Problem Area | Replaced damaged CFS in pic #6 | | Addressed | 10/9/2018 | |

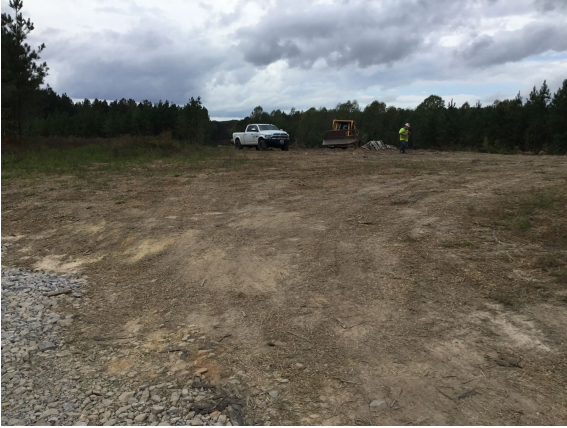
| Description | Northern Clearing working on the main MVP line but staging on H602 ROW at station 5+30 | Description | Access road thru stream SH42 buffer | | |

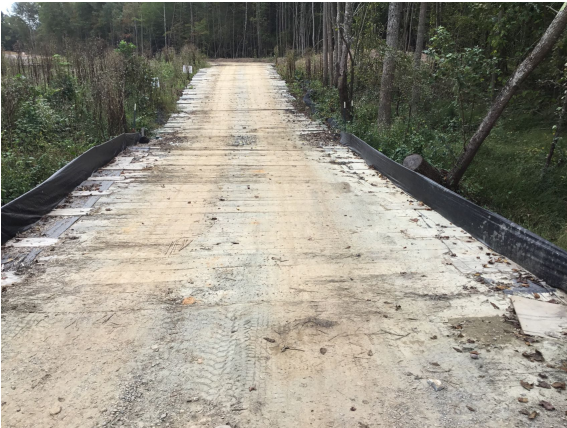
| Description | Temp bridge over Stream SH42 at station 13+00 | Description | Stream SH42 at station 13+00 | | |

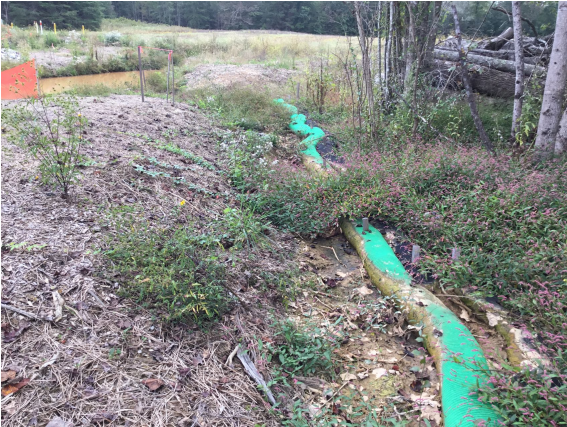
| Description | 12 inch CFS at station 18+00 | Description | Sump pit collecting Williams' dewatering at station 18+50 | | |
