Visual Site Inspection Report

Project Name	Transco Interconnect Station		AFE	124300113	Spread	Transco Interconnect Station	
Contractor	Kanahwa				Report #	9434	
Inspector	Dave Burkhart				Date/Time	10/15/2018 10:26 AM	
Permit #	TBD	Inspection Type	VA SWPP		Station Begin	0+00	
State	VA	Inspection Area	Full		Station End	0+00	
County	Pittsylvania	Ground	Dry		Temperature (°F)	65.00	
Municipality	Chatham	Weather	Cloudy		Rain Gauge (in)	0.00	
GPS Location	36.8347864478548, -79.3420718378205				Rain Accumulation Time (days)	0.00

Project Name	H-602 Pipeline Spread I	AFE	124300139	Spread	H-602 Pipeline Spread I	
Contractor	Precision			Report #	9435	
Inspector	Dave Burkhart			Date/Time	10/15/2018 10:27 AM	
Permit #	TBD	Inspection Type	VA SWPP	Station Begin	0+00	
State	VA	Inspection Area	Full	Station End	19+00	
County	Pittsylvania	Ground	Dry	Temperature (°F)	65.00	
Municipality	Chatham	Weather	Cloudy	Rain Gauge (in)	0.00	
GPS Location	36.8348143715754, -79.3421872426563			Rain Accumulation Time (days)	0.00

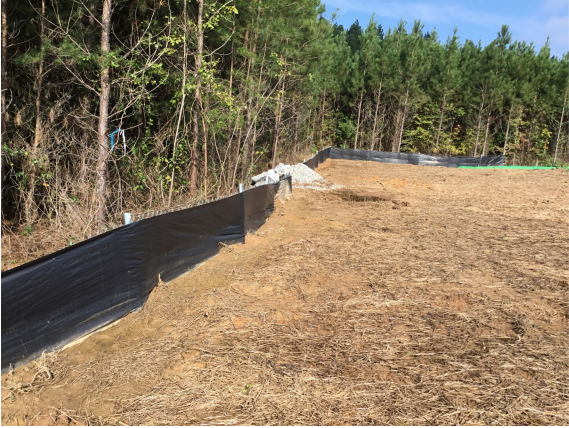
GPS Location	36.8347849574766, -79.3420627489388	GPS Location	36.8347927043557, -79.3422378693515		
Description	SSF and RFO along NW LOD	Description	SSF and lower outer bank of ST-1

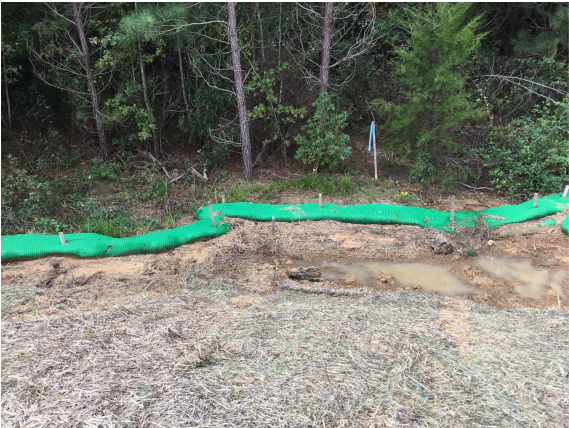
GPS Location	36.8347836618196, -79.3420633177372	GPS Location	36.8347725039691, -79.3420419004553		
Description	18 inch CFS along SW LOD near SB-1	Description	Fuel tanks and generator in containment

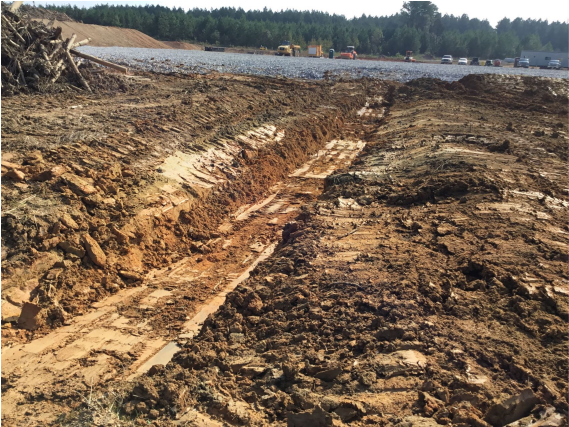
GPS Location	36.8348099710763, -79.3422371987992	GPS Location	36.8347833166242, -79.3422579859191		
Description	Installing channel G from temp pad to ST-1	Description	ST-1

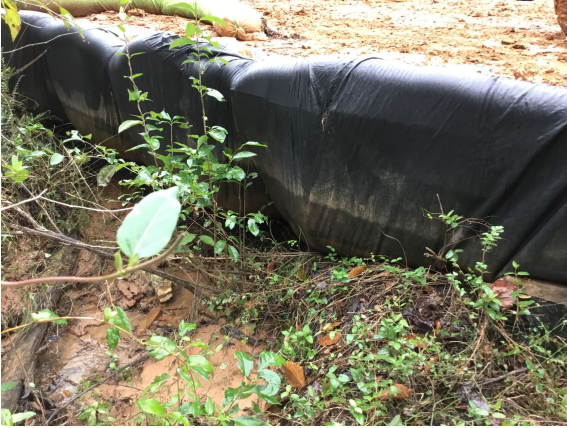
GPS Location	36.9653128087865, -79.6205303818729	GPS Location	36.9653821690352, -79.6205447987464		
Description	Geotech under bridge is full of silt sta 14888+69	Description	Maintenance required at sump sta 14448+00

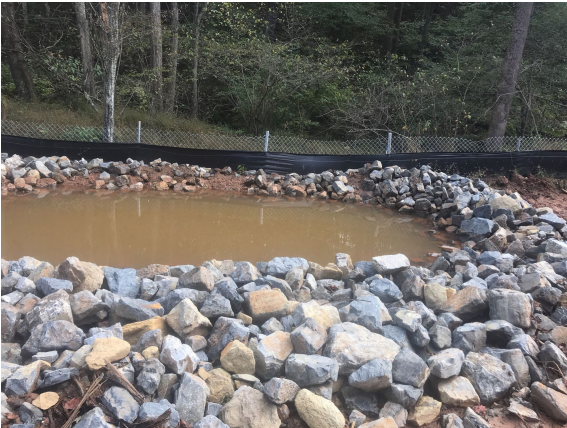
GPS Location	36.9651792431594, -79.6206643246856	GPS Location	36.9652780657978, -79.6206903085854		
Description	Plunge pool functioning properly sta 13842+00	Description	Maintenance required at sump sta 13827+00

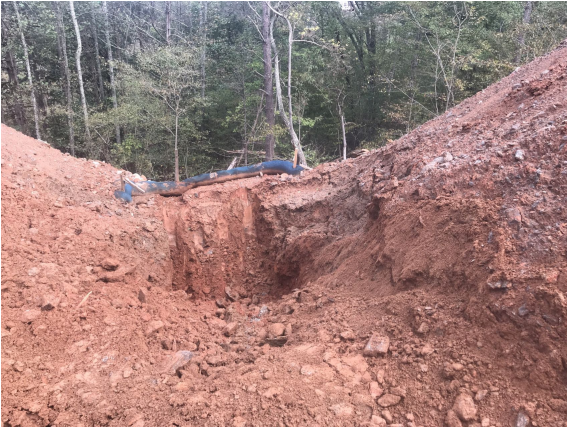
GPS Location	36.9652780657978, -79.6206903085854	GPS Location	36.9652780657978, -79.6206903085854		
Description	Maintenance performed on sump sta 13775+10	Description	Maintenance required sta 15168+00
