Visual Site Inspection Report

Project Name	H-602 Pipeline Spread I		AFE	124300139	Spread	H-602 Pipeline Spread I	
Contractor	Precision				Report #	9942	
Inspector	Dave Burkhart				Date/Time	10/25/2018 7:58 AM	
Permit #	TBD	Inspection Type	VA SWPP		Station Begin	00+00	
State	VA	Inspection Area	Full		Station End	19+00	
County	Pittsylvania	Ground	Dry		Temperature (°F)	35.00	
Municipality	Chatham	Weather	Sunny		Rain Gauge (in)	0.00	
GPS Location	36.8347866357799, -79.3420990672741				Rain Accumulation Time (days)	0.00

Project Name	Transco Interconnect Station		AFE	124300113	Spread	Transco Interconnect Station	
Contractor	Kanahwa				Report #	9943	
Inspector	Dave Burkhart				Date/Time	10/25/2018 7:59 AM	
Permit #	TBD	Inspection Type	VA SWPP		Station Begin	0+00	
State	VA	Inspection Area	Full		Station End	0+00	
County	Pittsylvania	Ground	Dry		Temperature (°F)	36.00	
Municipality	Chatham	Weather	Sunny		Rain Gauge (in)	0.00	
GPS Location	36.8348722905264, -79.3422626797849				Rain Accumulation Time (days)	0.00

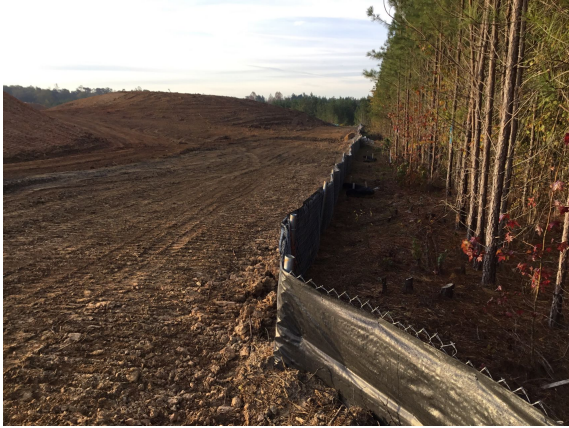
GPS Location	36.834778748487, -79.3422771804774	GPS Location	36.834778748487, -79.3422771804774		
Description	K.S. Removing debris from top soil	Description	SSF along west LOD

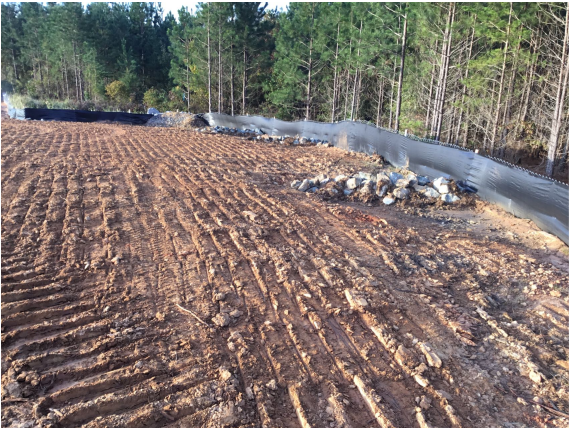
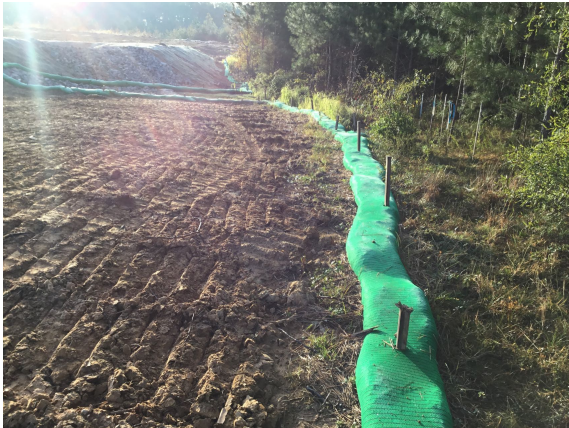
GPS Location	36.8347892754269, -79.3421332704486	GPS Location	36.834778748487, -79.3422771804774		
Description	Rock filters along west LOD	Description	18 inch CFS along west LOD below SB-1

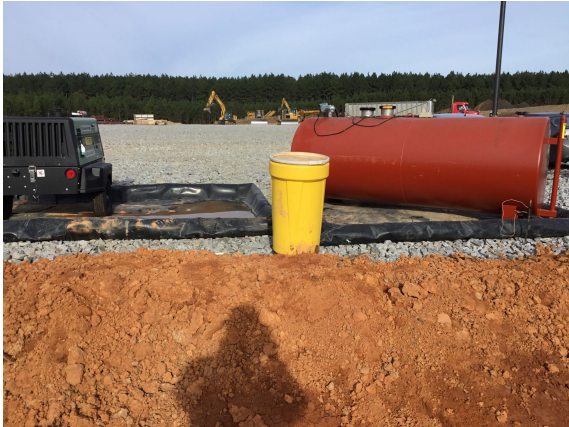
GPS Location	36.8347896465442, -79.342135273682	GPS Location	36.8347889457287, -79.3421318222469		
Description	Riser structure inside of SB-1	Description	Containment of generator and fuel tank. Spill response kit in place.
