Visual Site Inspection Report

Project Name	H-602 Pipeline Spread I	AFE	124300139	Spread	H-602 Pipeline Spread I
Contractor	Precision			Report #	8792
Inspector	Dave Burkhart			Date/Time	10/3/2018 9:43 AM
Permit #	TBD	Inspection Type	VA SWPP	Station Begin	0+00
State	VA	Inspection Area	Full	Station End	19+00
County	Pittsylvania	Ground	Dry	Temperature (°F)	74.00
Municipality	Chatham	Weather	Sunny	Rain Gauge (in)	0.00
GPS Location	36.8347814479658, -79.3420047279199			Rain Accumulation Time (days)	0.00

Project Name	Transco Interconnect Station		AFE	124300113	Spread	Transco Interconnect Station	
Contractor	Kanahwa				Report #	8793	
Inspector	Dave Burkhart				Date/Time	10/3/2018 9:45 AM	
Permit #	TBD	Inspection Type	VA SWPP		Station Begin	0+00	
State	VA	Inspection Area	Full		Station End	0+00	
County	Pittsylvania	Ground	Dry		Temperature (°F)	74.00	
Municipality	Chatham	Weather	Sunny		Rain Gauge (in)	0.00	
GPS Location	36.8348546047107, -79.3423829600954				Rain Accumulation Time (days)	0.00

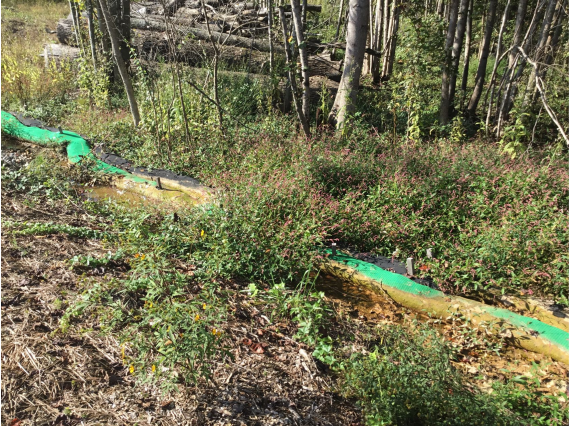
GPS Location	36.8347782529442, -79.3420299281354	GPS Location	36.8273616861895, -79.3439714983845		
Description	12 inch CFS at station 18+00. Filtering runoff from Williams daily dewatering	Description	Sump pit collecting runoff from Williams daily dewatering at station 18+50

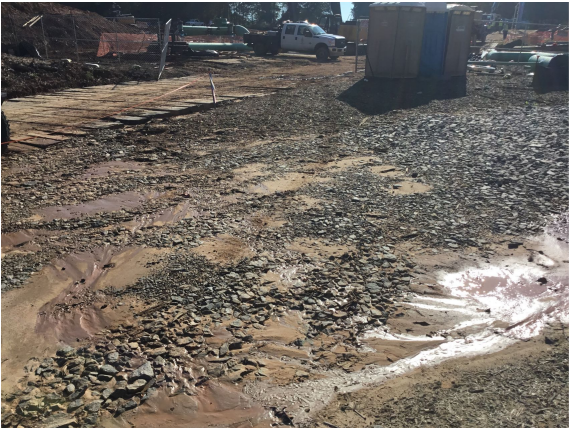
GPS Location	36.827435740304, -79.344348181113	GPS Location	36.8275470403874, -79.3439697143319		
Description	Sediment runoff from Williams site	Description	Stream SH42 at station 13+00

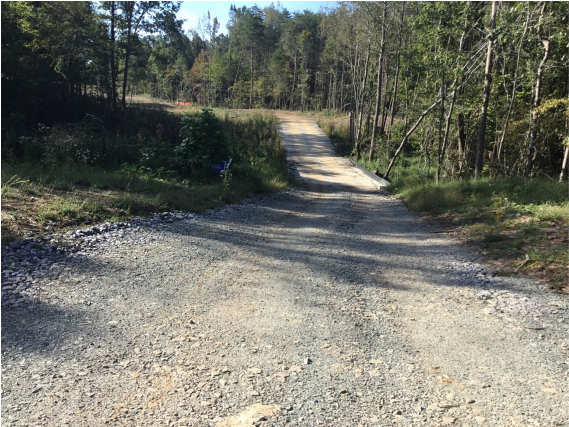
GPS Location	36.8289368134335, -79.3444861472392	GPS Location	36.8292581756011, -79.3442326784873		
Description	Access road thru stream buffer at station 13+00	Description	Access and ROW facing North at station 12+00

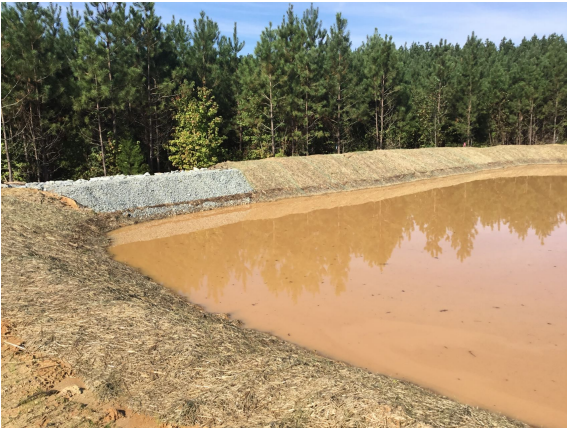
GPS Location	36.8339061923668, -79.3426273763919	GPS Location	36.8337880913511, -79.3441392202669		
Description	Finish grade and stone for temp pad	Description	SSF along west LOD near top soil spoil

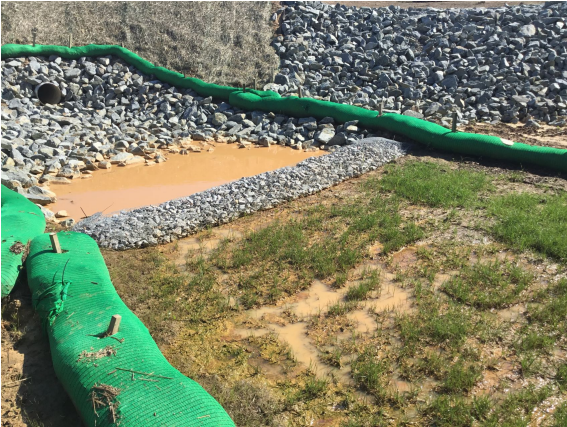
GPS Location	36.8324759044096, -79.3446824514115	GPS Location	36.8332528804981, -79.3441378616749		
Description	ST-2	Description	Top soil spoil
