Re: Mountain Valley Pipeline, LLC Docket No. CP16-10-000 Weekly Status Report No. 84

## NOTICE OF VIOLATION

Violation No <u>W19-34-014-JTL</u>

Facility Name: Mountain Valley Pipeline Project Permit No. WVR310667

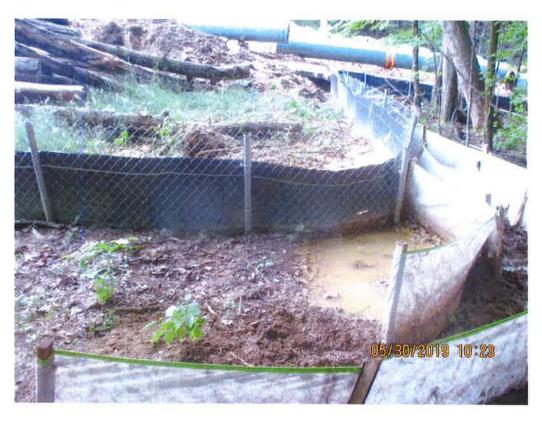
Controls at station No. 6474+16. Recent enhancement was observed.

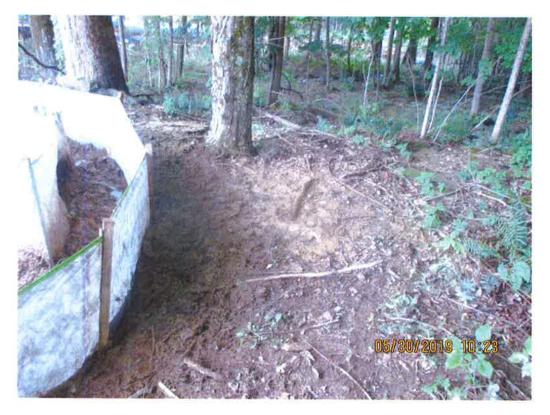
- (1, 6, 13, 19, 21) Above stream S-N10 several controls needed maintenance and evidence that sediment laden water (SLW) had left the site was observed at station No. 6474+16 through 6478+48. Sediment deposits were observed below these controls approximately 200 feet towards stream S-N10 and S-N11.
- (1, 6, 13, 19, 21) Several Waterbar outlets had been overwhelmed with sediment and controls were not functioning as designed at station No. 6508+30 and station No. 6510+40. At Station No. 6510+40 the sediment that overwhelmed the outlet controls had been conveyed past the LOD and into Wetland W-N18. Controls were lacking maintenance and not functioning as designed causing sediment to be deposited approximately 200 feet past the LOD downslope of the outlet.

Facing downslope towards Stream S-N10. Scouring of vegetation and sediment deposits were observed below these controls.

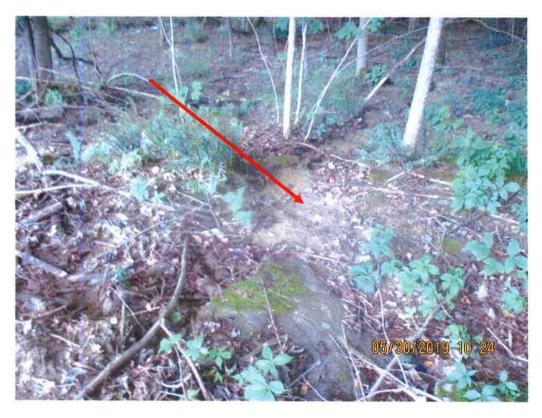
Section D.1-Permitte has failed to properly operate and maintain all facilities and systems: Evidence was observed at stations 6474+16, 6478+48, 6508+30, 6510+10 and 6514+60 that controls were not being maintained causing Sediment to be deposited past the LOD.

Sediment deposits past LOD and controls at station No. 6474+16. Arrow depicts deposits.

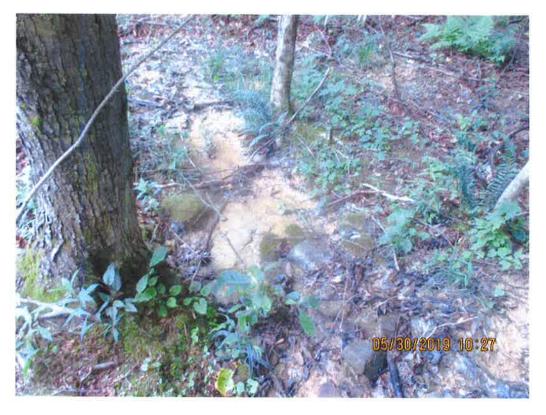
Sediment deposits past the LOD and controls at station No. 6474+16.

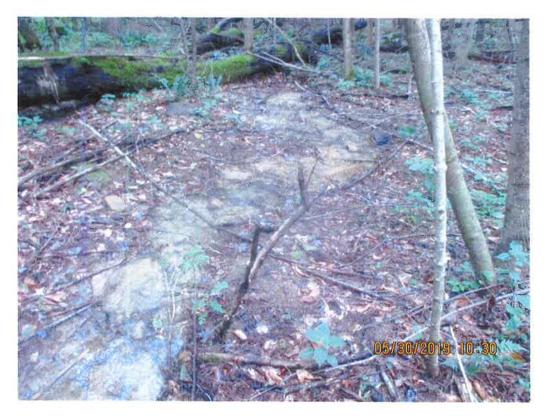
Stream S-N10 facing downstream near station No. 6478+48

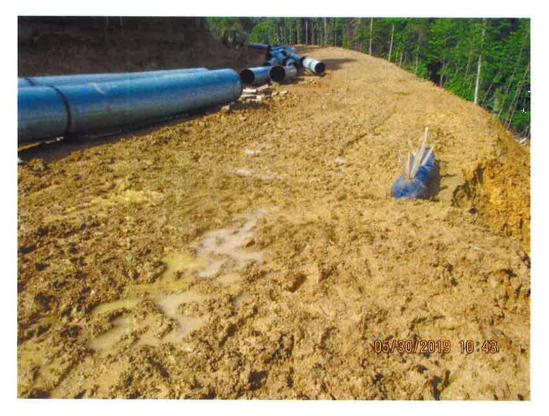
Waterbar outlet terminating onto slope near station No. 6485+10.

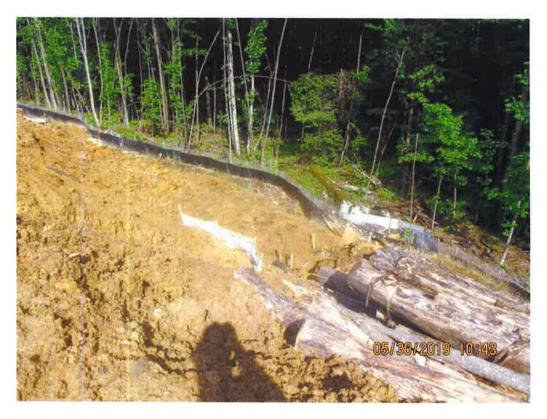
Slope below Waterbar terminus. Perimeter controls becoming overwhelmed with sediment.

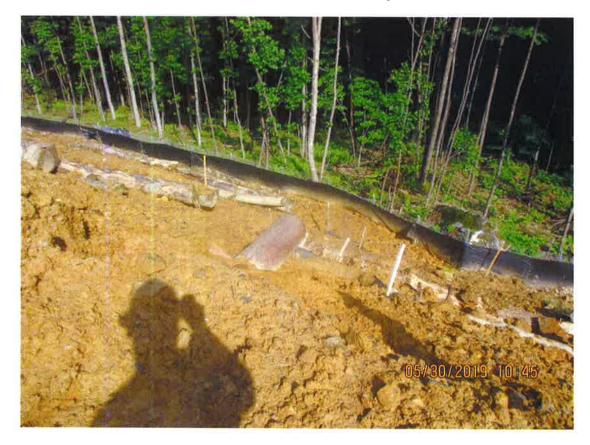
<u>Section G.4.e.2.A.i.d. - Permittee has failed to stabilize clean water diversions prior to becoming functional:</u> <u>Above stream S-EE1 and at station 6485+10 clean water diversions had not been stabilized prior to</u> becoming functional.

Pipe outlet below seep. Diversion not stabilized and No rip rap apron installed as required per SWPPP near station No. 6485+10. The inlet had been cut due to trench being dug.

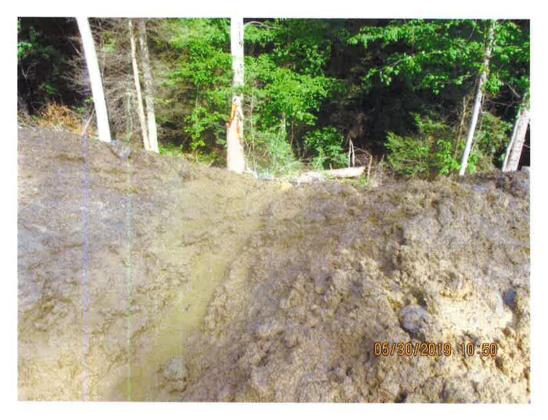
Waterbar outlet terminating onto slope at station No. 6485+10.

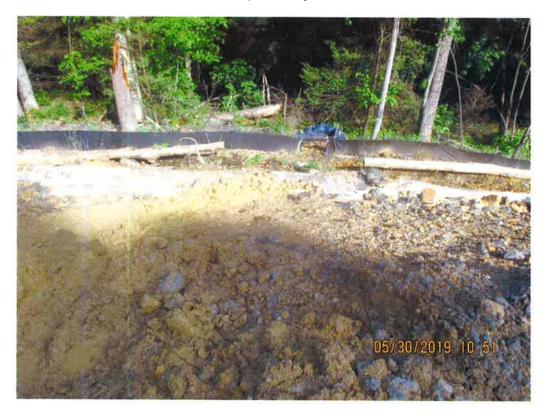
Waterbar outlet terminating onto slope at station No. 6485+10. Erosion present on slope above perimeter controls.

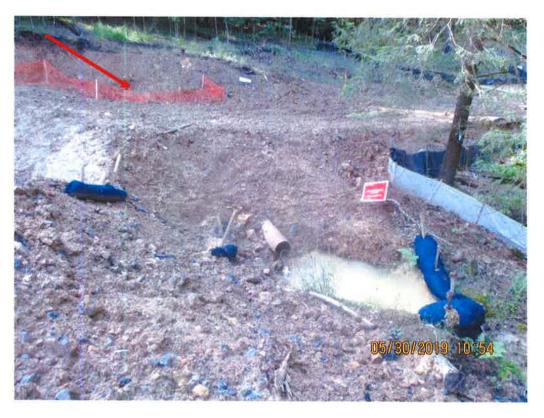
Sep drain outlet above Stream S-EE1. Clean water diversion not stabilized above or below inlet/outlet. Clean water was being conveyed approximately 15 foot across disturbed soil to a sump where the inlet was located. The topsoil pile around the inlet was eroding into the sump. Arrow depicts where inlet was located.

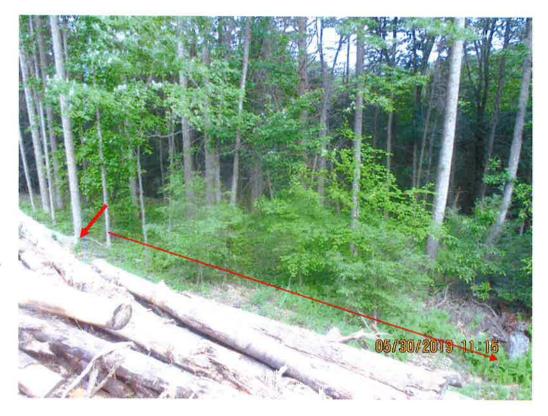
- 3. (1, 6, 13, 15, 21) It was observed that perimeter controls were lacking at station 6495+00. Priority 1 silt fence had not been extended to tie into perimeter outlet controls in this area. Log piles were present with no perimeter controls in place.
- (1, 2, 6, 13, 15, 21) Clean water diversions installed at seeps were not stabilized prior to becoming functional. No rip rap aprons installed at culvert outlets located below seeps as required per SWPPP.
- 5. (1, 6, 13, 19, 21) At Access Road MVP-NI-155 controls were in place per SWPPP. However, the Additional work space had erosion occurring on the NW corner of the LOD. Super silt fence was present and starting to lean over due to the amount of Sediment and SLW being deposited behind it. Sediment deposits were observed past the LOD in this area.

No perimeter control installed per SWPPP on downslope side if fill slope at station No. 6495+00.

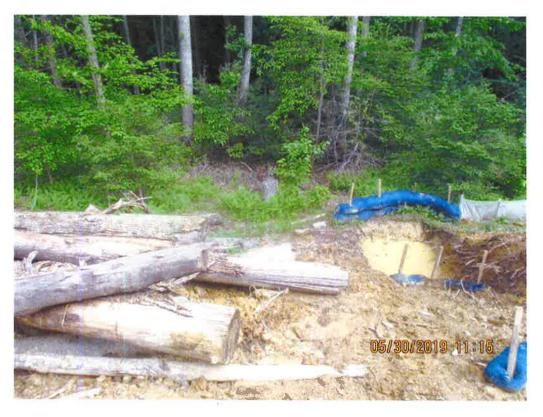
Same area near station No. 6495+00. Perimeter controls not extended per SWPPP into outlet controls.

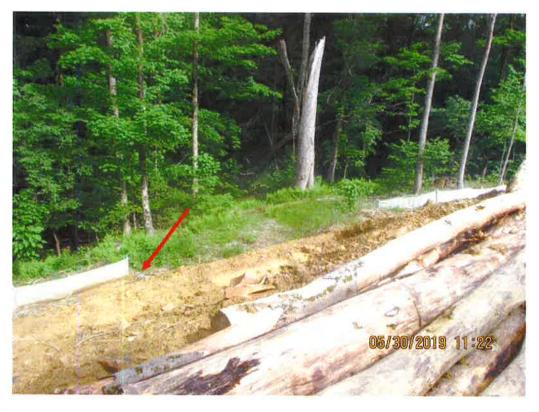
Section G.4-Permittee has failed to follow approved SWPPP: At station 6945+00 ROW diversion had not been installed per SWPPP. Station No. 6497+50 Perimeter controls not installed per SWPPP.

Station No. 6497+50. Perimeter controls not installed per SWPPP. Diversion berm installed however, arrow depicts section where sediment was being deposited against controls and not tied into berm.

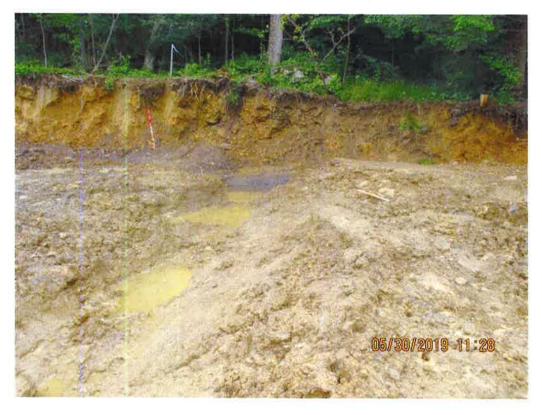
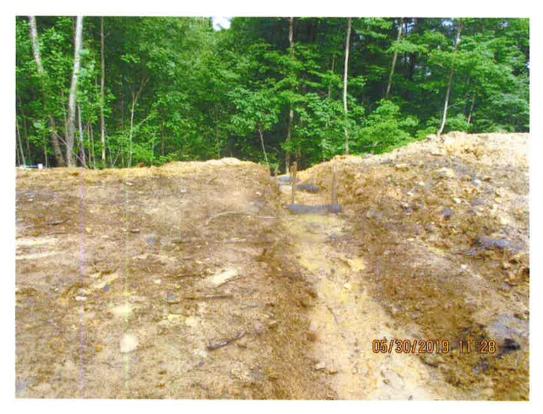
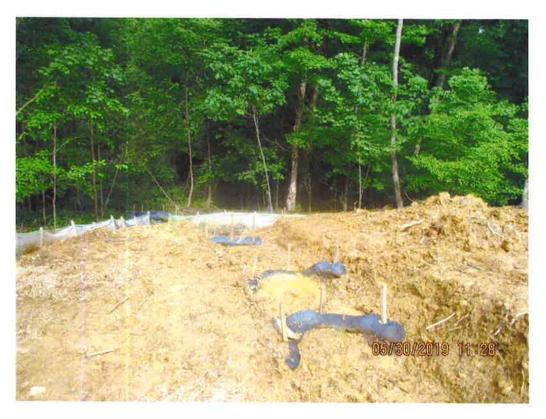
Seep running onto ROW above Stream S-N13. Diversion not stabilized near station No. 6940+00.

Seep running onto ROW via Waterbar above Stream S-N13. Diversion not stabilized near station No. 6940+00.

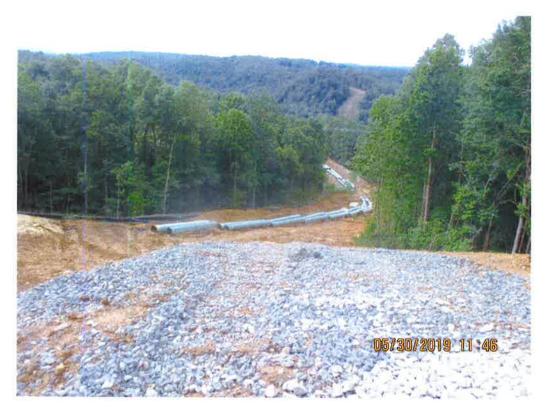
Construction entrance at Deepwell road crossing facing South at station No. 6504+20.

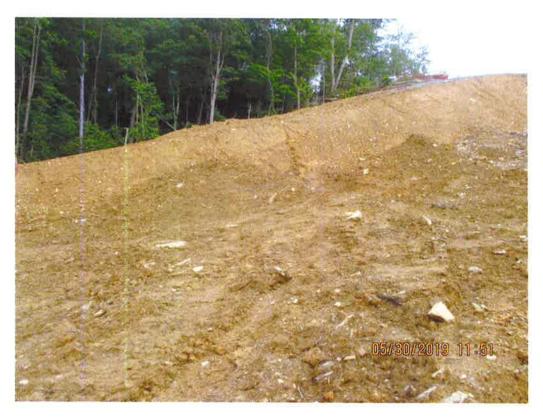
Facing upslope at Deepwell road construction entrance near station No. 6504+20. Erosion present on fill slope and ROW leading to Waterbar.

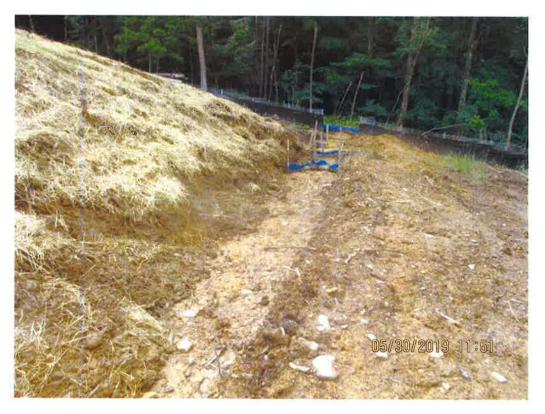
Waterbar with CFS checks installed and scouring topsoil pile below Deepwell road crossing at Station No. 6508+30.

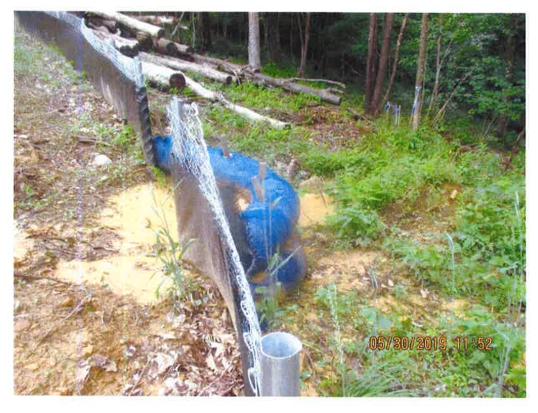
Section G.4.e.2.A.ii.j-Permittee has allowed sediment laden to leave the site without going through and appropriate device: At station No.'s 6508+30, 6510+40 and 6514+60 evidence that SLW had left the site was observed.

Waterbar outlet near station No. 6508+30. Sediment deposits past controls and LOD observed.

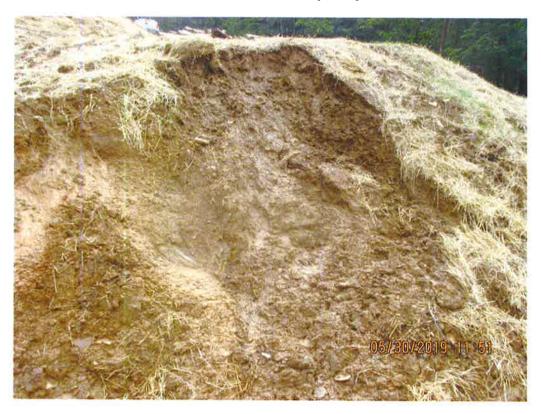
Topsoil pile slipping into Waterbar at station No. 6508+40.

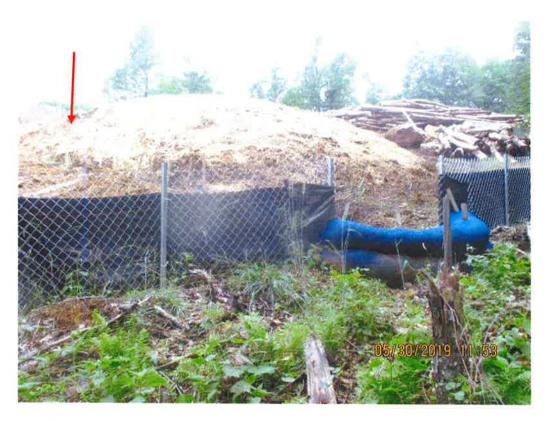
Facing upslope at Waterbar and topsoil pile at station No. 6508+30. Arrow depicts topsoil pile that is slipping into Waterbar.

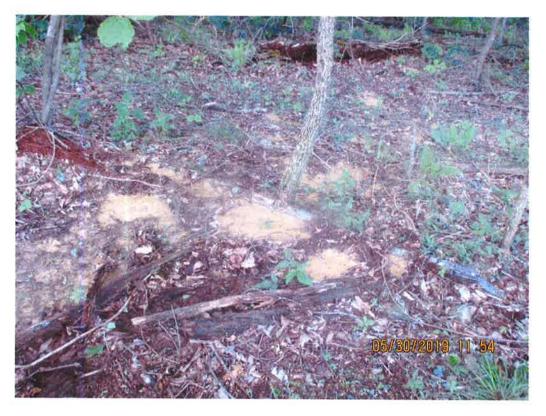
Sediment deposits observed past LOD and Controls below Waterbar and topsoil pile at station No. 6508+30.

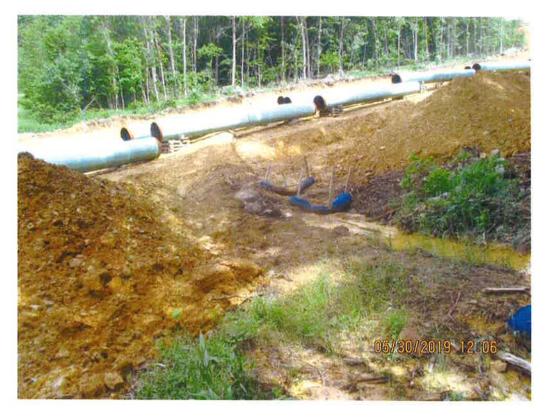
Waterbar at station No. 6510+40 facing upslope.

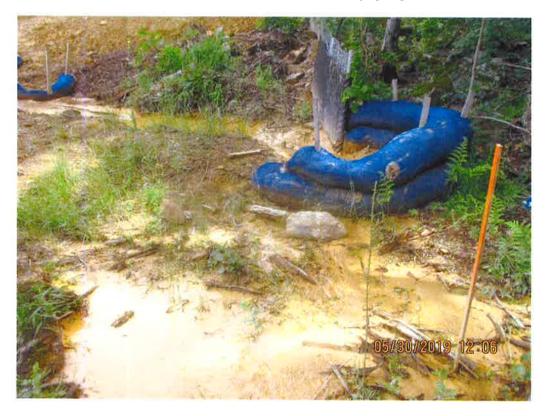
Waterbar outlet at station No. 6510+40 facing upslope. Sediment deposits were observed past LOD and conveying towards Wetland W-N18.

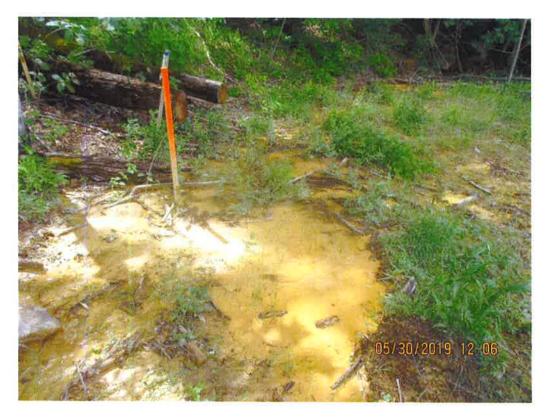
Sediment deposits downslope of Waterbar outlet at station No. 6510+40.

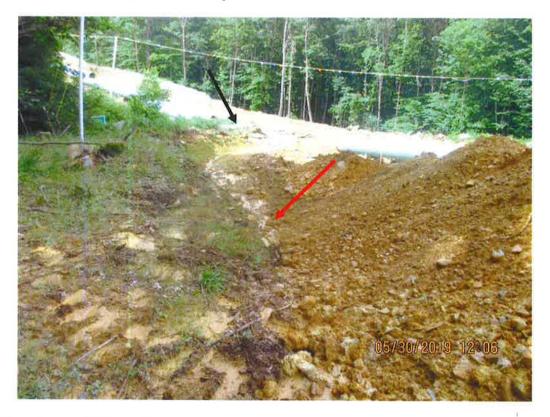
Sediment deposits and SLW traveling downslope at station No. 6510+40. Seep was present in cut next to topsoil pile. Channel wasn't stabilized and conveys to a sump with a slope drain that crosses ROW. Arrow depicts seep. Black arrow shows sump with slope drain inlet.

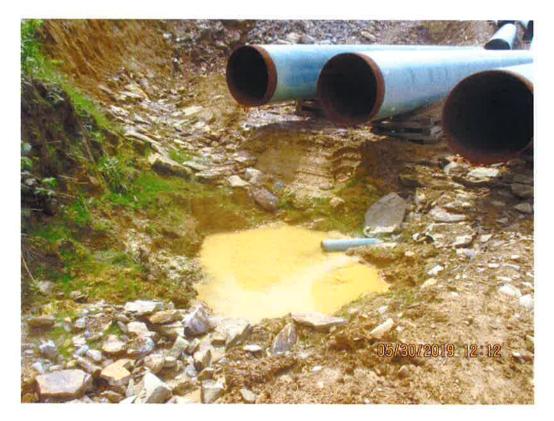
Sump with slope drain inlet for seep at station No. 6510+40.

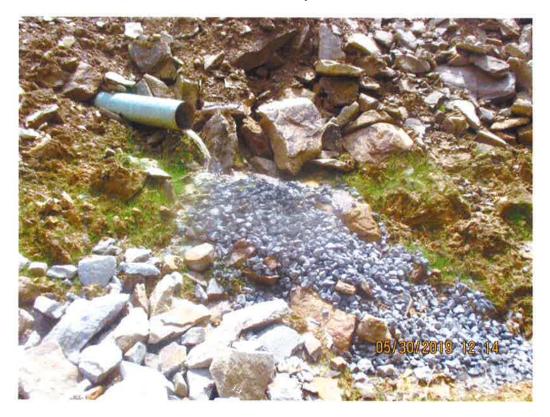
Seep slope drain outlet. Rock apron present.

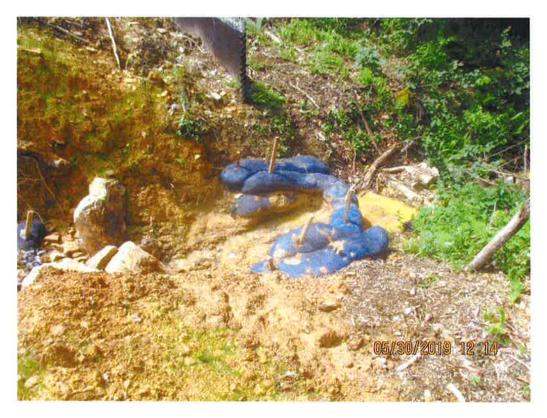
Below seep slope drain outlet. SLW and sediment overwhelming controls.

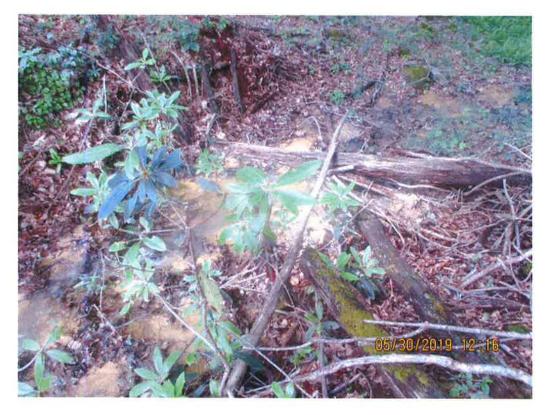
Sediment deposits and SLW observed past controls and LOD at station No. 6510+40.

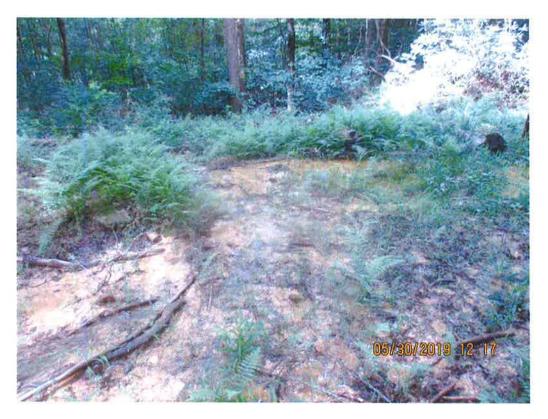
SLW and sediment deposits observed past controls and LOD near station No. 6510+40 approximately 200 feet past LOD.

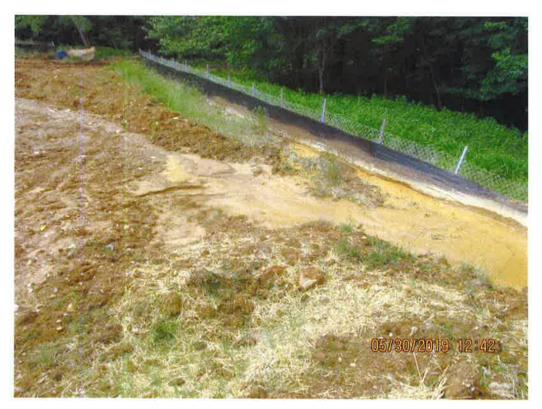
Erosion and sediment/SLW overwhelming perimeter controls at ATWS-22-7A at station No. 6514+60. Sediment deposits observed past controls and LOD.

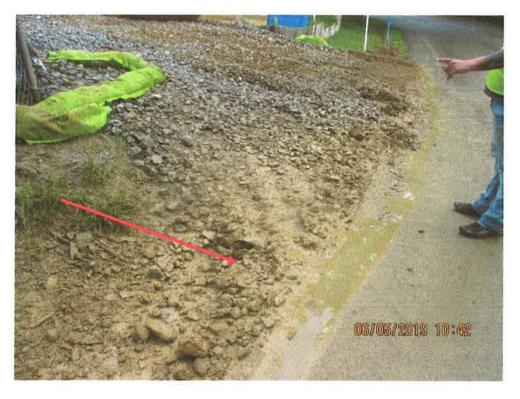
Section D.1-Perimittee has failed to at all times properly operate and maintain all systems of treatment and control: Construction entrance at Rt 82 crossing was not maintained to prevent sediment laden water and sediment to be deposited past the permitted LOD.

Construction entrance at the Route 82 crossing at station No. 5539+00. Arrow depicts culvert inlet.

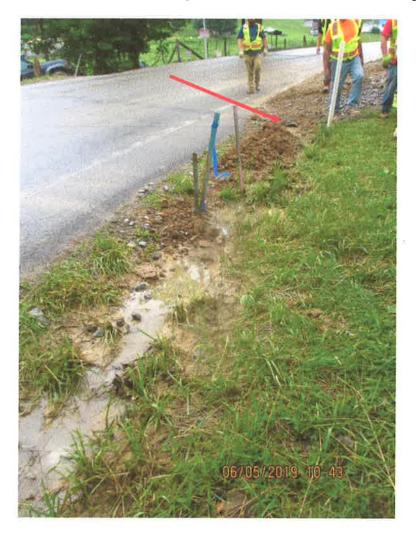
Roadside ditch and culvert outlet. Sediment laden water being conveyed downslope.

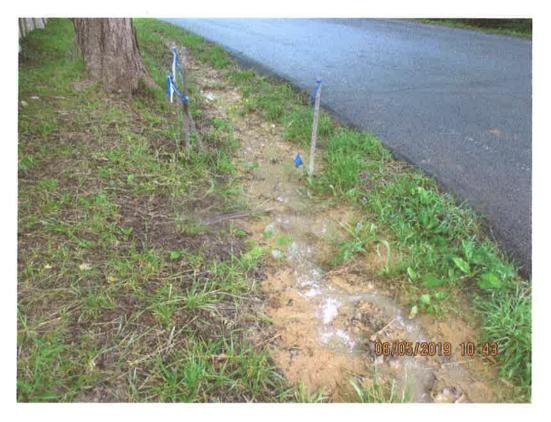
Section G.4.e.2.A.ii.j Permittee has failed to prevent sediment laden water from leaving the site without going through an appropriate device: At the Route 82 crossing sediment deposits and sediment laden water were observed past the LOD. Sediment deposits were observed in the roadside ditch that paralleled Route 28 as well as downslope past a culvert outlet approximately 500 feet past the LOD.

Sediment deposits and sediment laden water being conveyed past the LOD along Route 82.

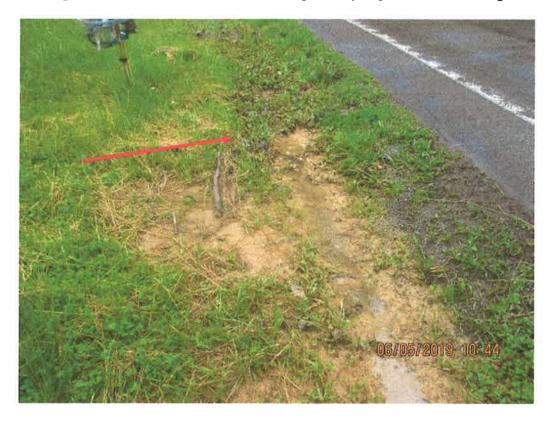
Sediment deposits in roadside ditch that parallels route 82. Arrow depicts culvert intake that conveys under route 82.

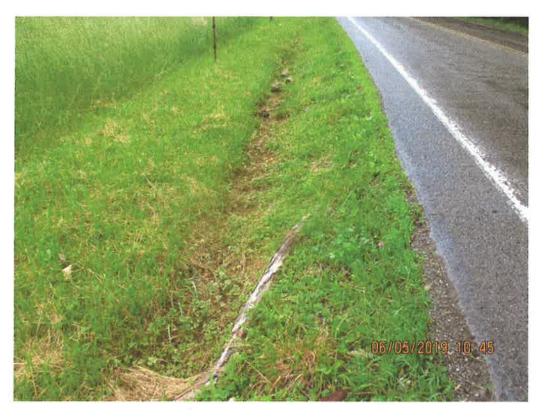
Upslope of culvert intake that conveys under route 82. No sediment deposits present at time of inspection.

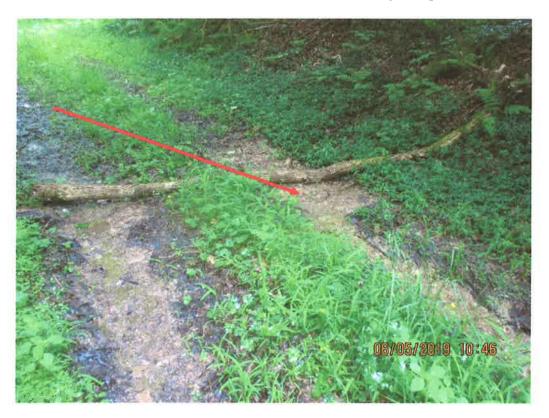
Sediment deposits approximately 500 feet past the LOD downslope of construction entrance.
