Re: Mountain Valley Pipeline, LLC
Docket No. CP16-10-000
Weekly Status Report No. 90

Docket No. CP16-10-000
Weekly Report No. 90
Report Period: 07/13/19- 07/19/19

**Re: Mountain Valley Pipeline Project (Permit No. WVR310667)
Response to Notice of Violation No. W19-34-014-JTL**

STATE OF WEST VIRGINIA
Department of Environmental Protection
Environmental Enforcement
NOTICE OF VIOLATION

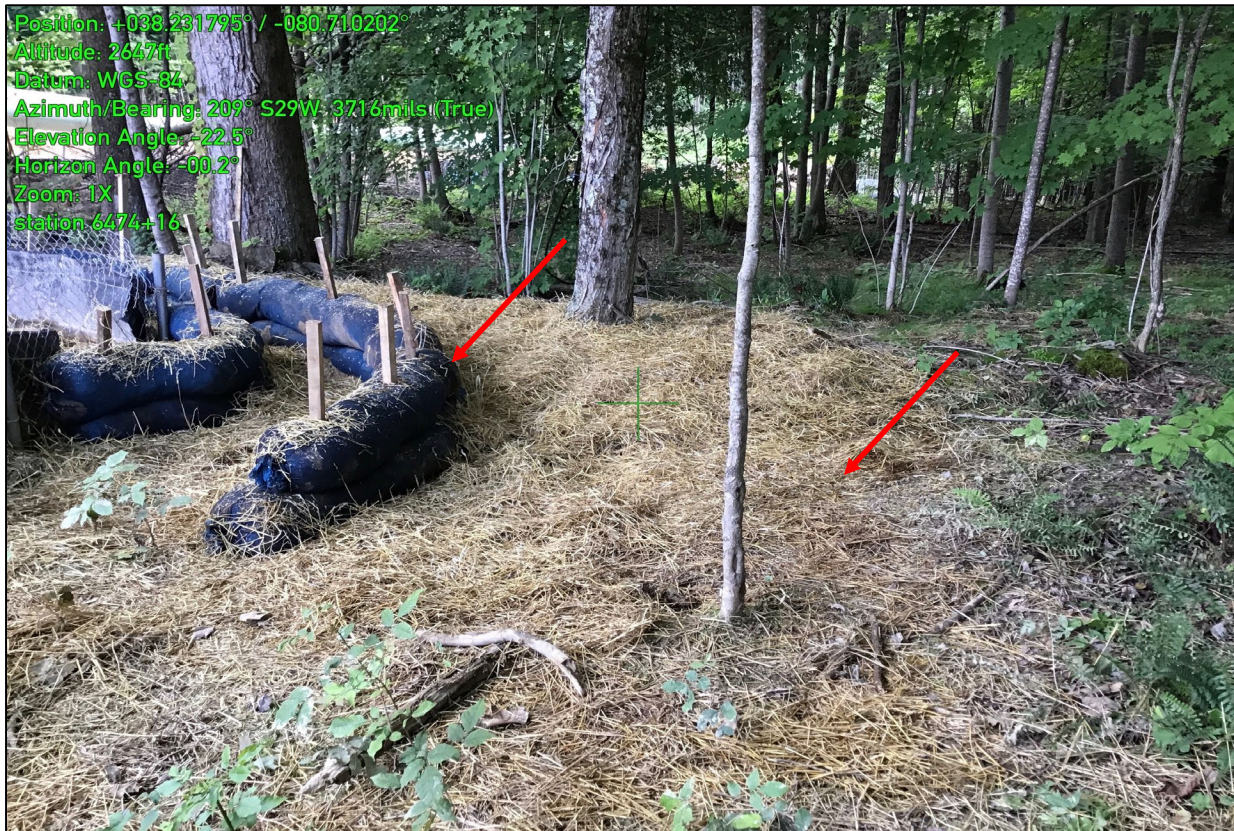
Photo 1: Photo illustrates the temporary stabilization and CFS that has been installed near Station 6474+16.

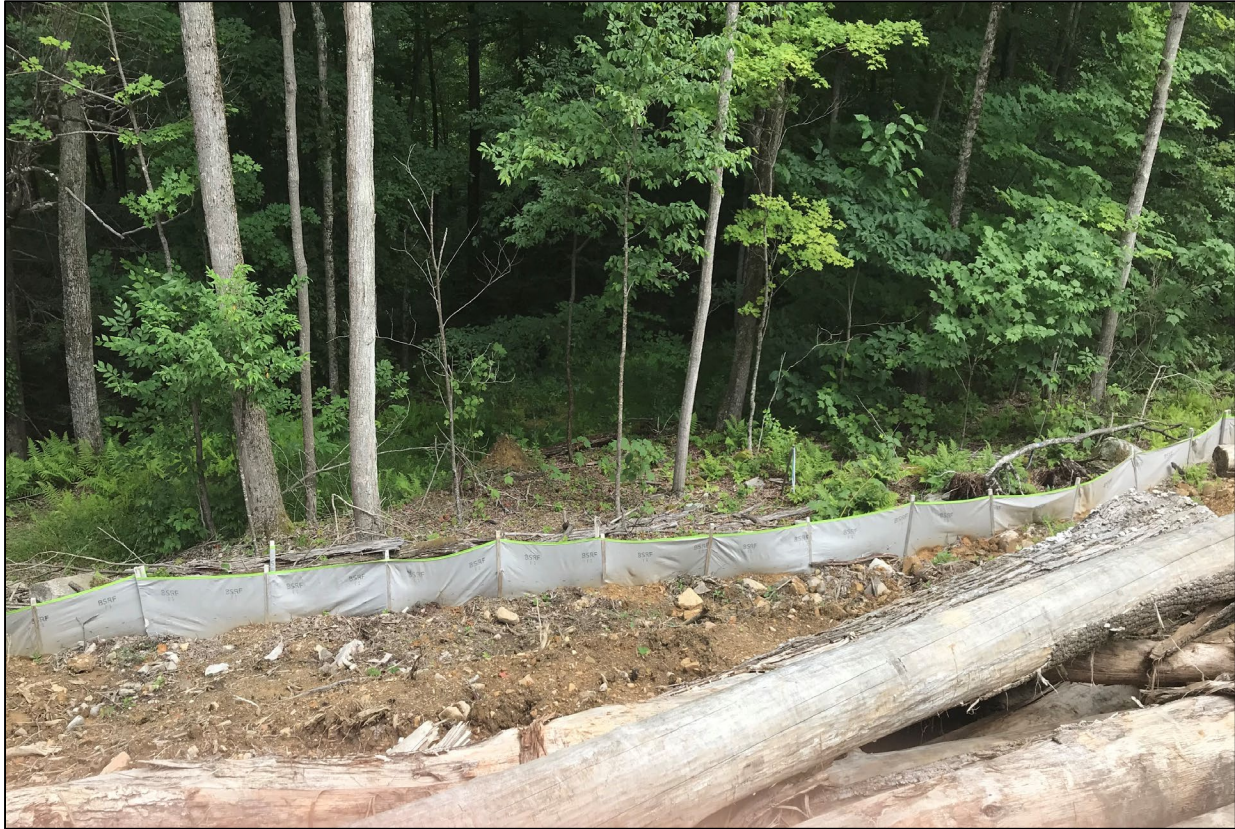
Photo 5: Photo illustrates the additional row of P1 silt fence that has been installed near Station 6497+50.

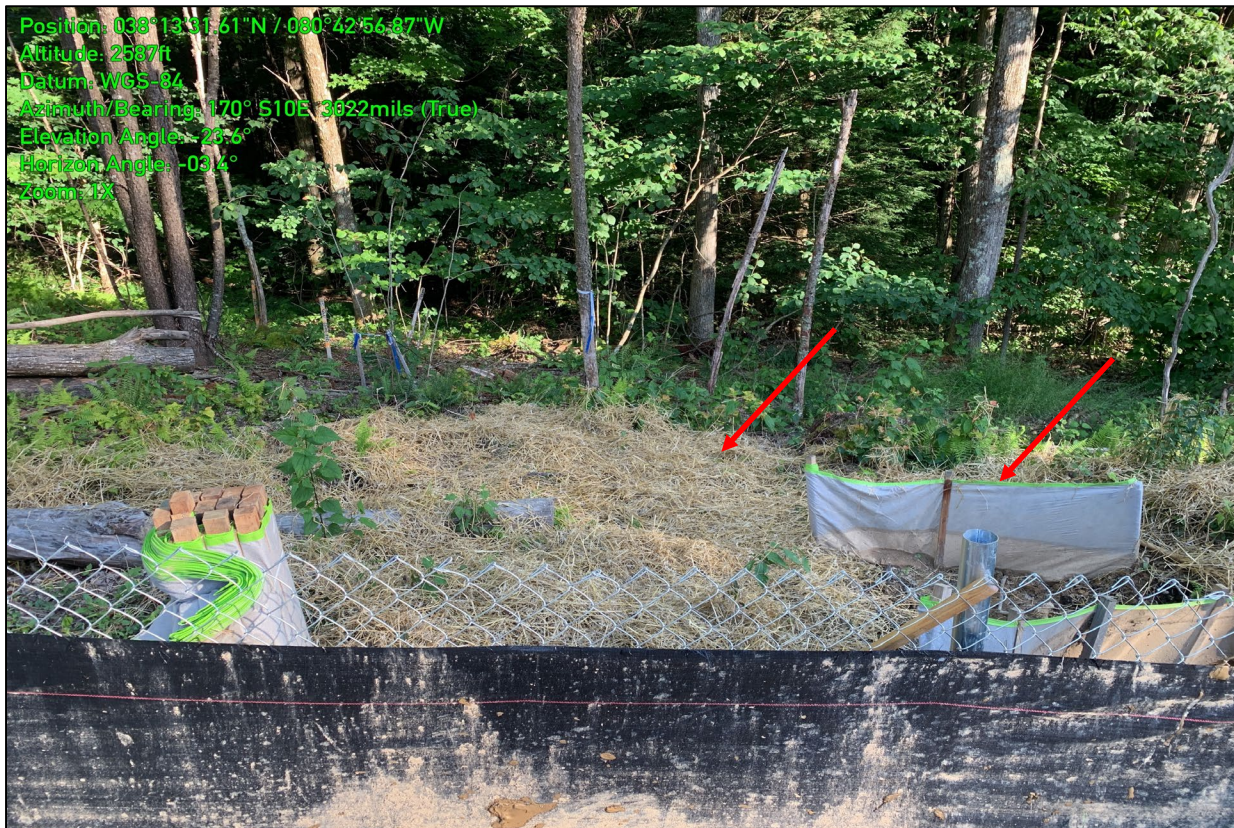
Photo 6: Photo illustrates the temporary stabilization and additional ECDs that have been installed near Station 6508+30

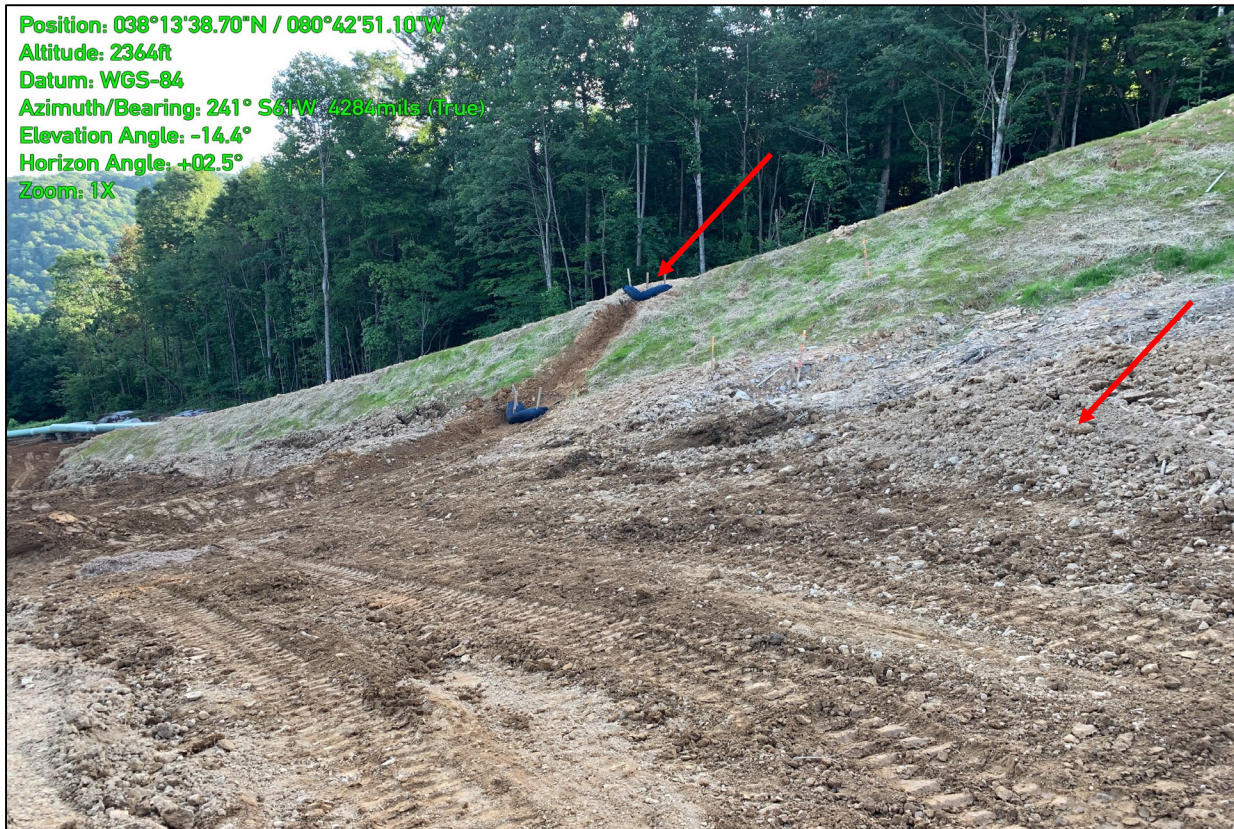
Photo 7: Photo illustrates the additional water bar that was installed near Station 6504+20 and the regraded LOD.

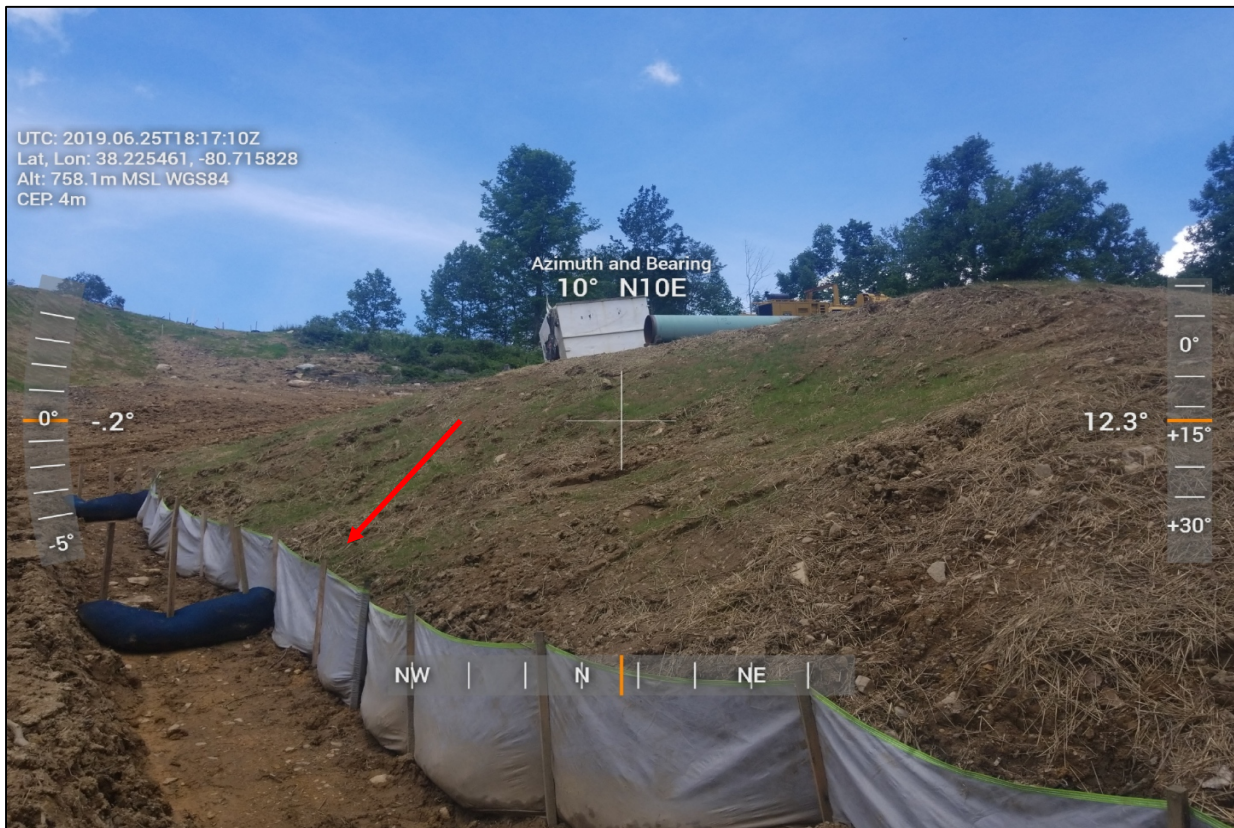
Photo 8: Photo shows the row of P1 fencing that has been installed to separate the stockpile from the waterbar near Station 6508.

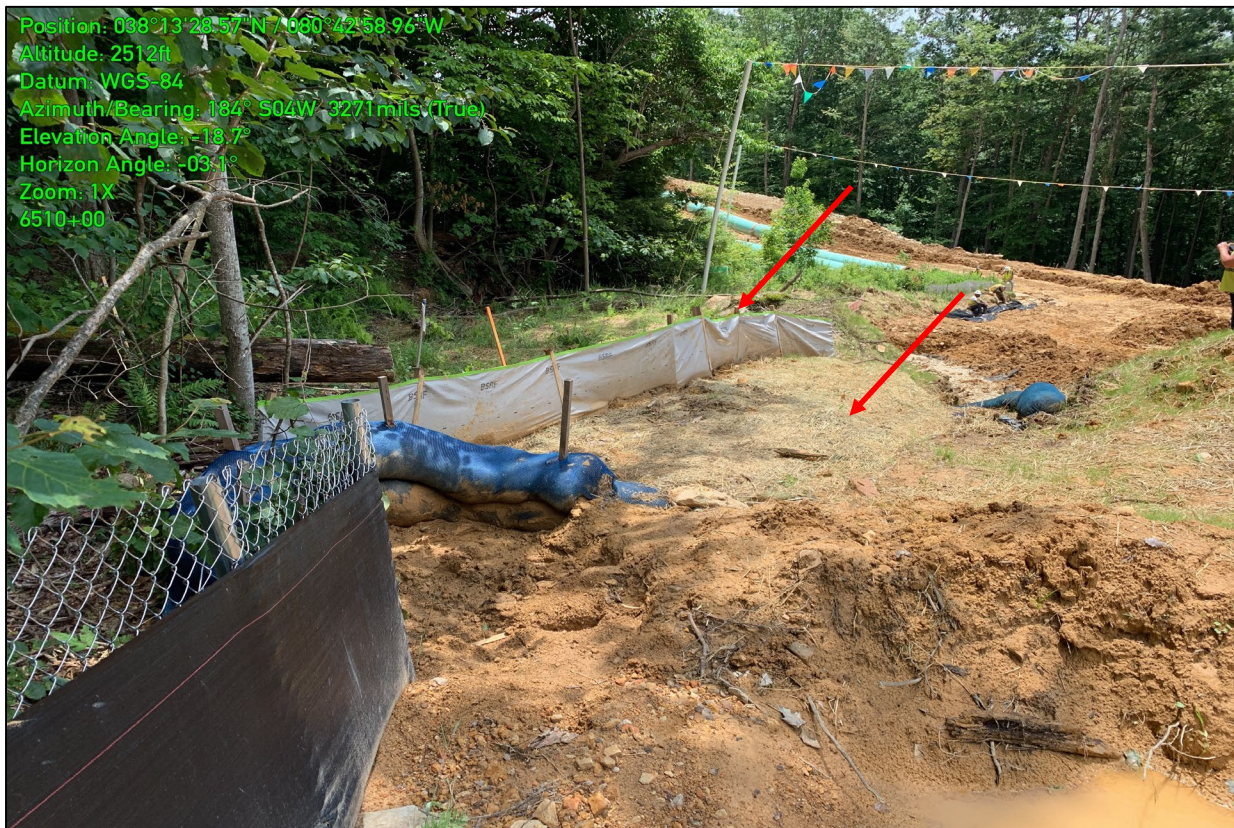
Photo 10: Photo shows the additional P1 silt fence and temporary stabilization that has been installed near Station 6510+40.

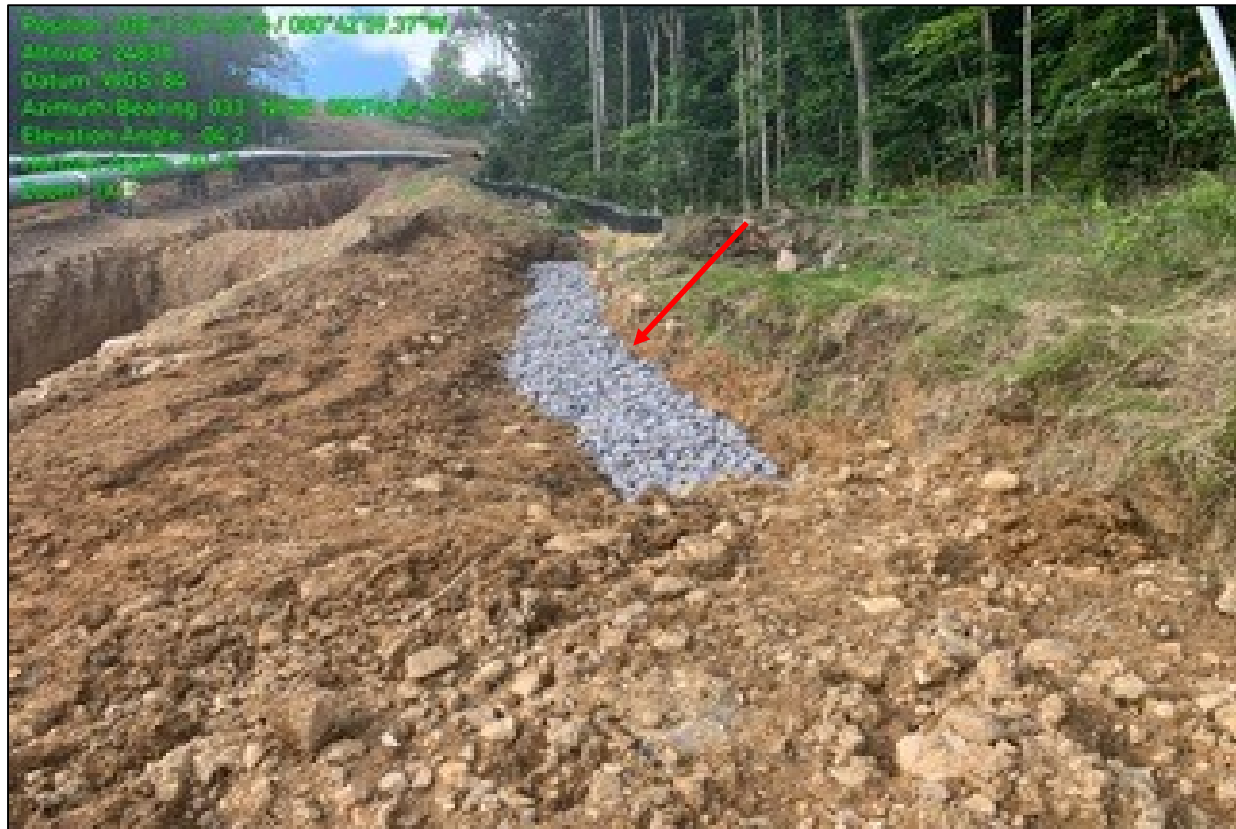
Photo 11: Photo illustrates the drainage channel installed near Station 6510+40.

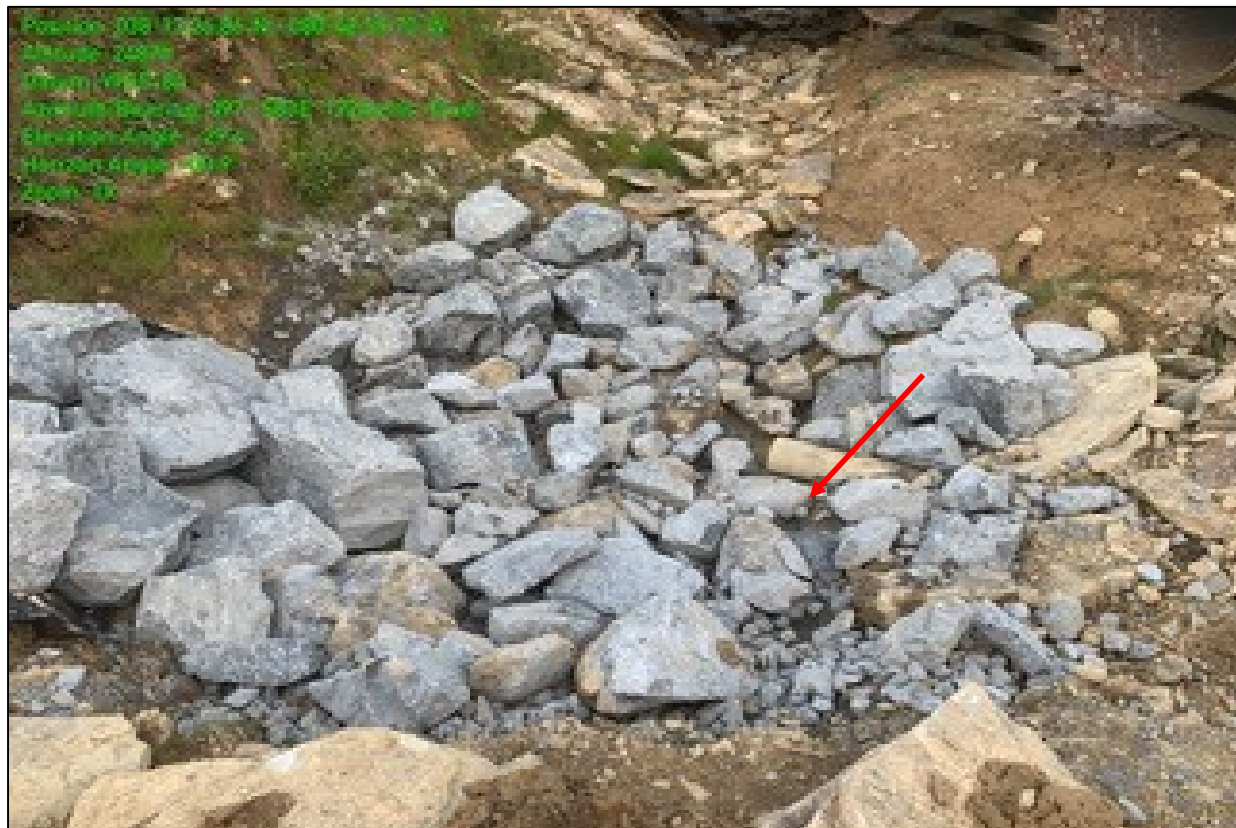
Photo 12: Photo shows the additional rock that has been added for stabilization near Station 6510+40.

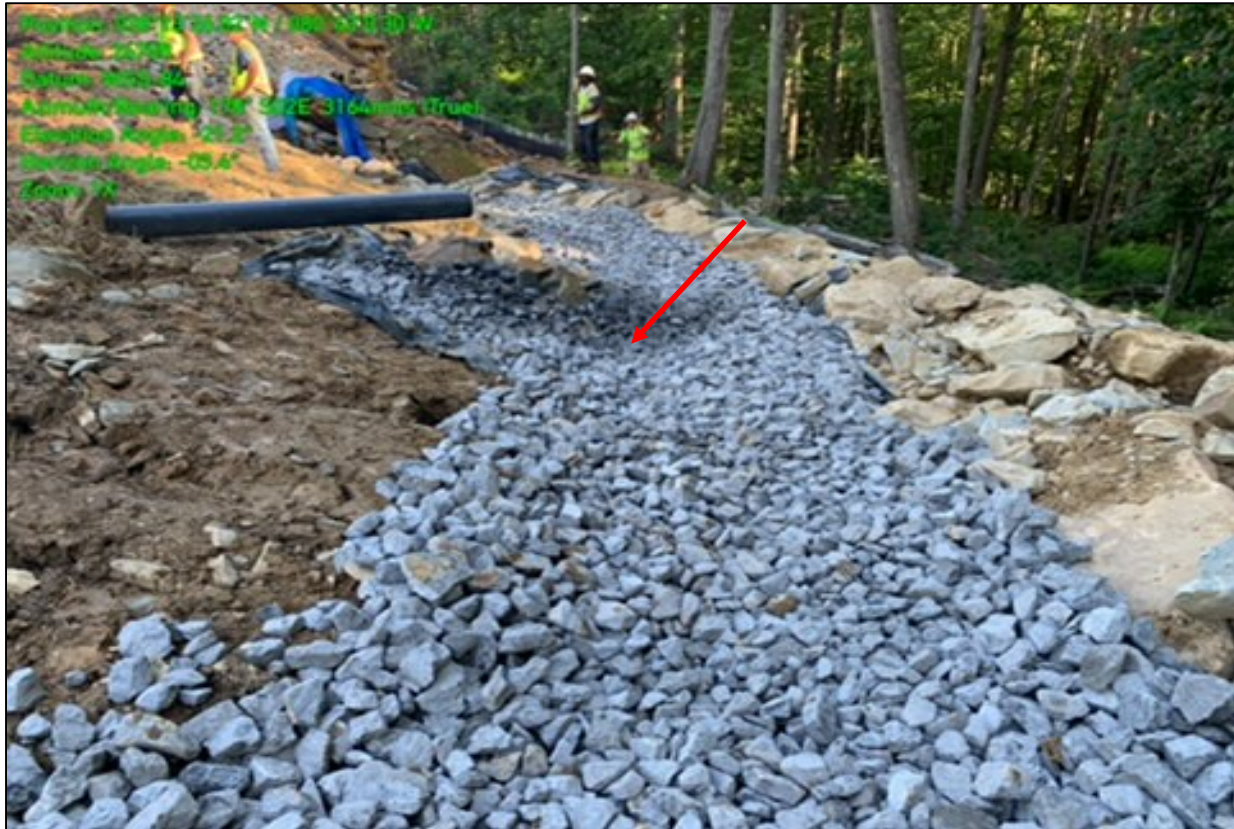
Photo 13: Photo illustrates the drainage channel installed near Station 6510+40.

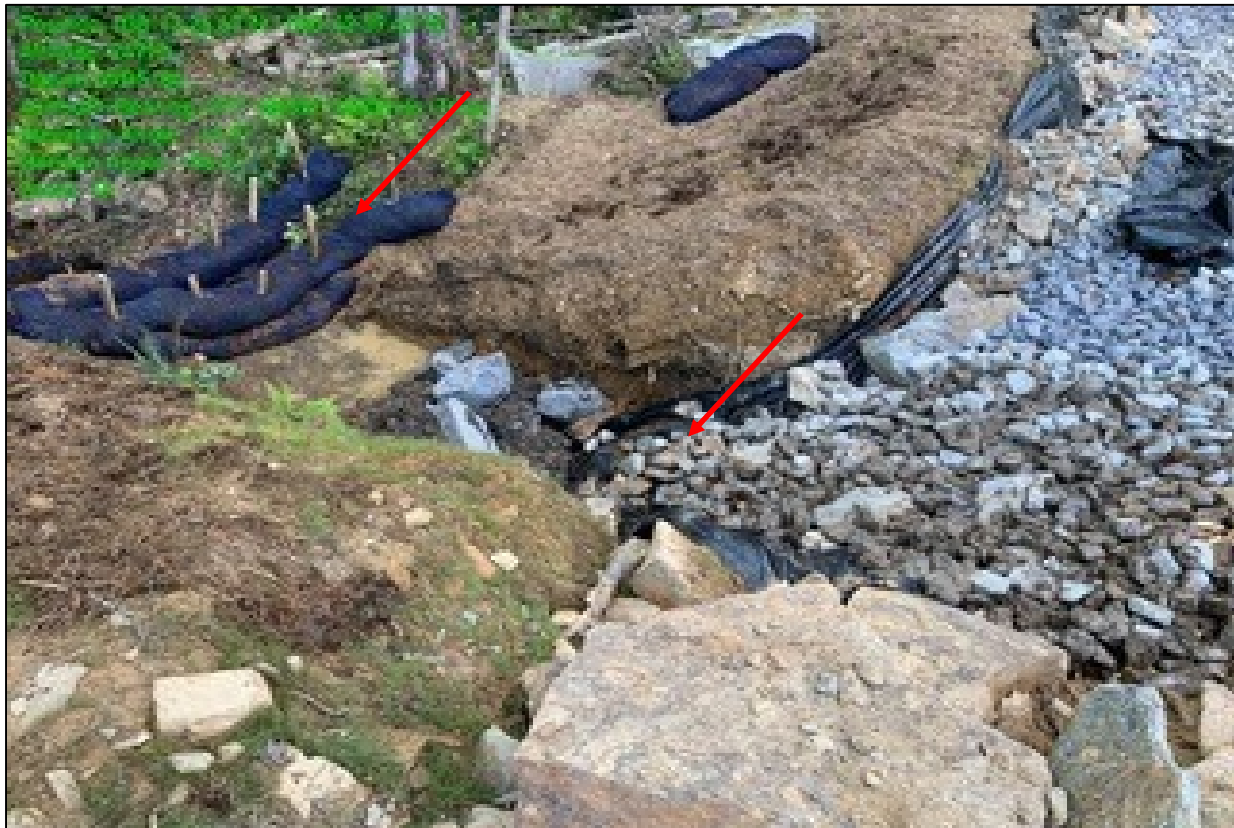
Photo 14: Photo shows the additional rock and CFS that have been installed near Station 6510+40.

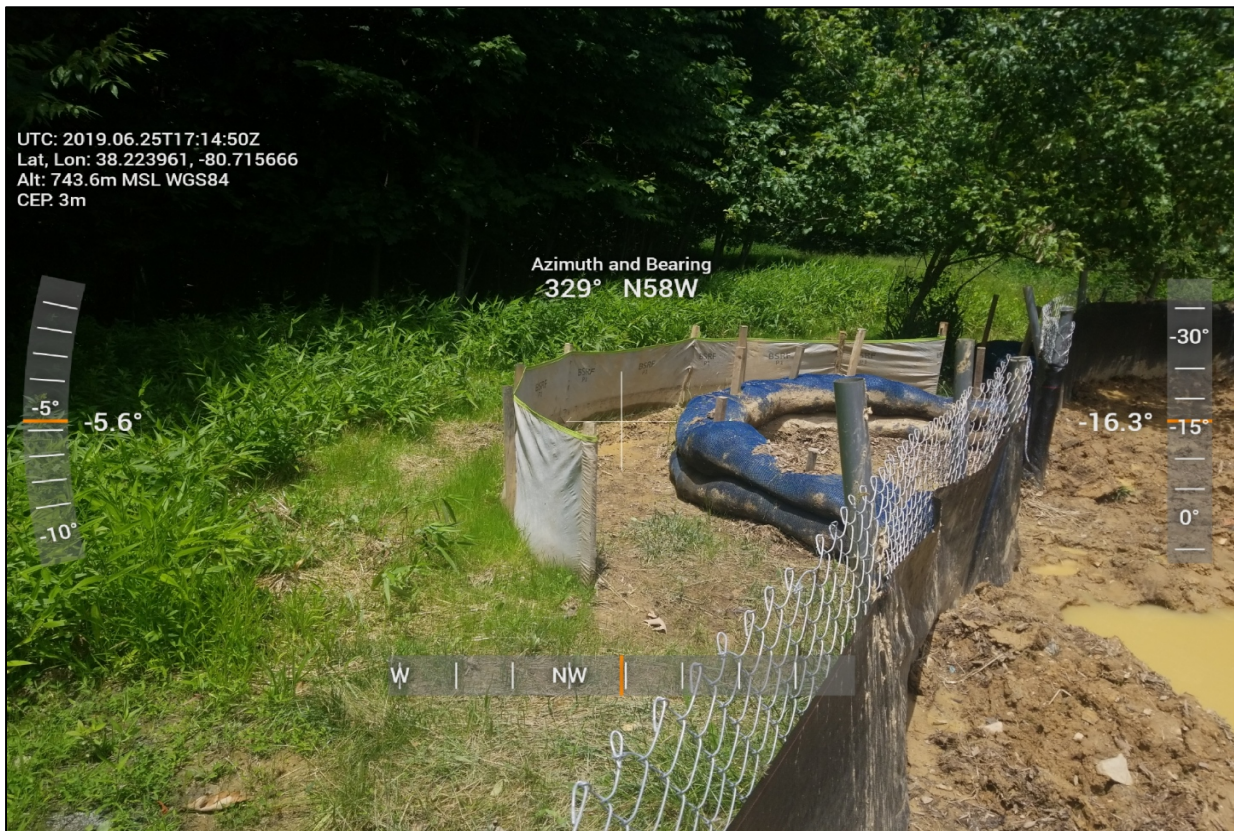
Photo 15: Photo illustrates the additional ECDs that have been installed along ATWS-22-7A., near Station 6514+60.

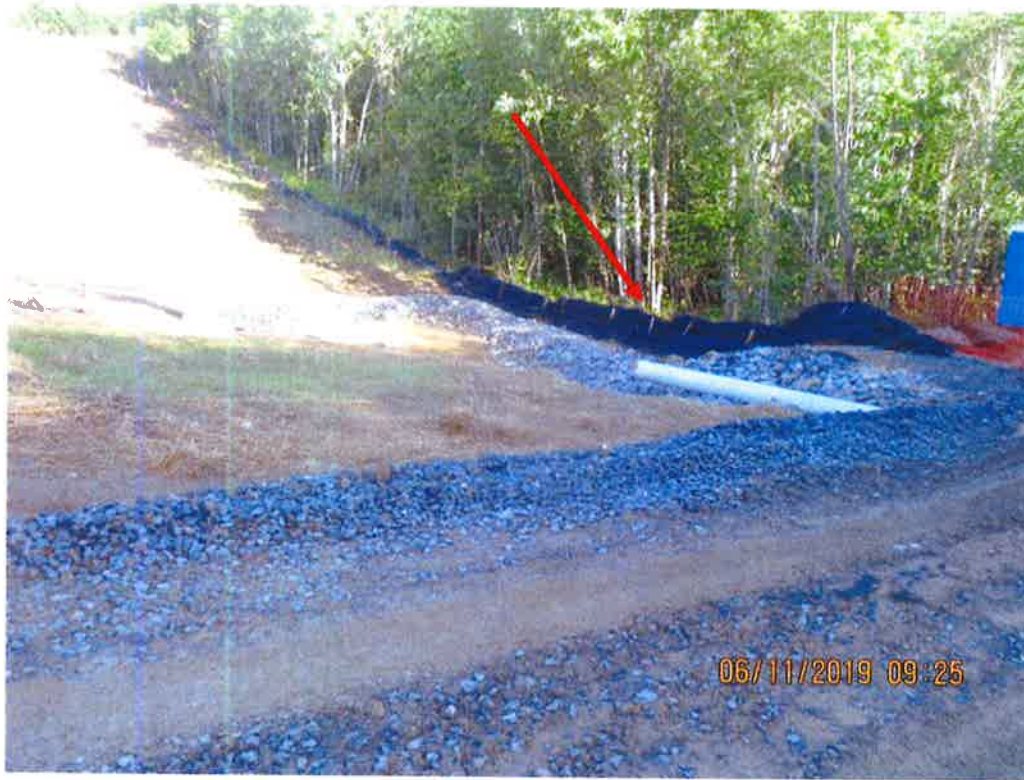
Facing towards Access Road 182.5 at station No. 7570+00. Perimeter controls enhanced since last inspection.

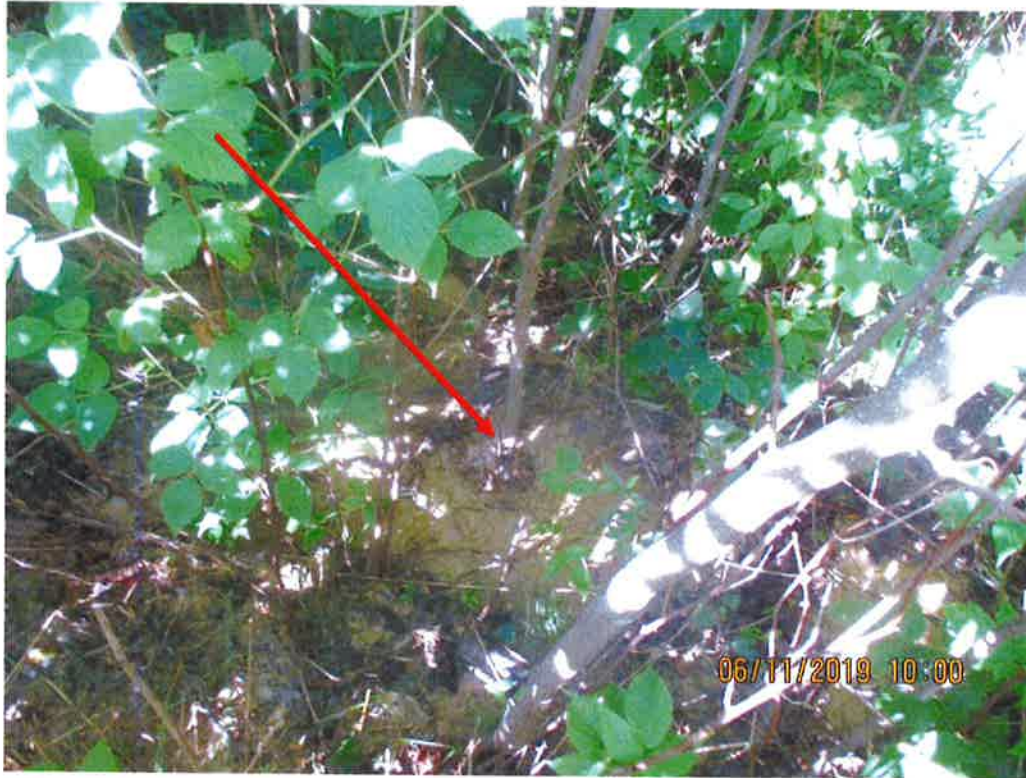
At station No. 7590 downslope of Waterbar outlet sediment deposits were present past the LOD.

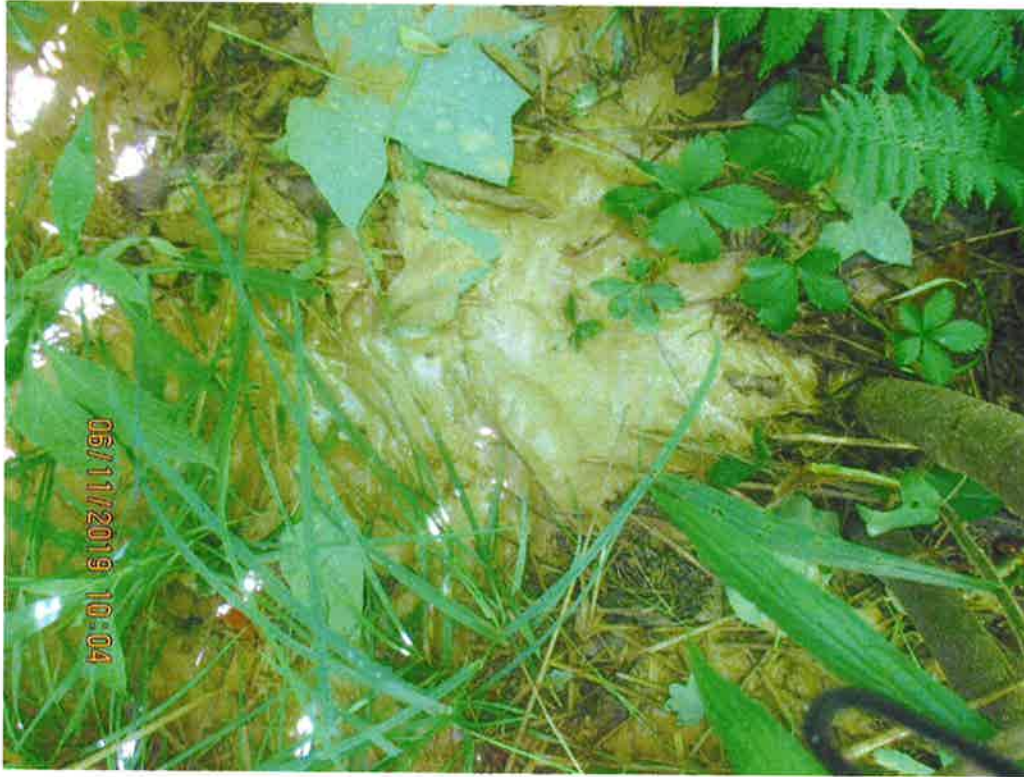
200-foot upslope of Krosier road crossing Deposits present past LOD downslope of Waterbar outlet.

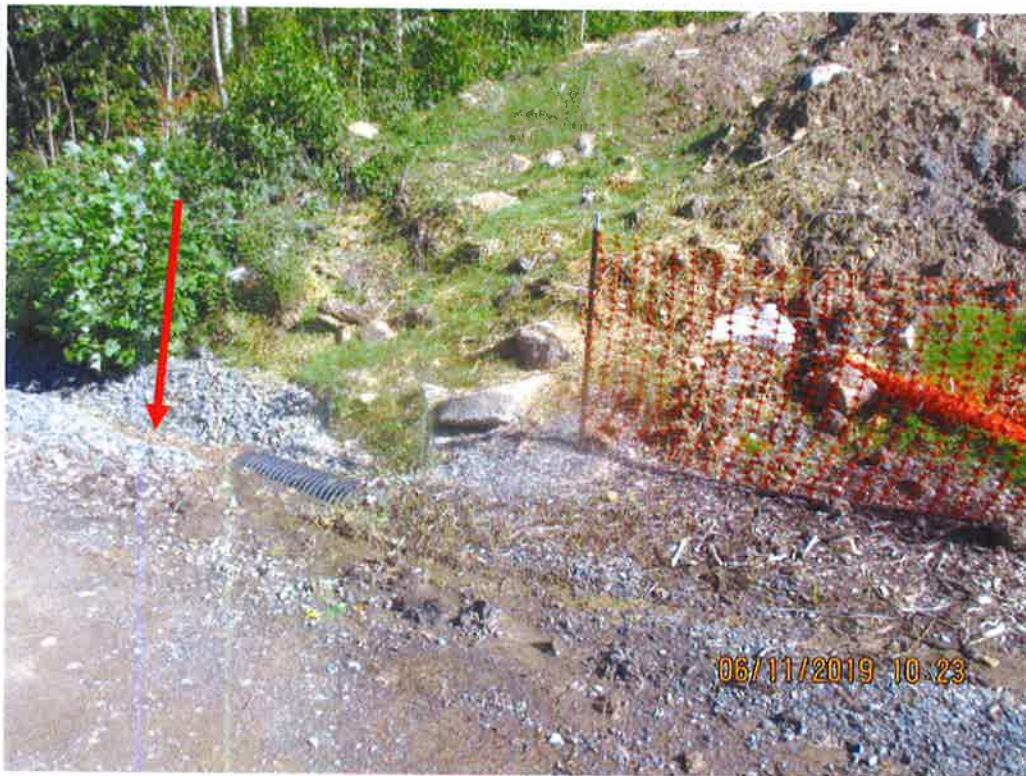
Culvert outlet with sediment deposits in ditch line. Erosion present on slope above outlet. Arrow depicts deposits present in ditch.

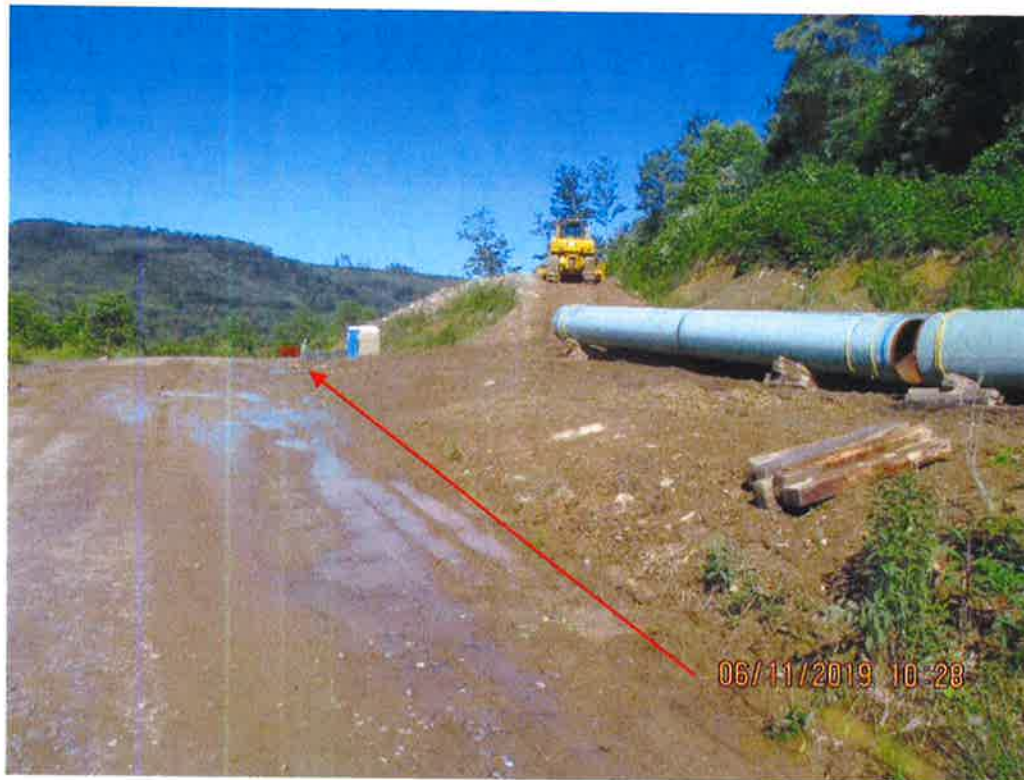
Standing on Krosier road facing east at additional workspace and ROW crossing. Mud and sediment present on road. Run-off flowing towards culvert inlet along Krosier road. Arrow depicts culvert inlet location.

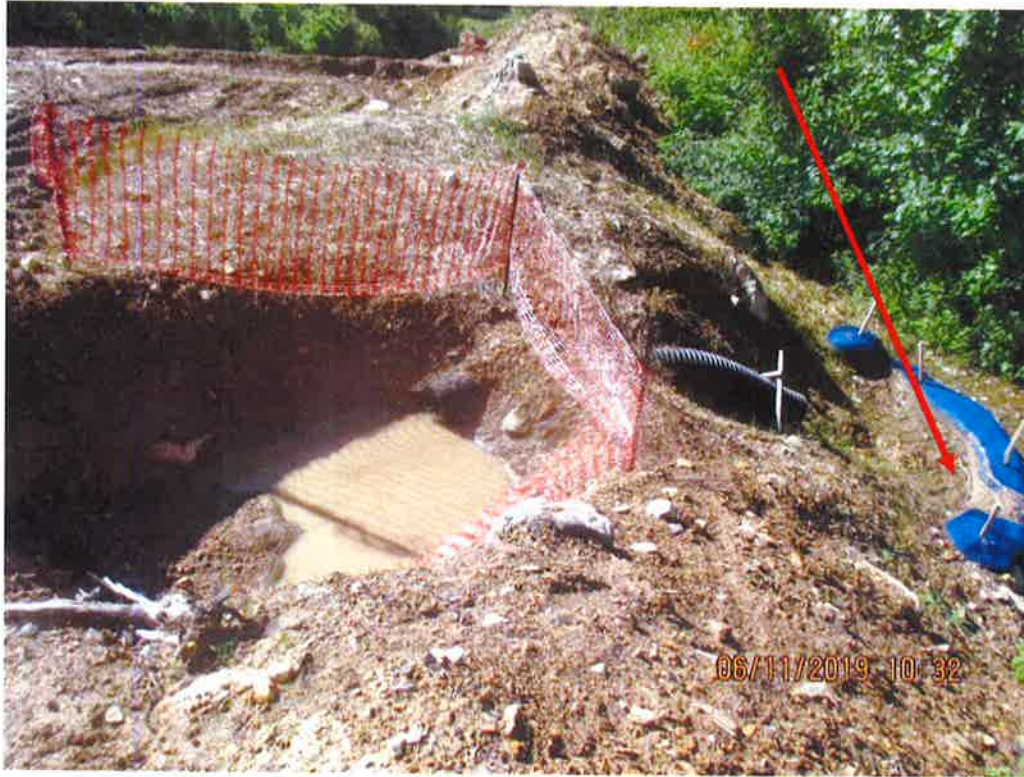
Downslope of Krosier Road Crossing near station No. 7576+01. Waterbar outlet perimeter controls in need of maintenance. Sediment laden water (SLW) and deposits were present past controls and LOD. Arrow depicts sediment backed up behind controls causing SLW to overtop the control.

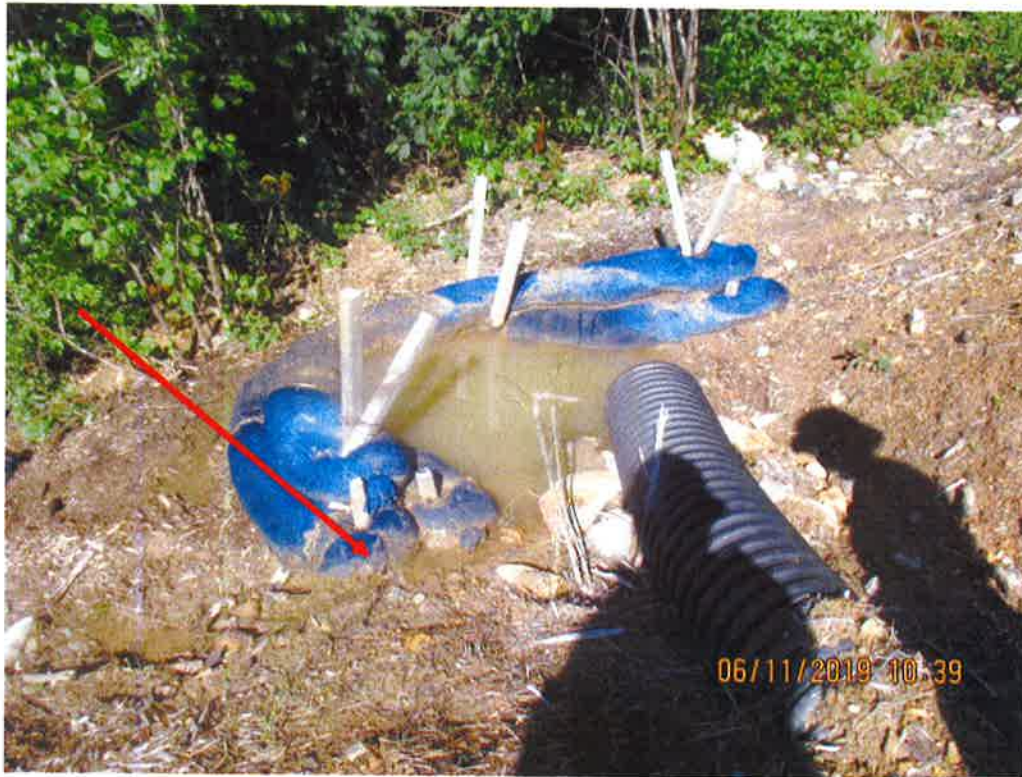
Below upper Krosier Road crossing near station no. 7576+01 facing downslope below Waterbar outlet. Arrow depicts evidence of Run-off flowing around controls and causing erosion downslope of controls was observed.

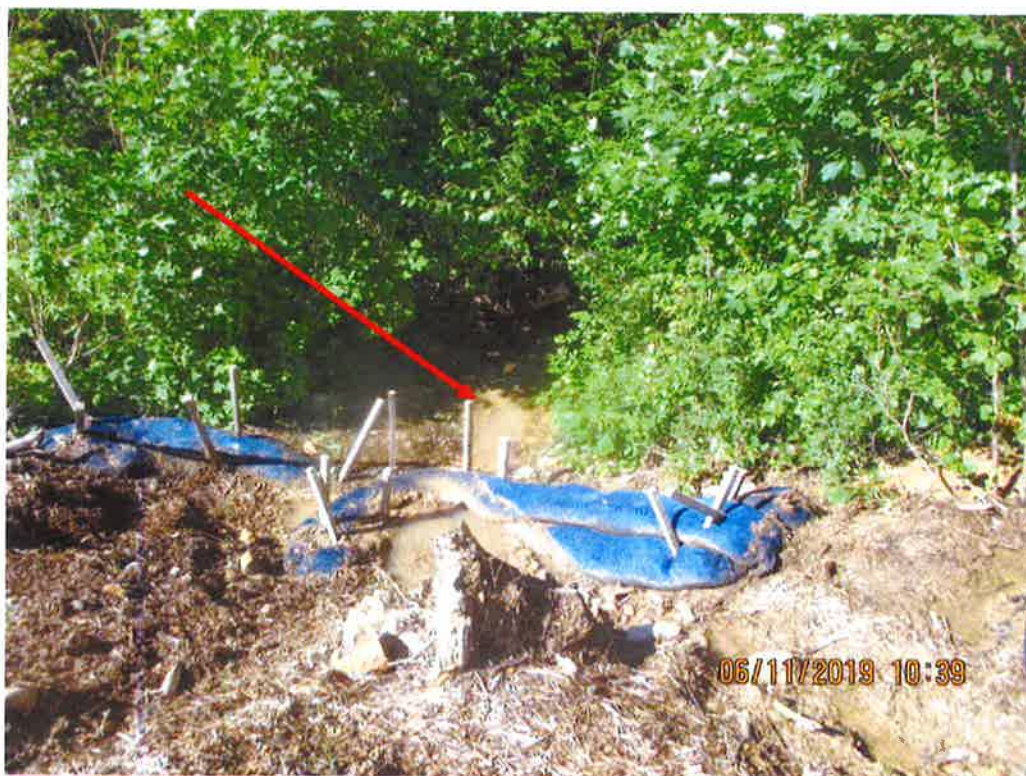
Standing at station No. 7576+01 downslope of Waterbar that had sediment being deposited in it due to run on from seep. Controls overwhelmed with sediment. Erosion on slope, SLW and deposits observed past LOD and controls.

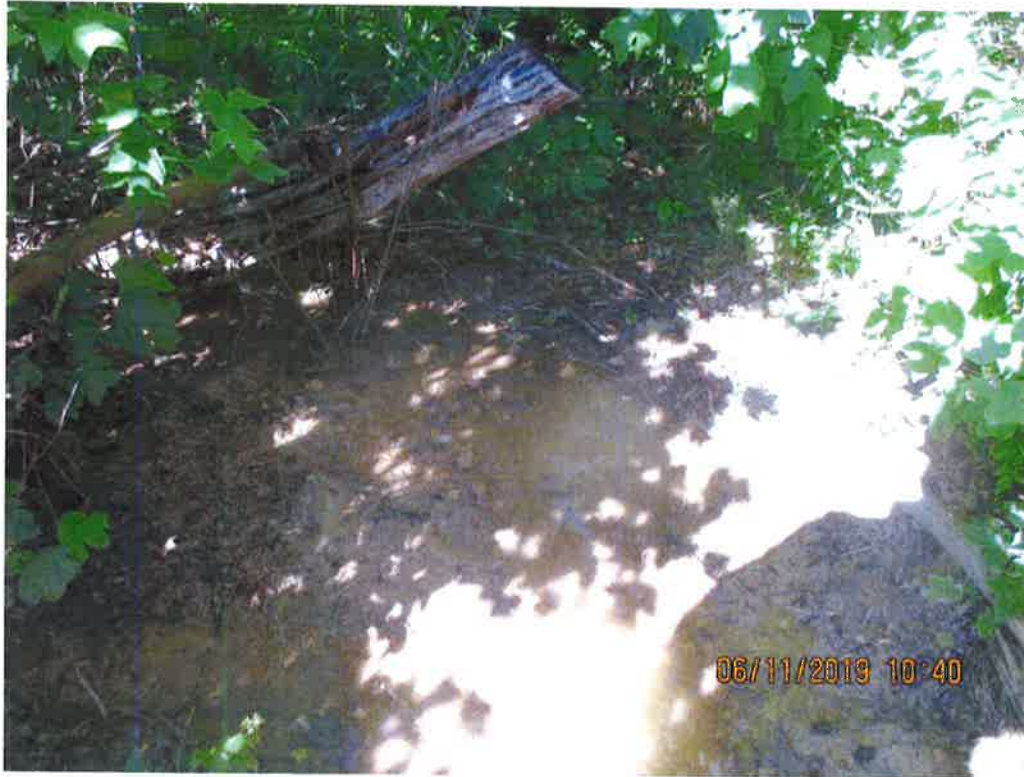
Standing at station No. 7576+01 downslope of Waterbar that had sediment being deposited in it due to run on from seep. SLW and deposits observed past LOD and controls.

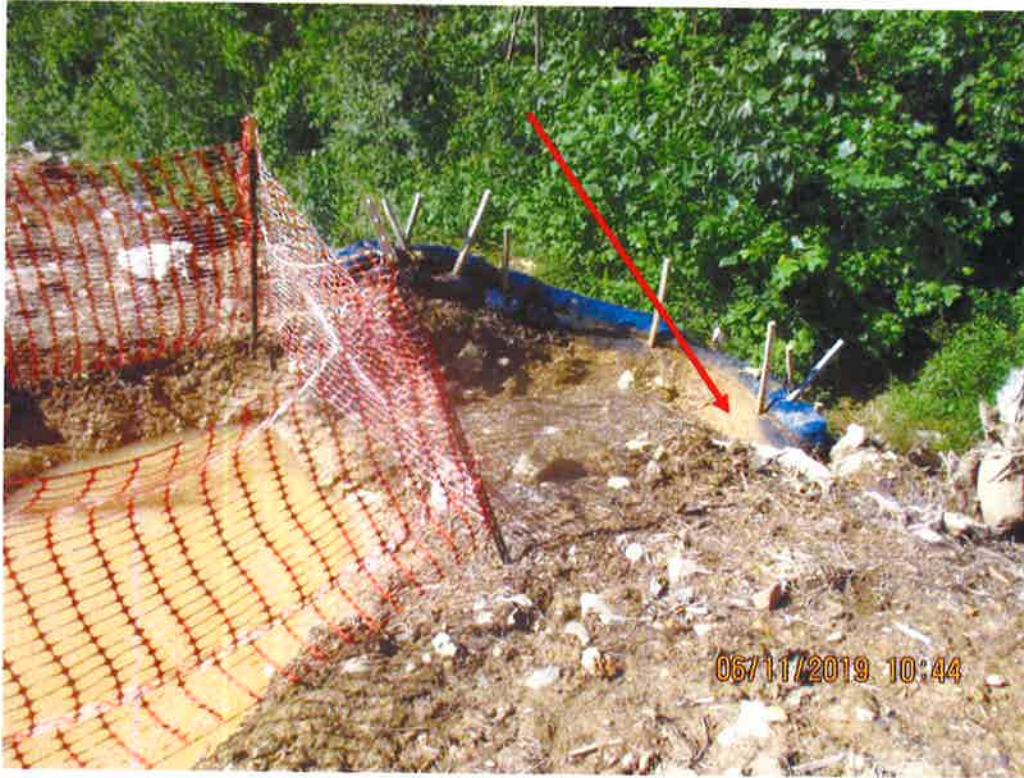
Waterbar outlet near No. 7604+41. Sump and perimeter controls in need of maintenance. Sediment deposited behind perimeter controls.

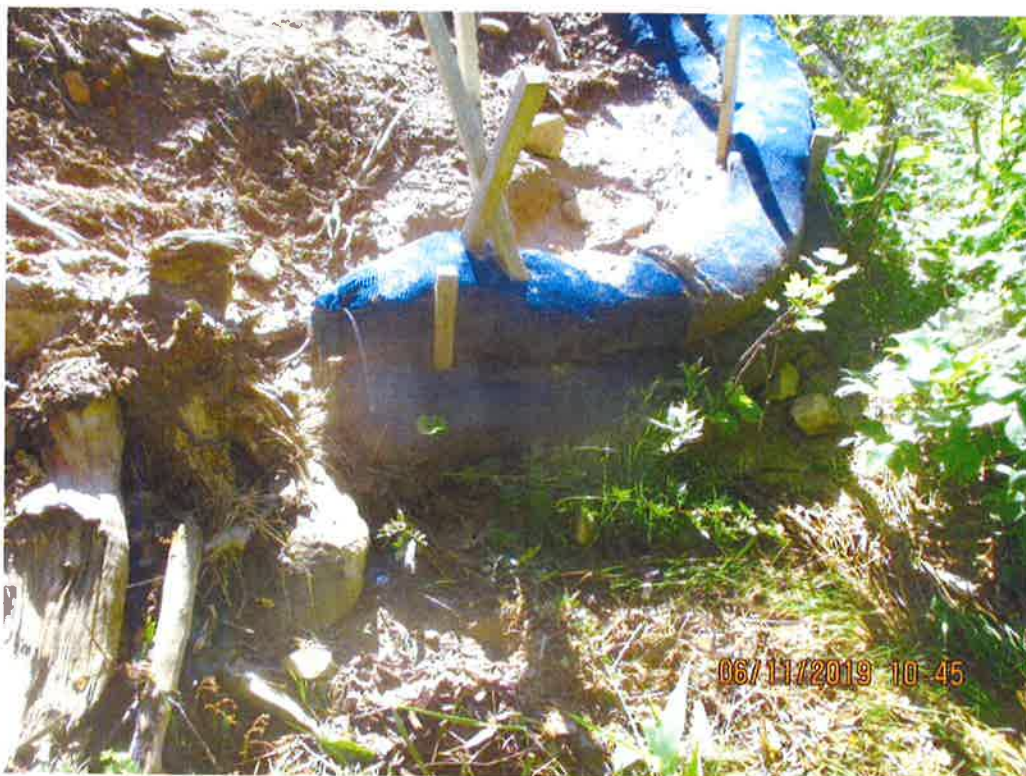
Downslope of Waterbar outlet near No. 7604+41. Perimeter controls in need of maintenance. Sediment deposited behind perimeter controls. Sediment deposits observed past controls and LOD.

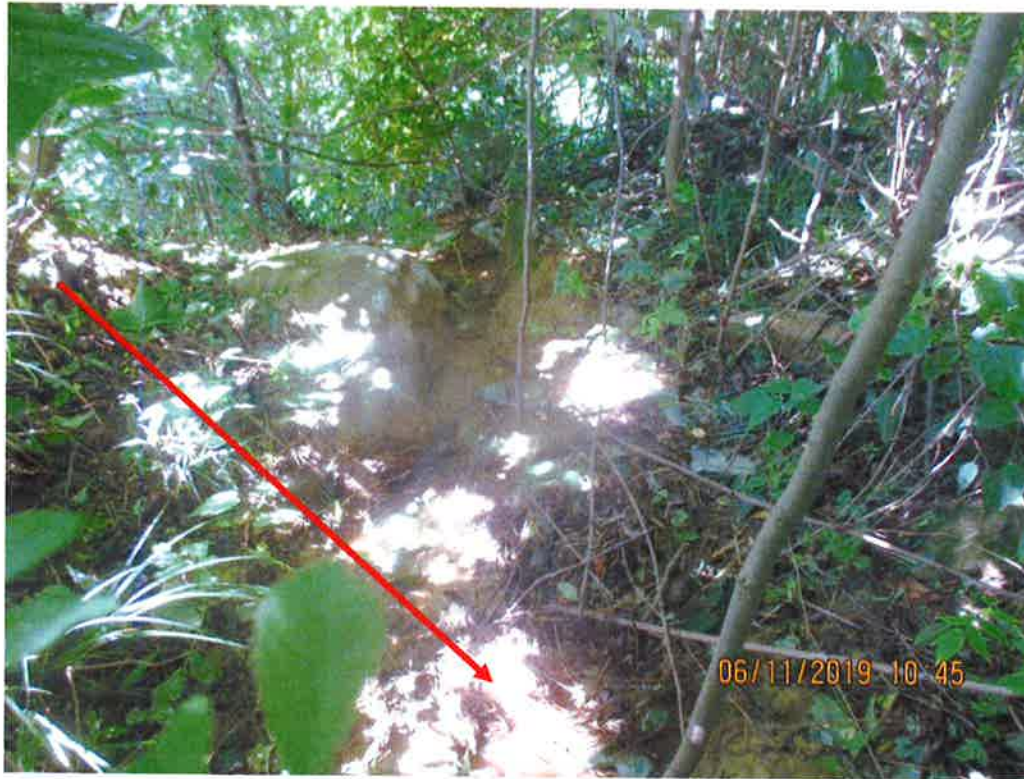
Downslope of Waterbar outlet near No. 7604+41. Sediment deposits observed past controls and LOD.

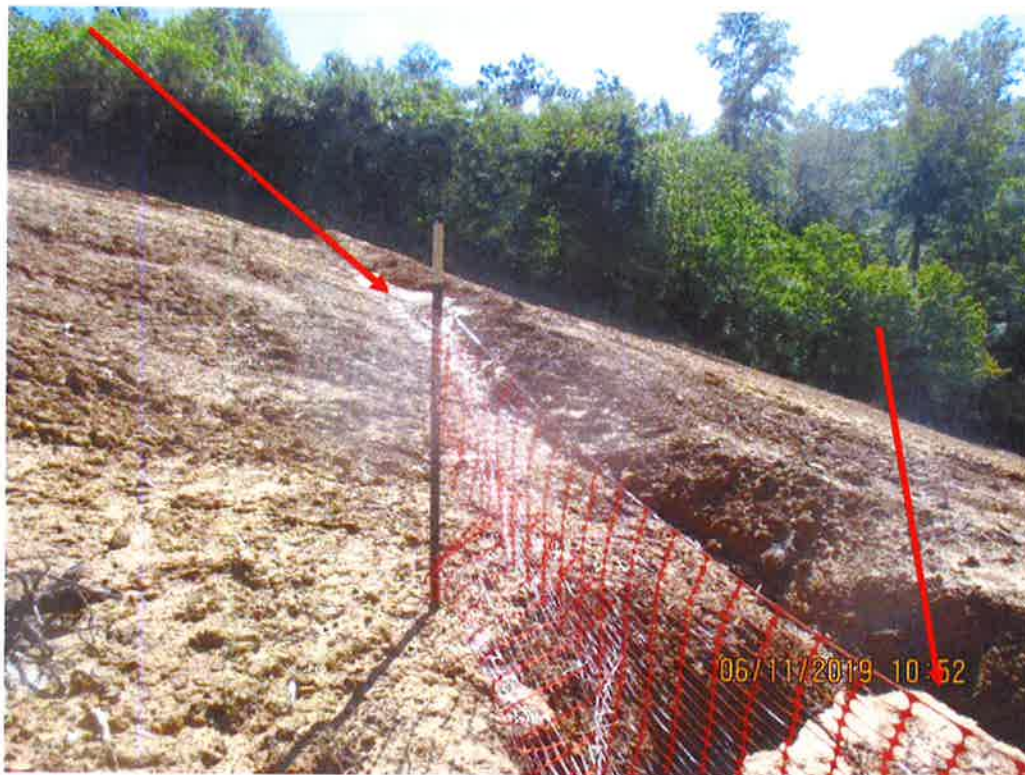
Standing above Station No. 7604+41. Waterbar had sediment being deposited in it from erosion upslope. Sump was full of sediment and needed maintained. Arrow depicts sediment in Waterbar and sump.
