Re: Mountain Valley Pipeline, LLC
Docket No. CP16-10-000
Weekly Status Report No. 90

Docket No. CP16-10-000
Weekly Report No. 90
Report Period: 07/13/19- 07/19/19

**Re: Mountain Valley Pipeline Project (Permit No. WVR310667)
Response to Notice of Violation No. W19-34-014-JTL**

STATE OF WEST VIRGINIA
Department of Environmental Protection
Environmental Enforcement
NOTICE OF VIOLATION

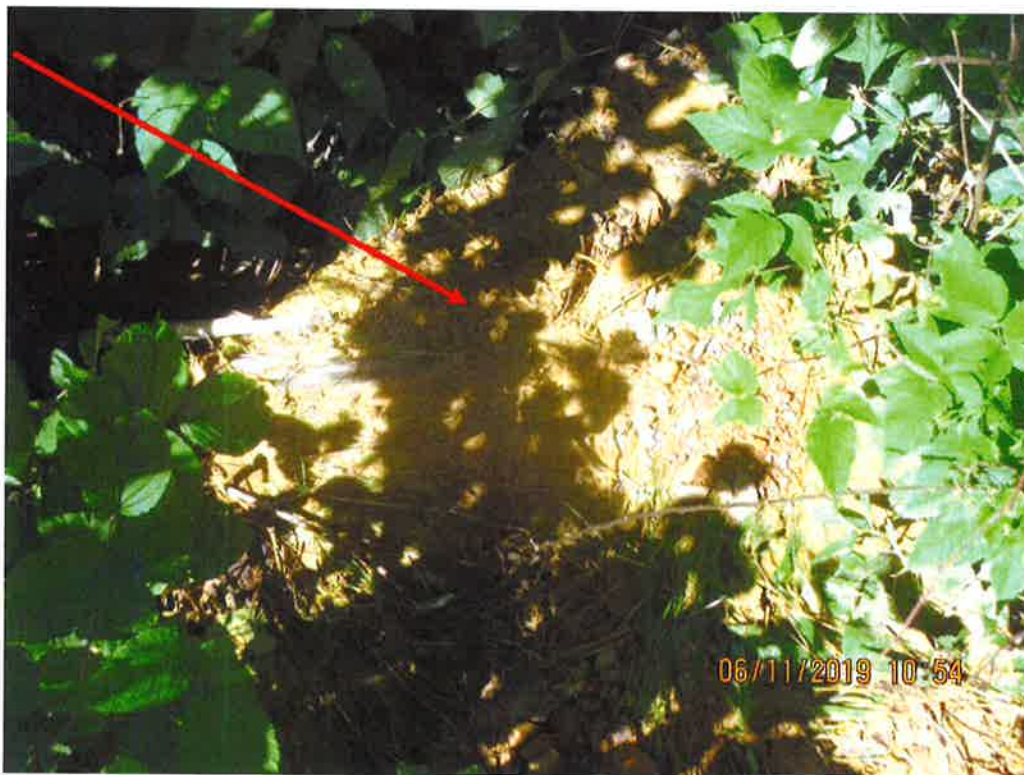
Standing above Station No. 7604+41. Perimeter controls overwhelmed with sediment. Sediment deposits observed past controls and LOD.

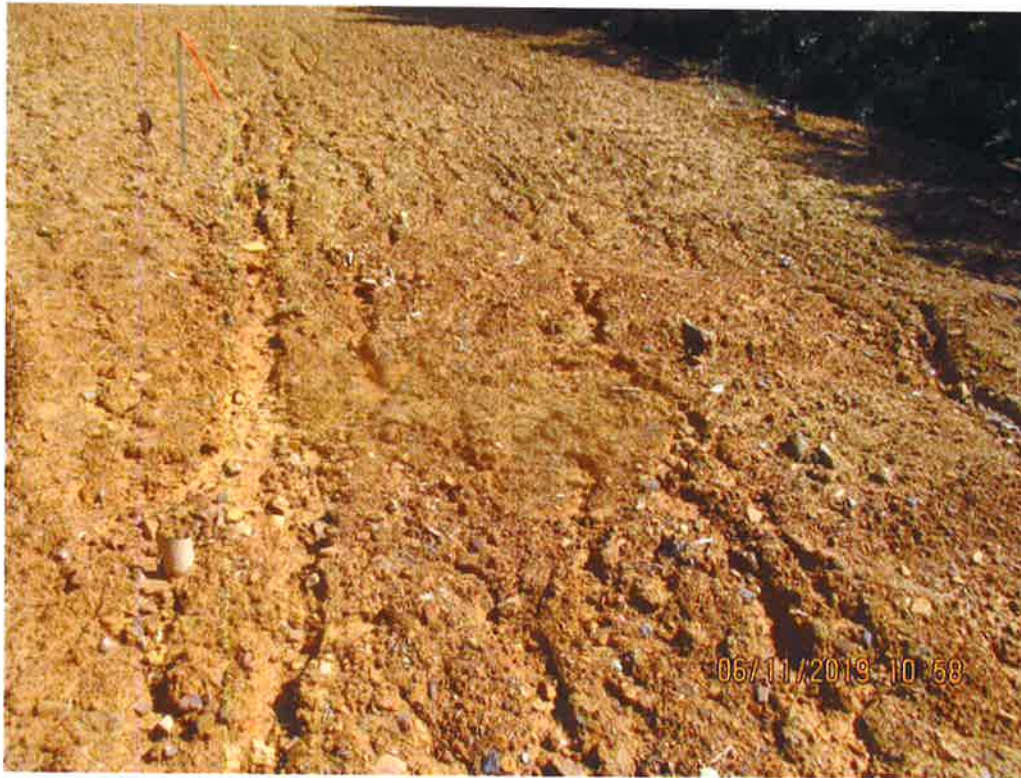
Above Lower Krosier Road crossing. Erosion present on ROW above Waterbar. Facing upslope near station no. 7604+41.

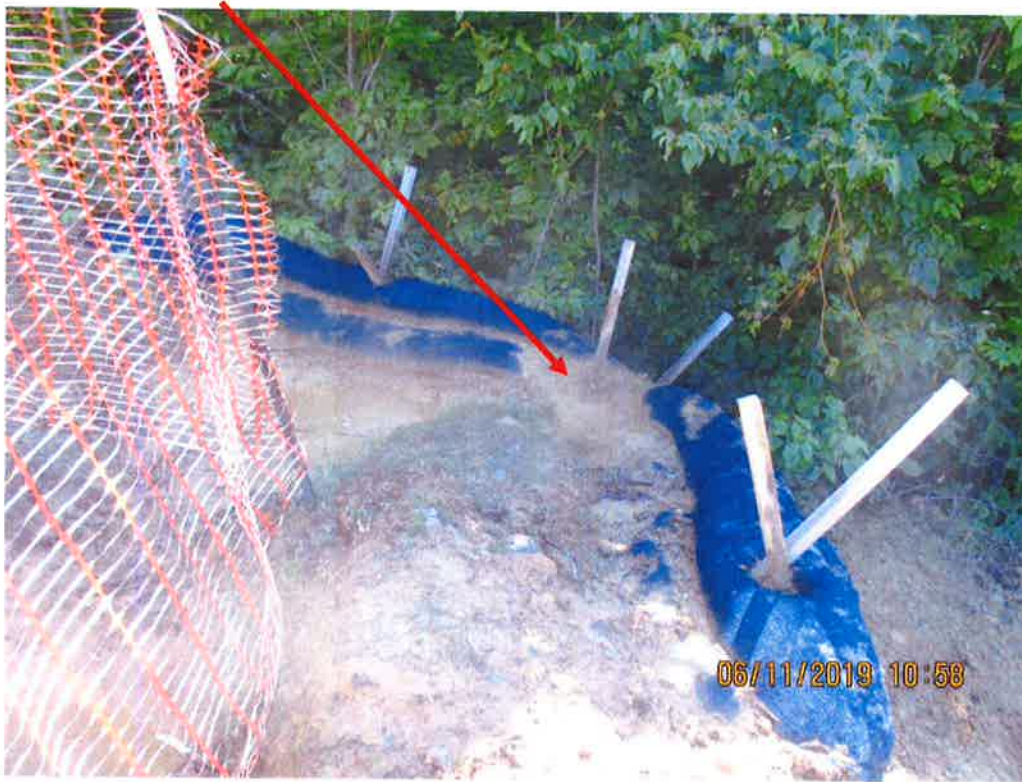
Above Lower Krosier Road crossing. Erosion present on ROW above Waterbar. Sediment being deposited in Waterbar and sump, overwhelming sump and perimeter controls near station no. 7604+41.

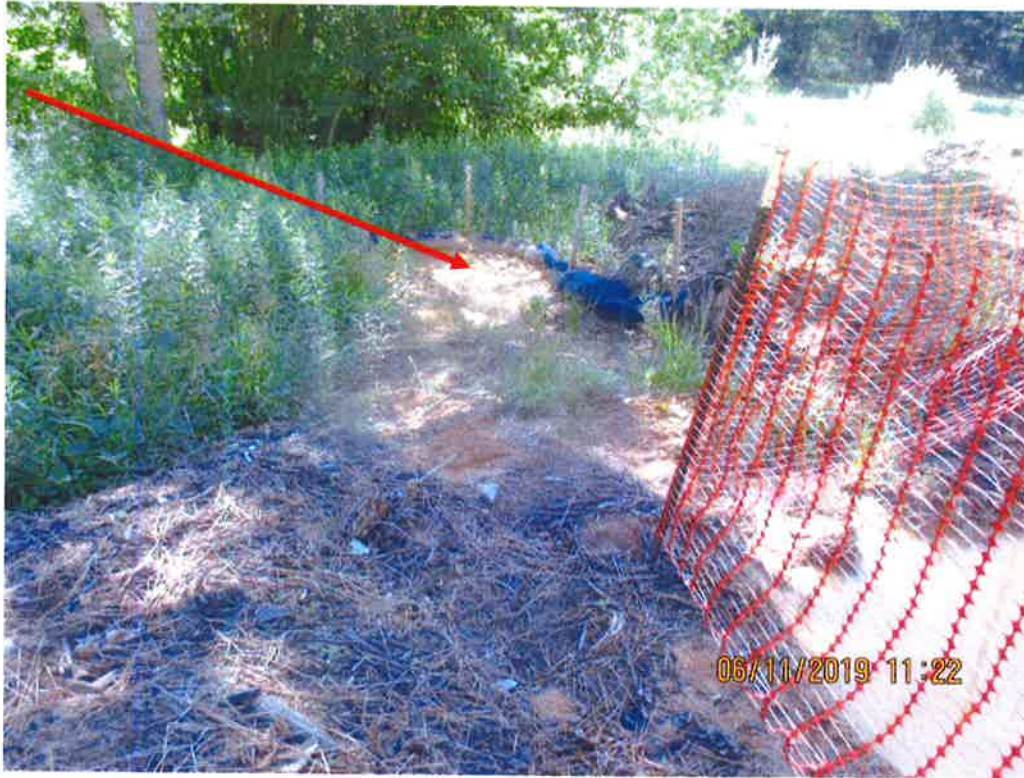
Facing South (Downslope) at station No. 7609+50. Waterbar outlet controls overwhelmed with SLW and deposits.

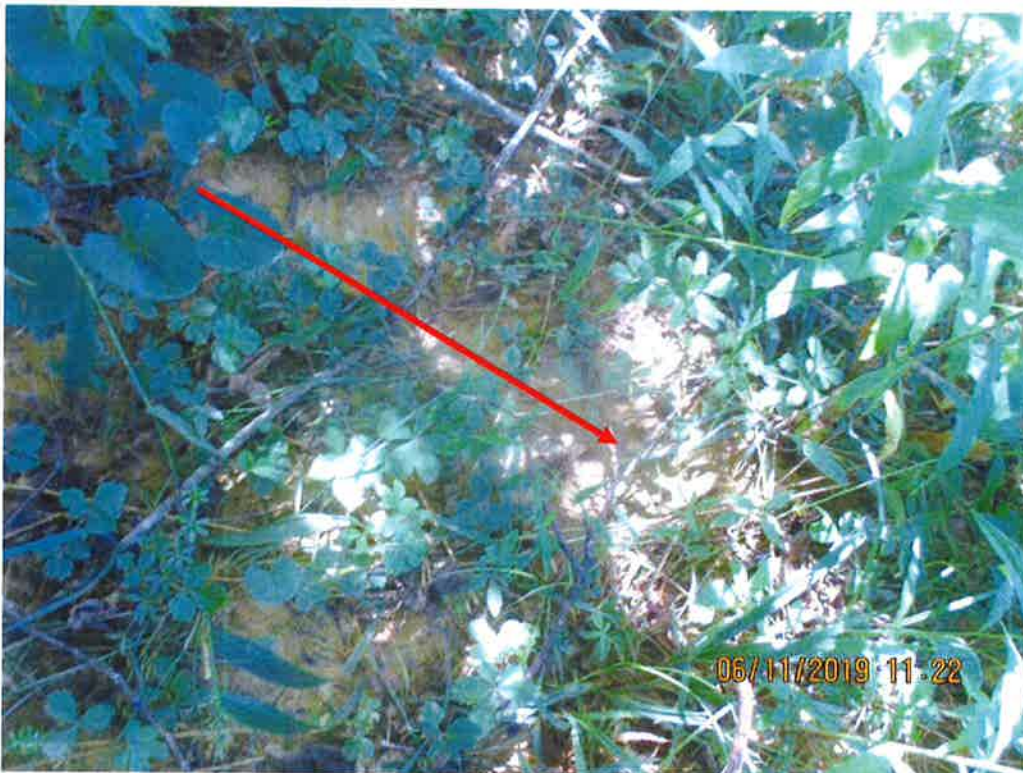
Facing South (Downslope) at station No. 7609+50. Waterbar outlet controls overwhelmed with SLW and deposits. Deposits observed past controls and LOD above wetland W-QR2. This is an area of concern due to the deposits potentially being transported into a stream that wasn't delineated and parallels the LOD and terminates back onto the ROW above the Meadow River.

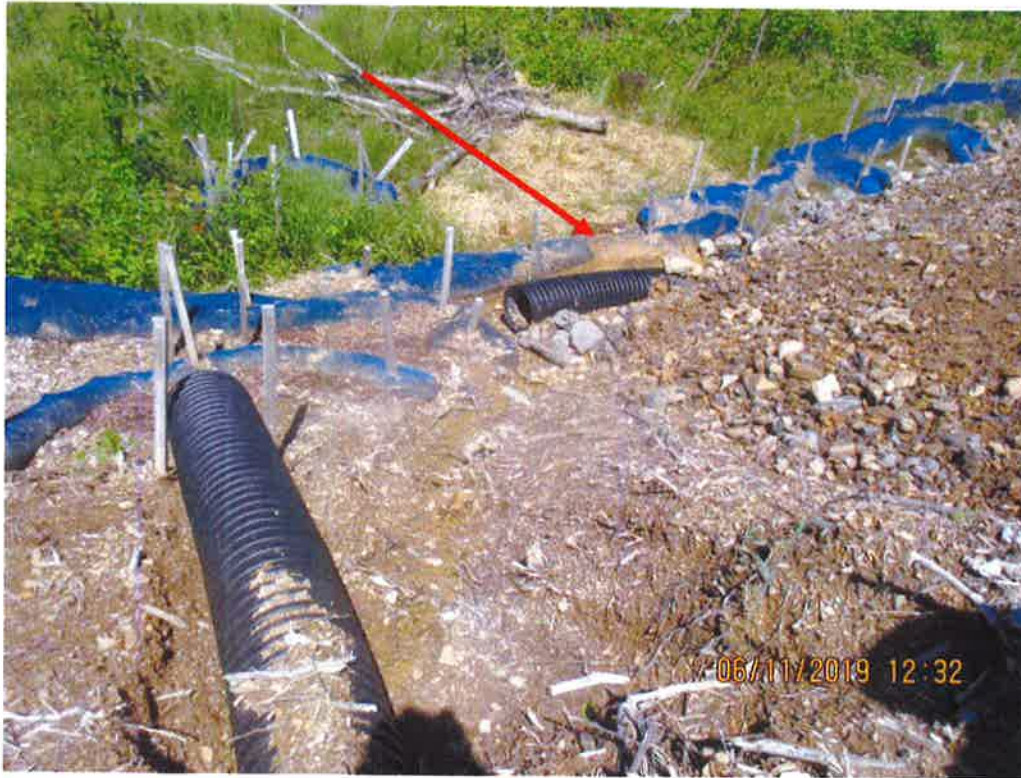
Standing at station No. 7636+00 at Waterbar outlet and slope drain. Slope drain was being undercut. Sediment was overwhelming perimeter control. Sediment deposits observed past controls and LOD.

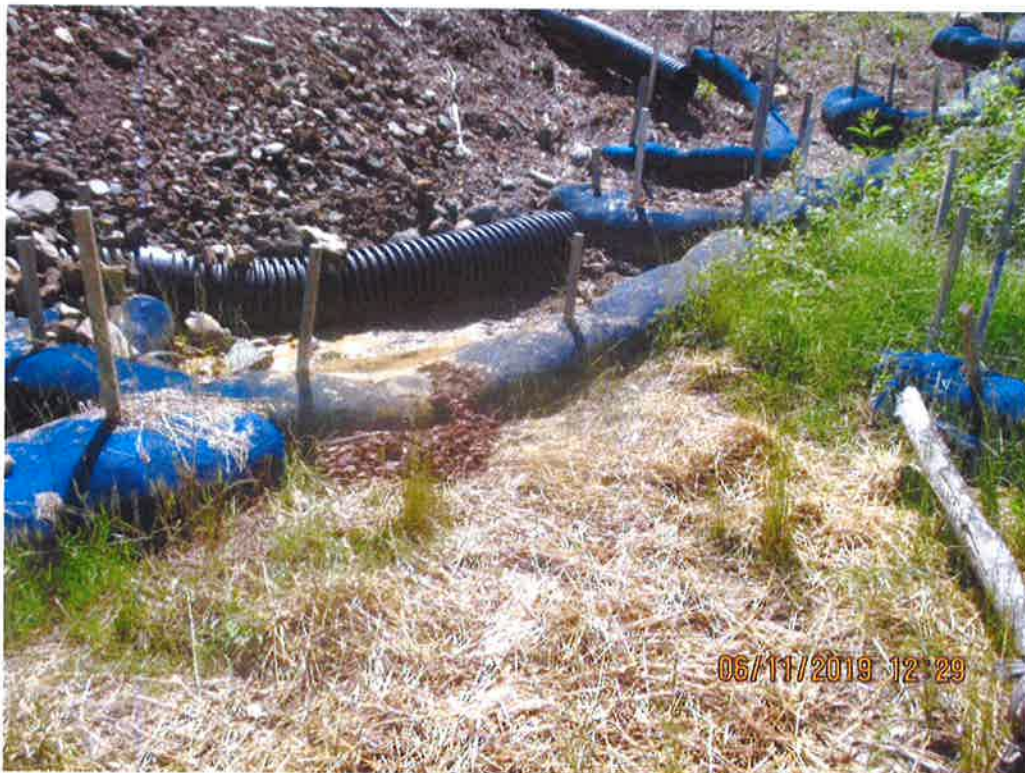
Standing at station No. 7636+00 at Waterbar outlet and slope drain. Slope drain was being undercut. Sediment was overwhelming perimeter control. Control in need of maintenance.

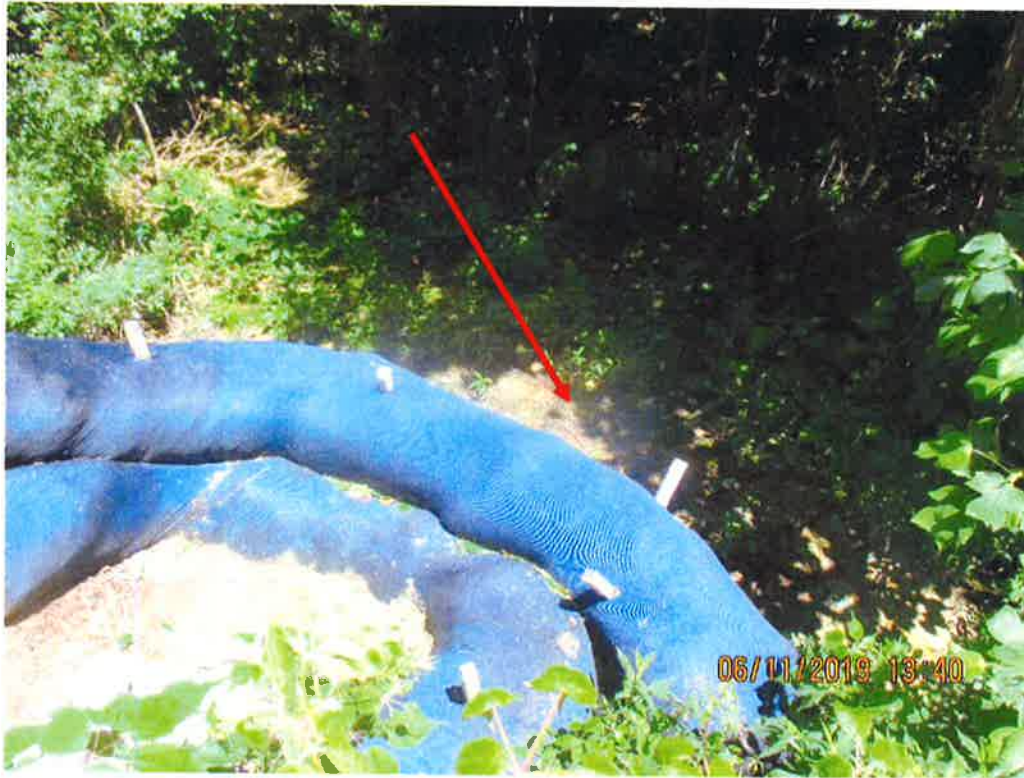
Controls below culvert outlet and bridge crossing with AR-182.5. Sediment deposits and SLW observed past these controls and LOD. Arrow depicts deposits.

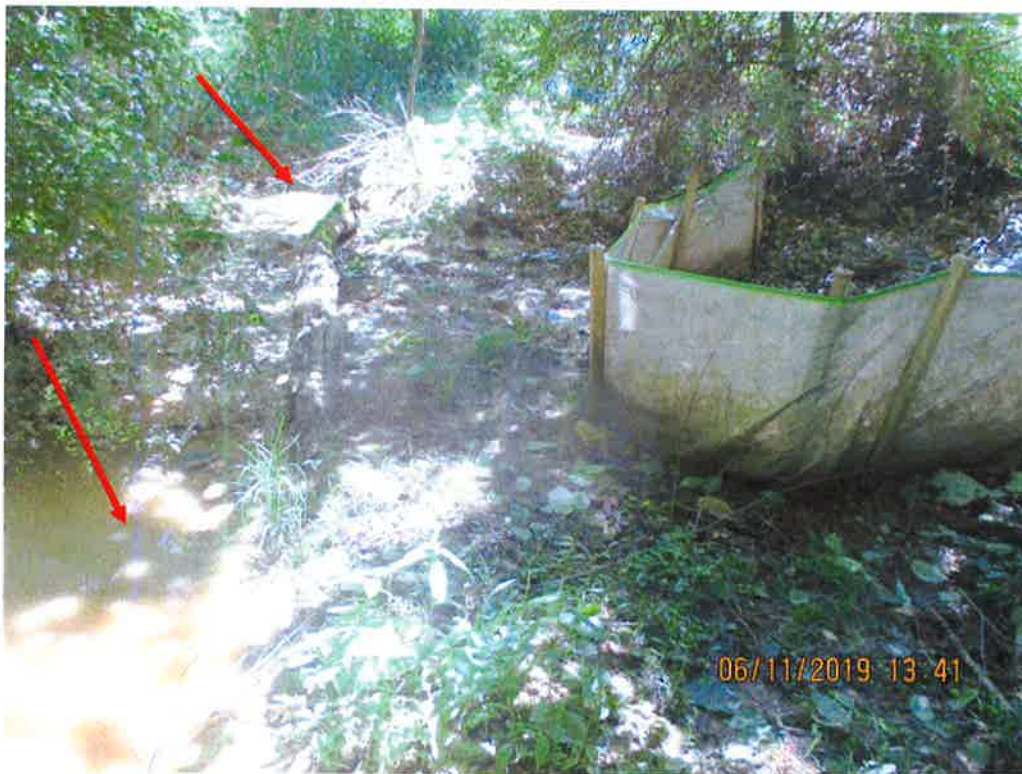
Further downslope of culvert outlet and standing below another culvert outlet where P1 silt fence was installed. Sediment deposits and SLW present. Arrows depict outlet controls and where SLW and deposits were observed.

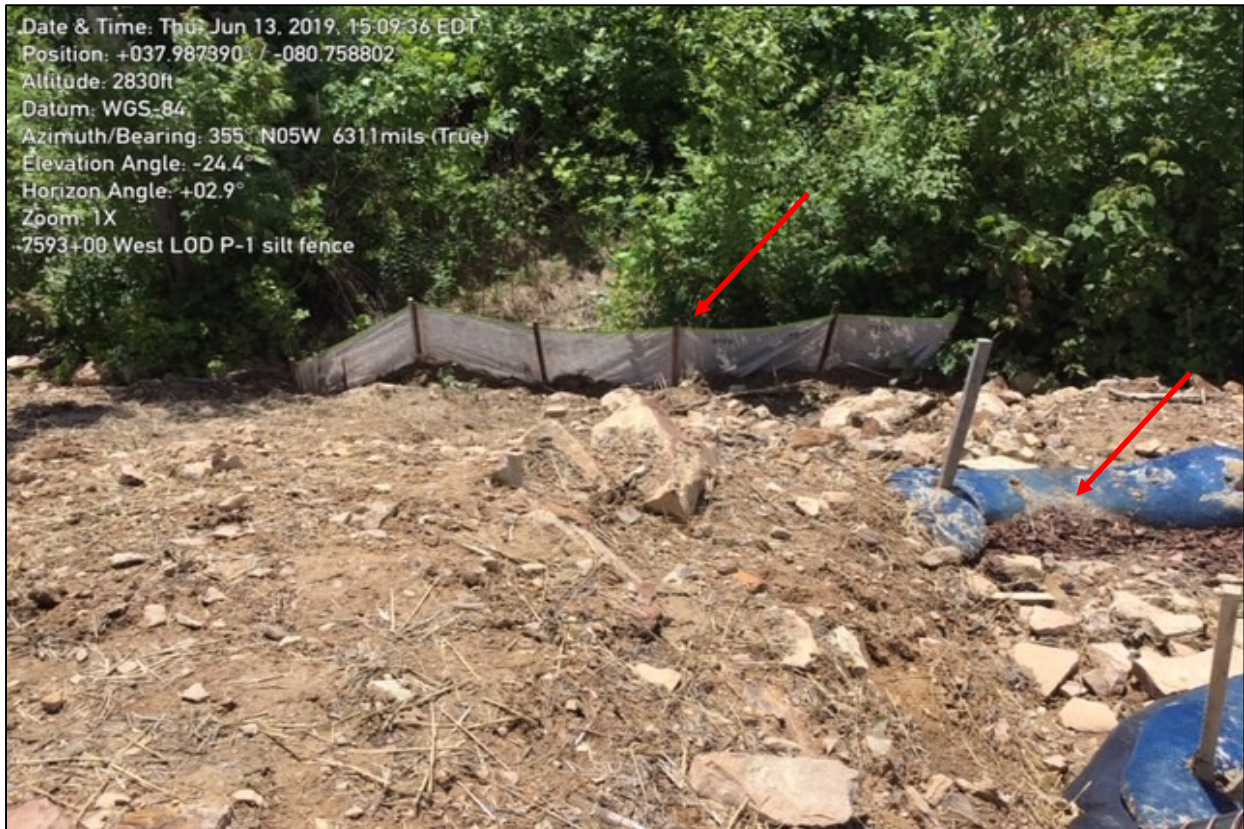
Photo 1: Photo illustrates the additional Priority 1 (P1) silt fence that have been installed and the filtration media has also been installed in front of existing compost filter sock (CFS).

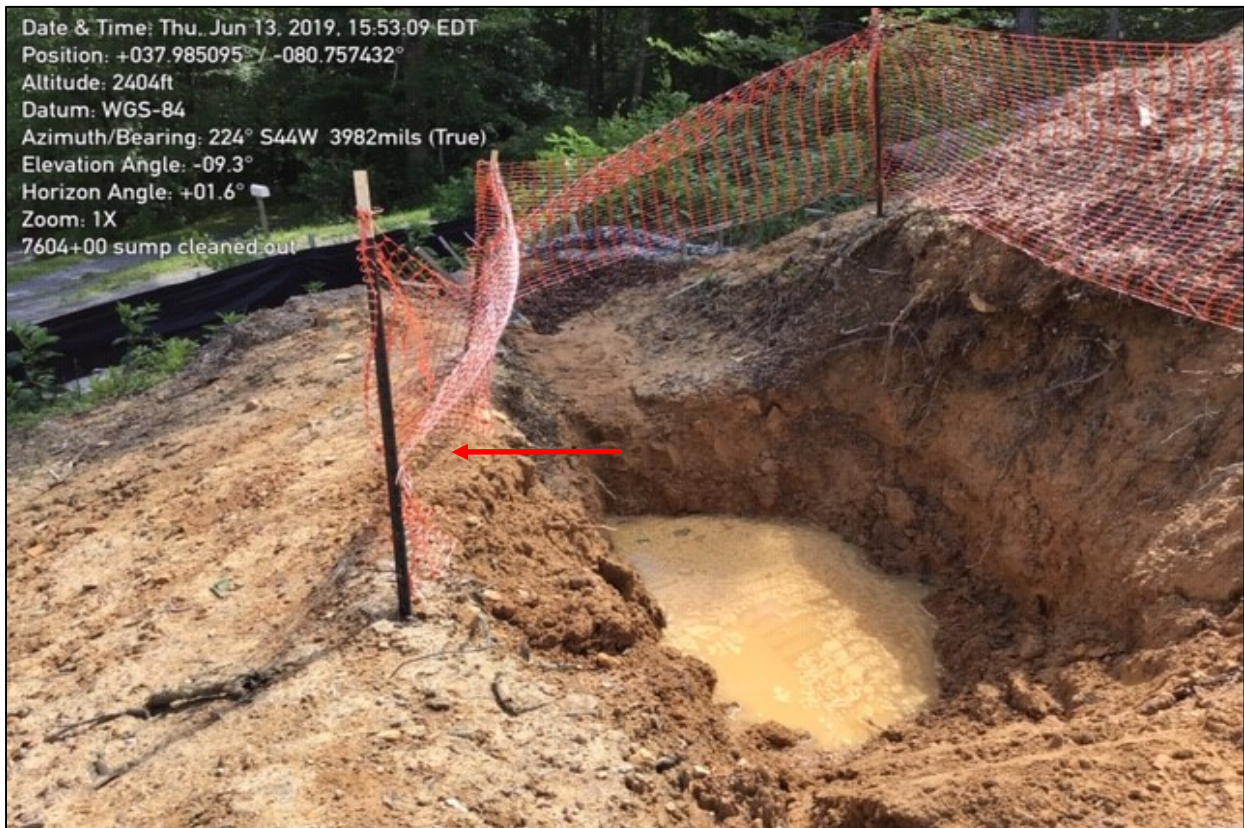
Photo 2: Photo illustrates the cleaned sump upslope of Crosier Road.

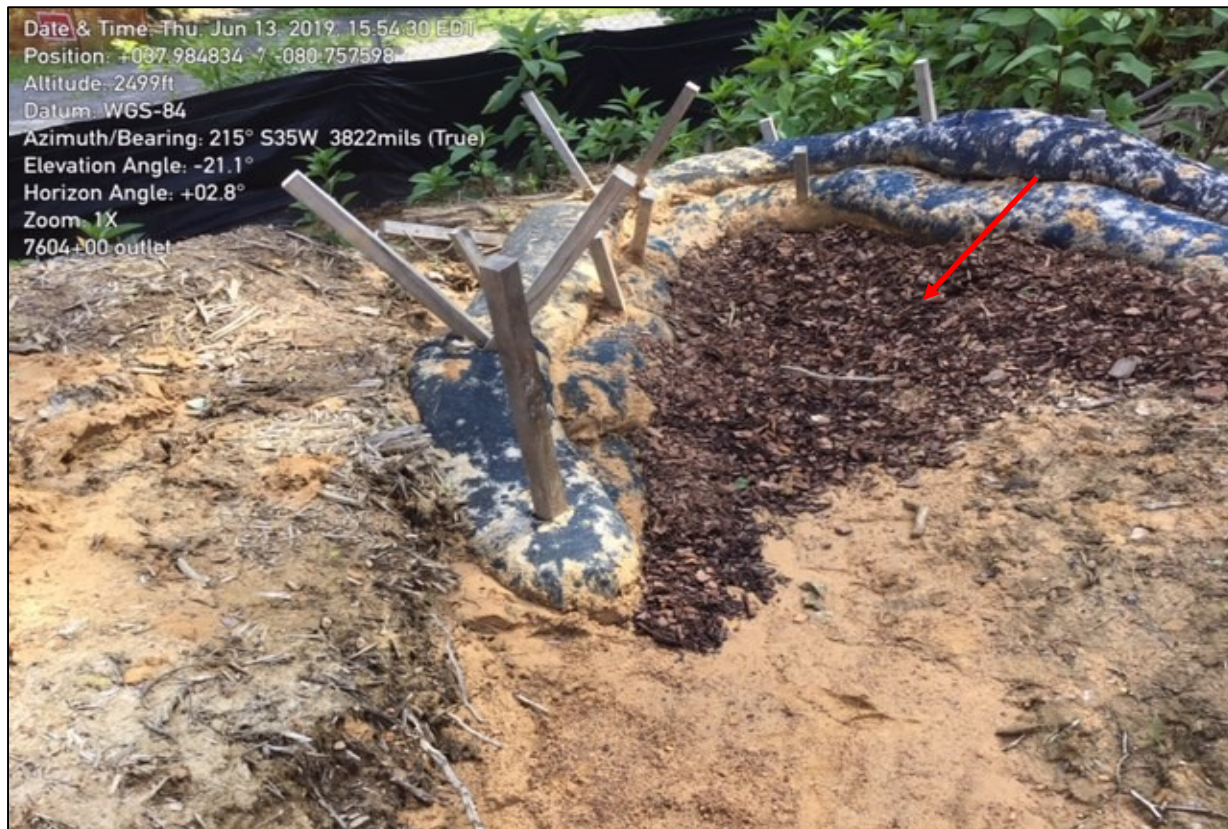
Photo 3: Photo illustrates additional filtration media that has been installed in front of existing CFS. This is upslope of Crosier Road.

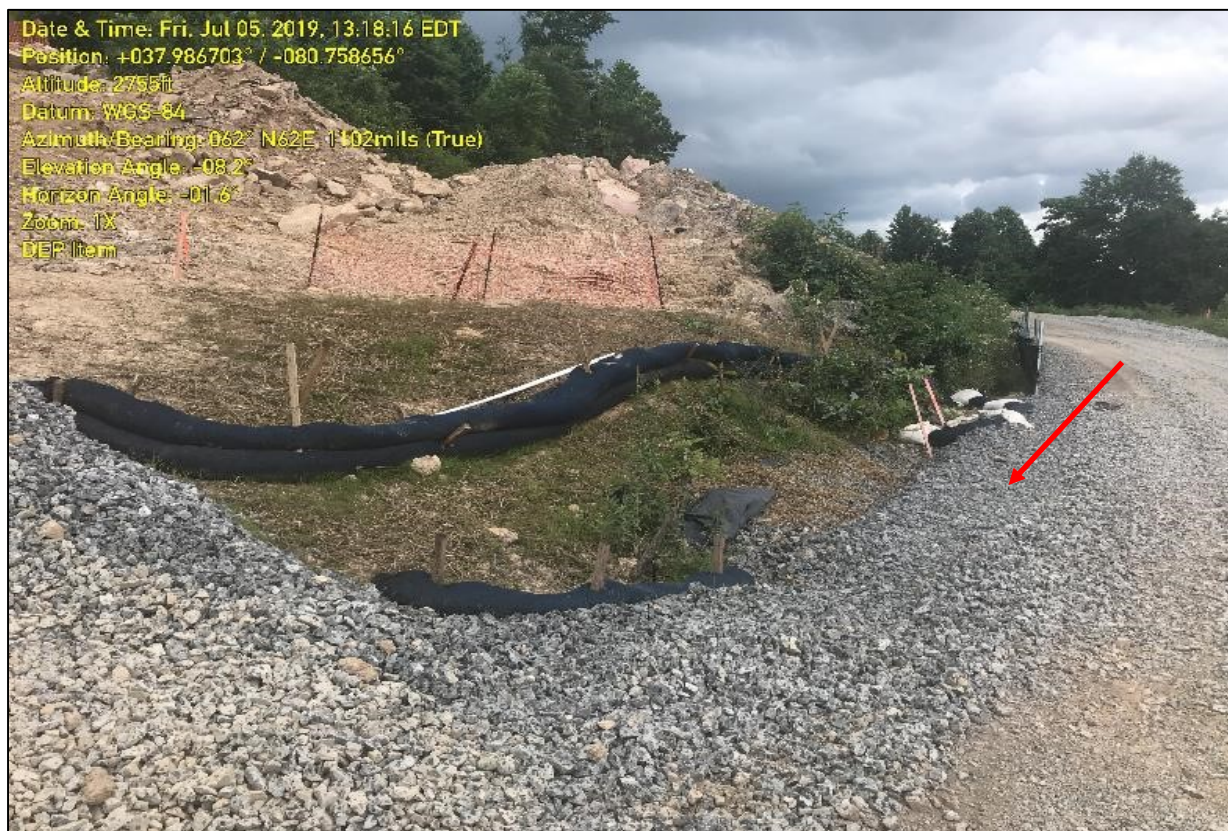
Photo 4: Photo illustrates the additional gravel that has been installed along Crosier Road.

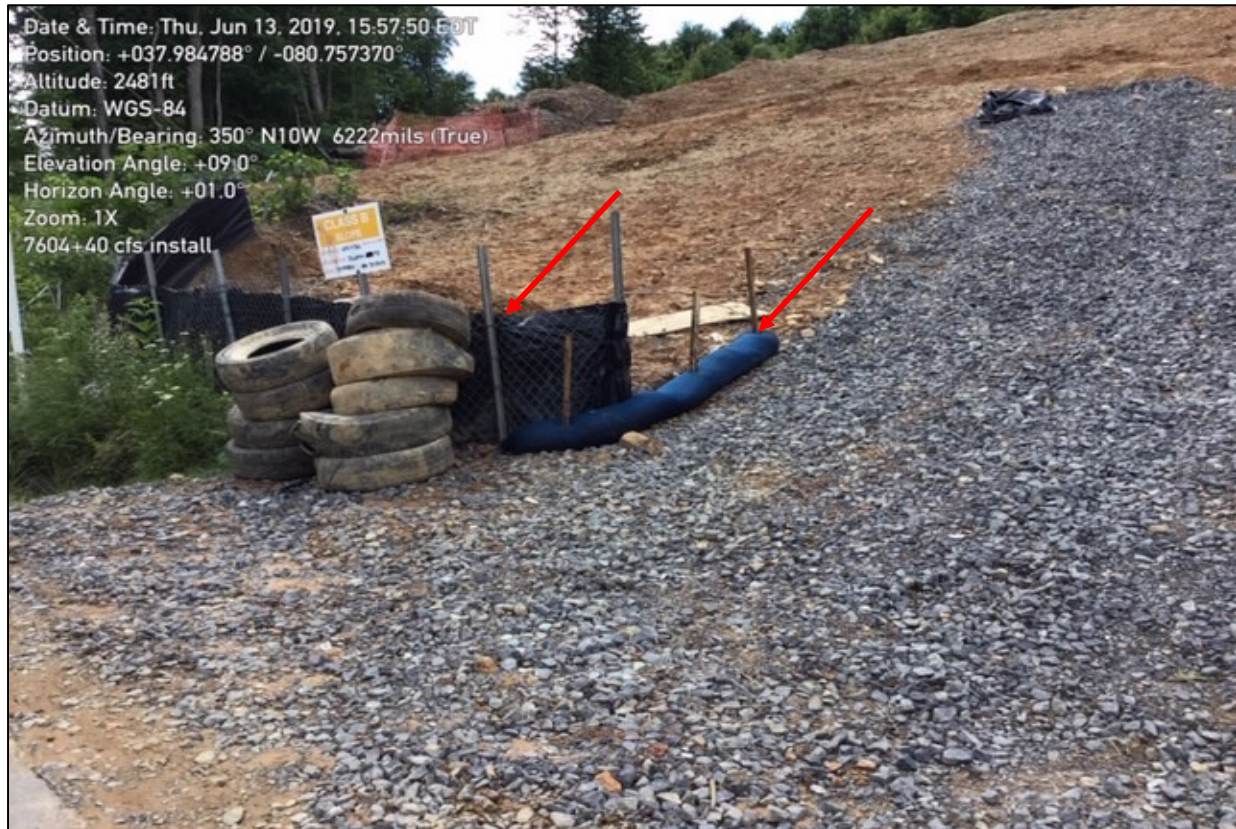
Photo 5: Photo illustrates the additional ECDs, including CFS and supersilt fence (SSF) that have been installed along Crosier Road.

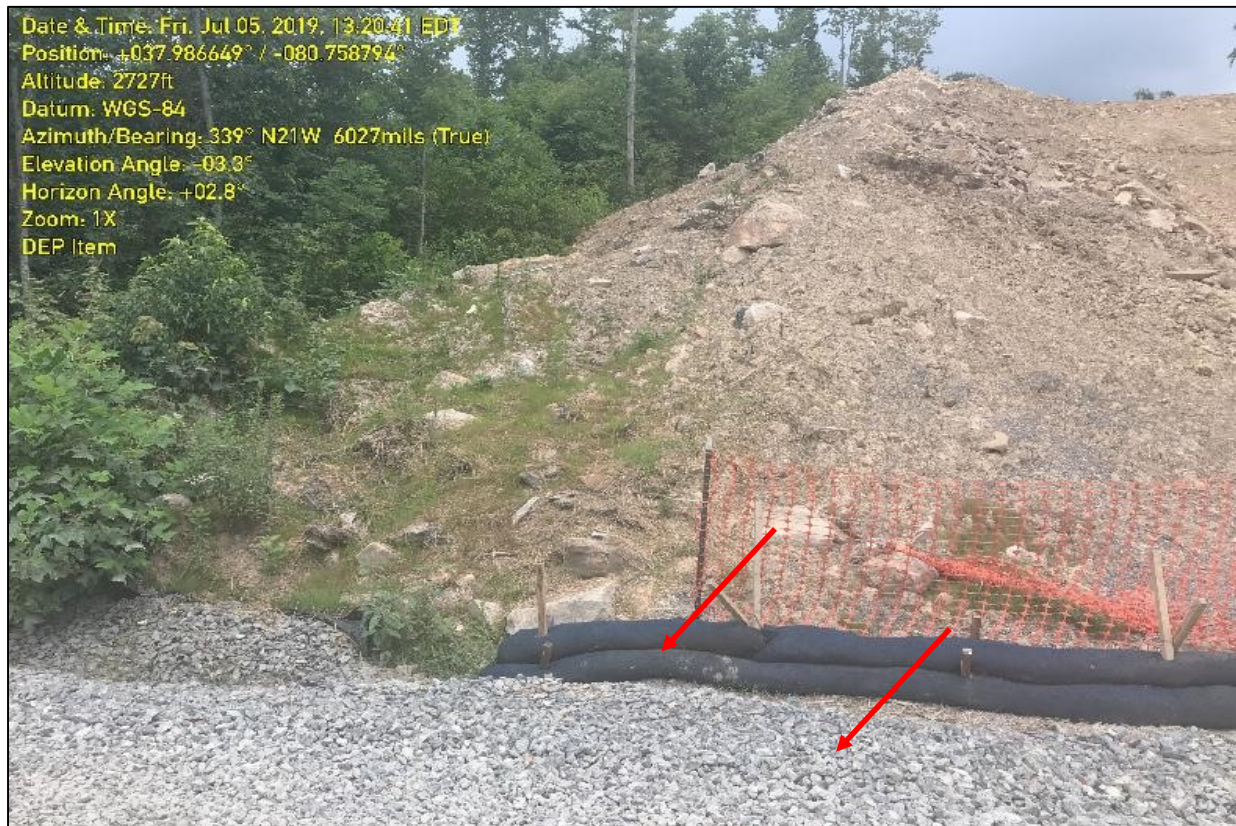
Photo 6: Photo illustrates the additional ECDs – CFS and additional gravel – that have been installed near the Crosier Road Culvert.

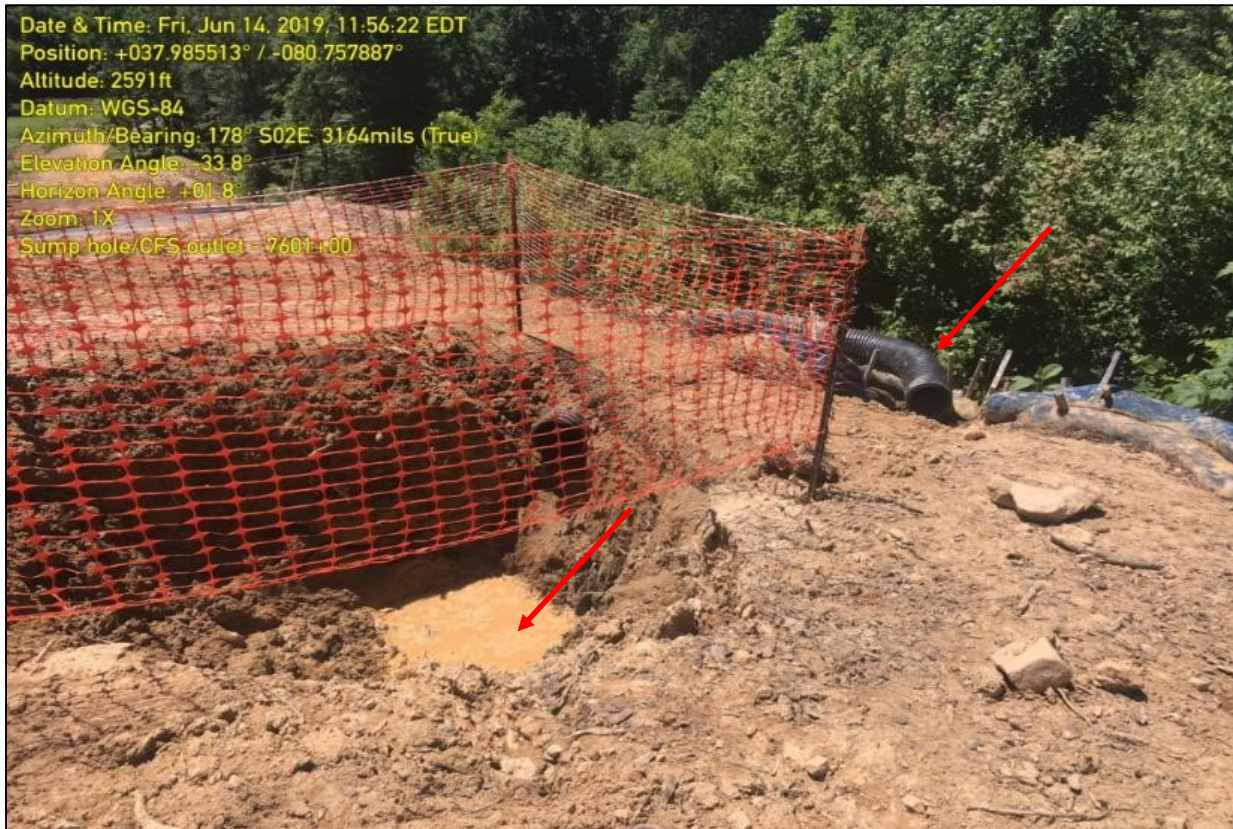
Photo 7: Photo illustrates the cleaned sump and additional CFS that has been installed near Station 7601+00.

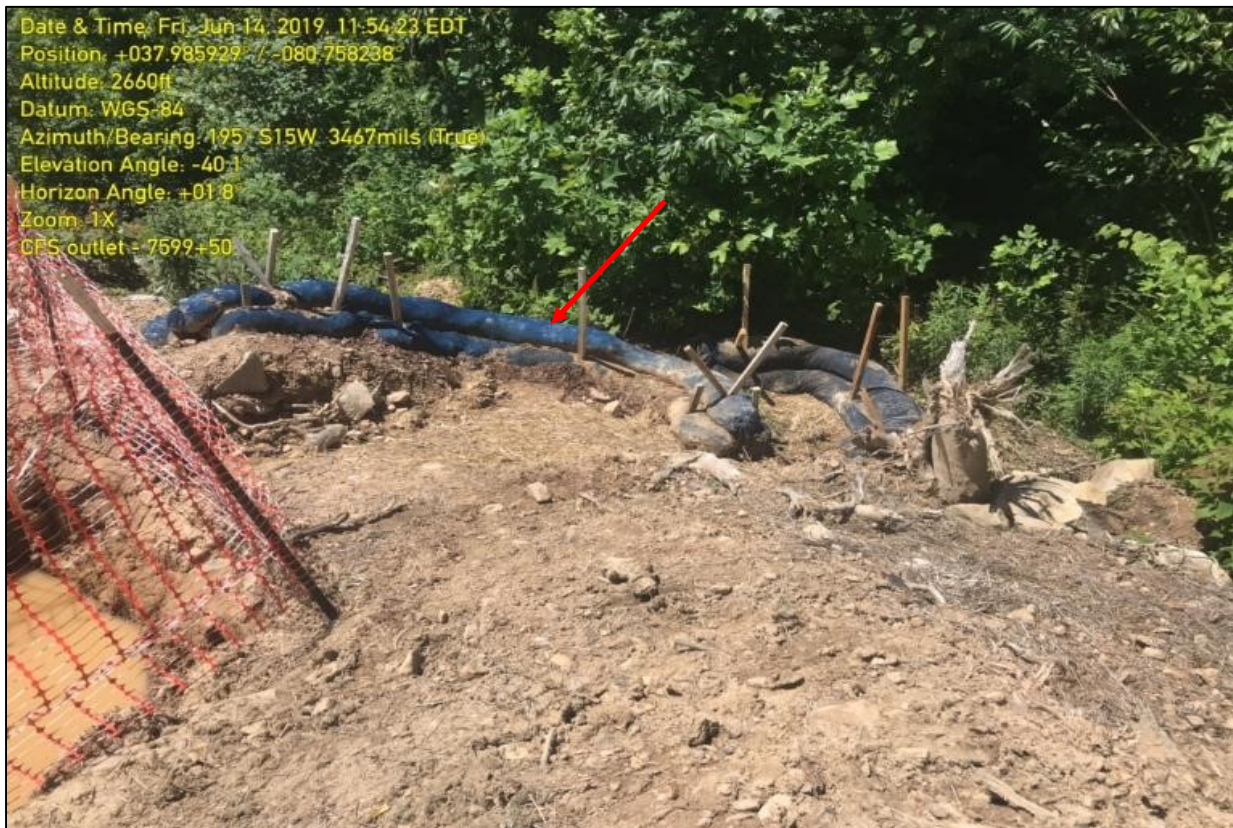
Photo 8: Photo illustrates the additional rows of ECDs that have been installed near Station 7599+50.

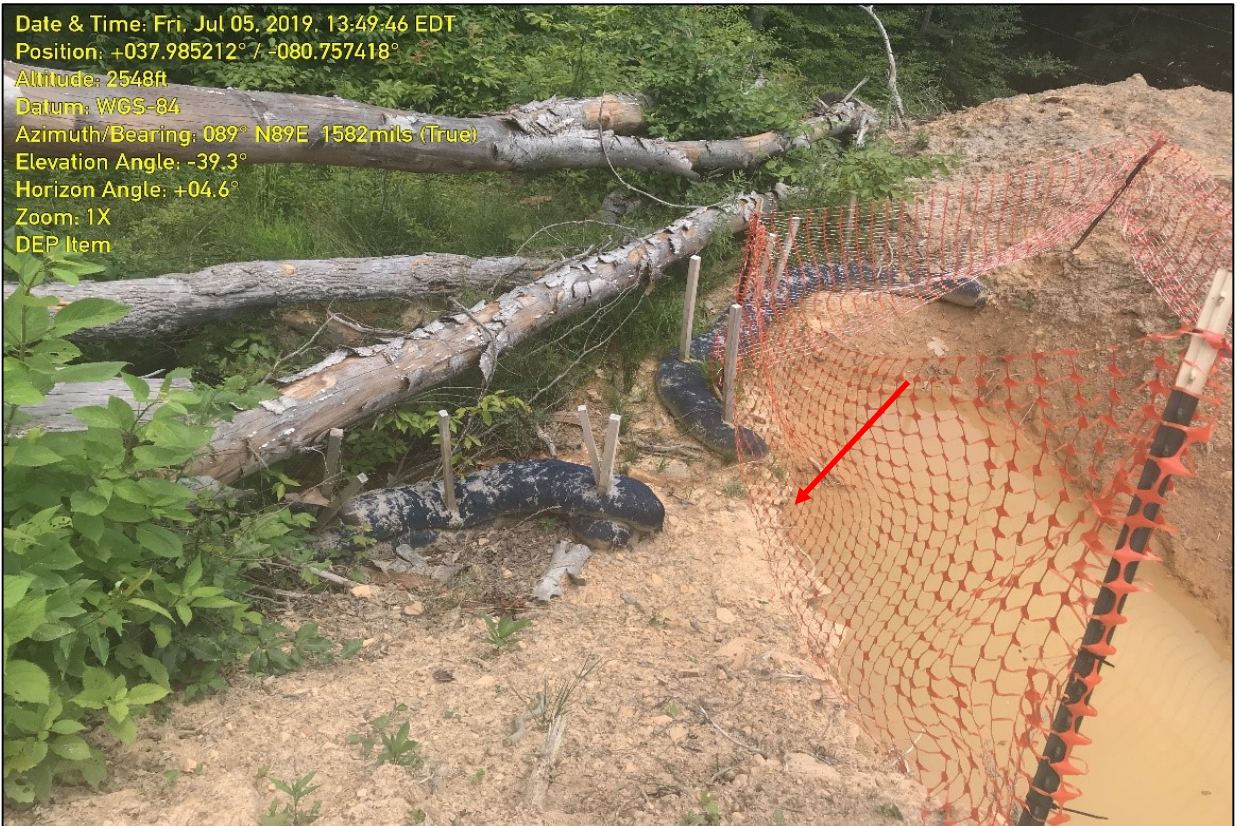
Photo 10: Photo illustrates the sump cleanout near station 7604+01.

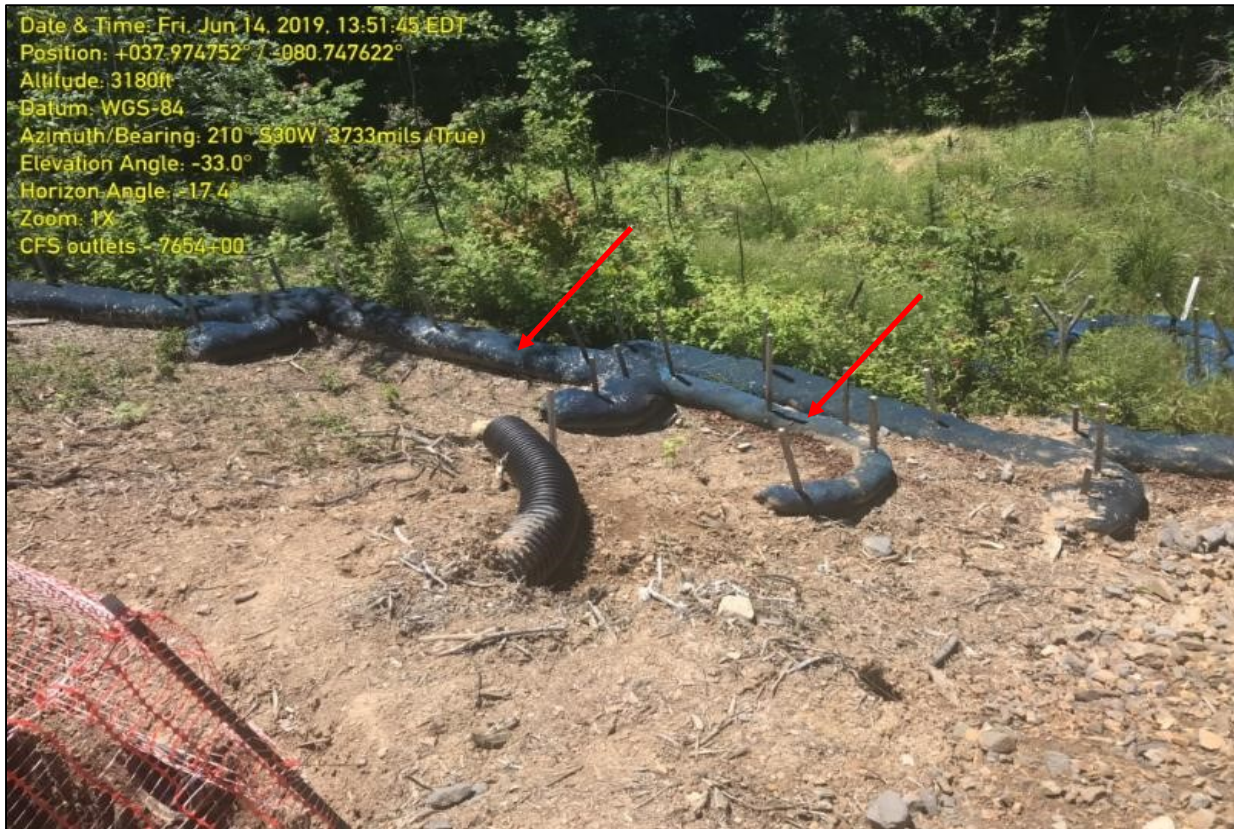
Photo 11: Photo illustrates the cleaned out area near Station 7656+00. The CFS has been replaced and the sediment has been pulled back onto the LOD. This area was identified as Station 7636+00 in the DEP report.

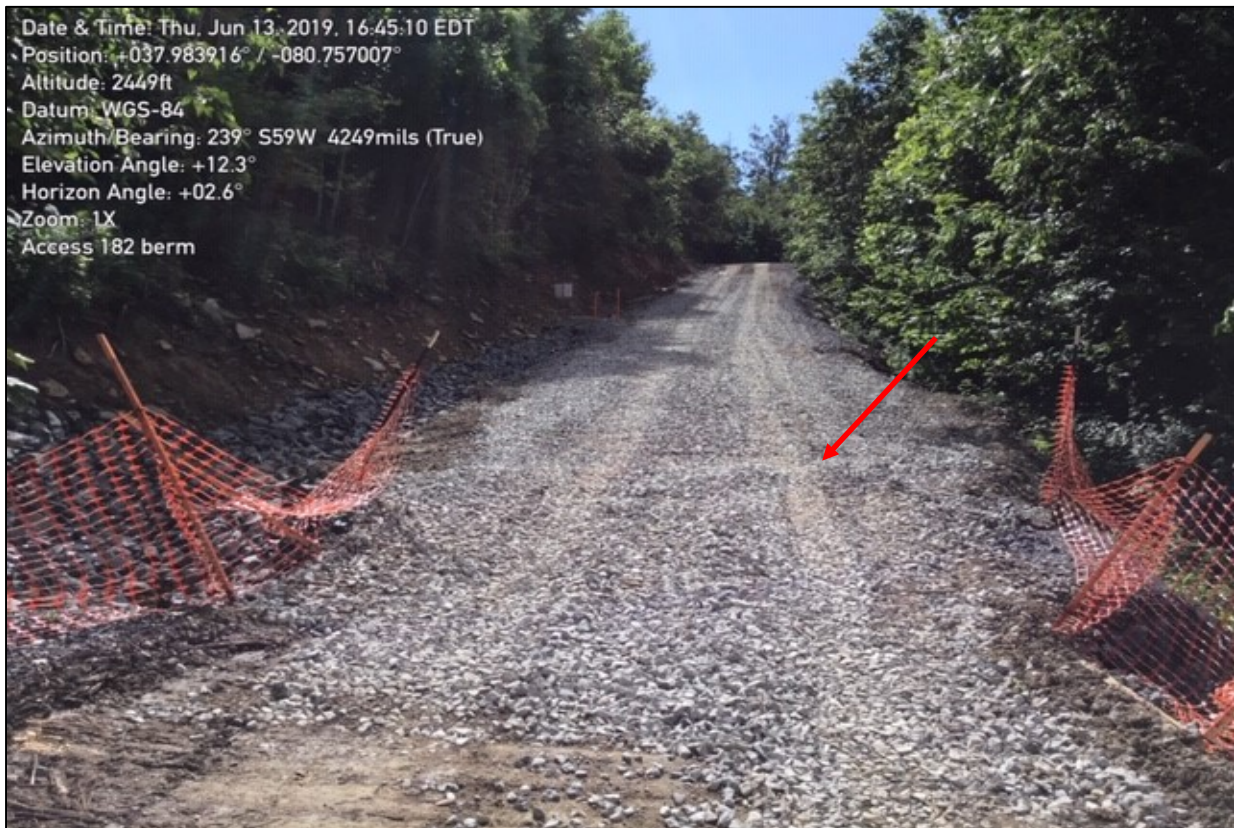
Photo 12: Photo illustrates the regraded broad-based dip in Access Road 192.

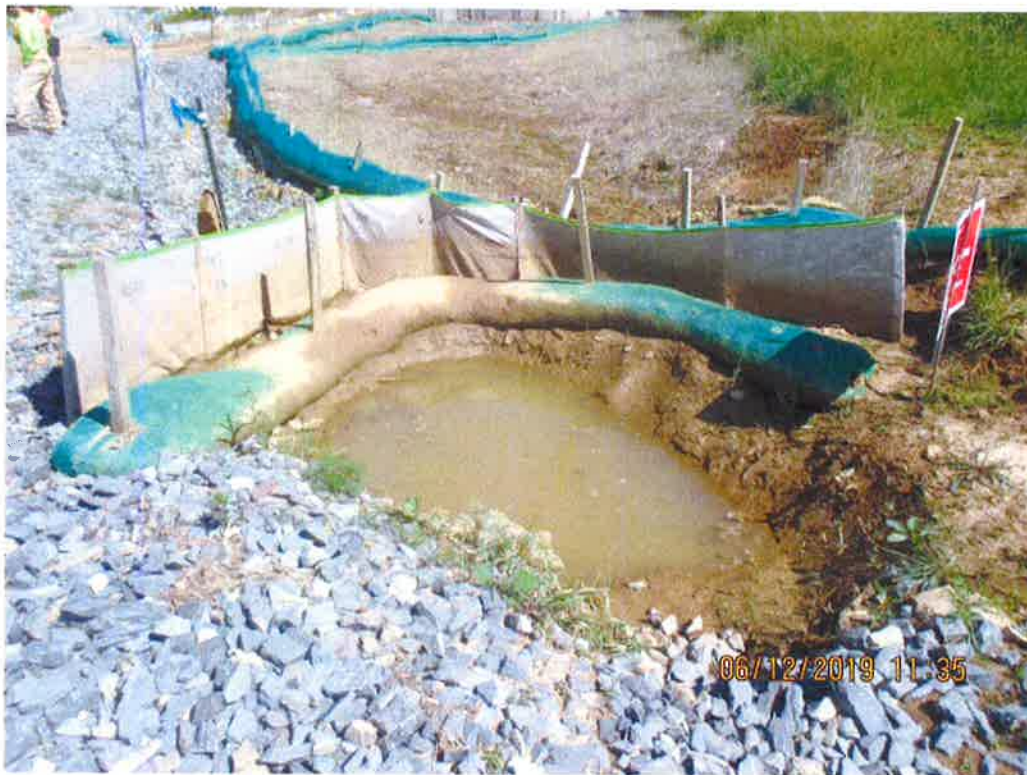
Controls added on edge of LOD to control run-on from adjacent property disturbance.

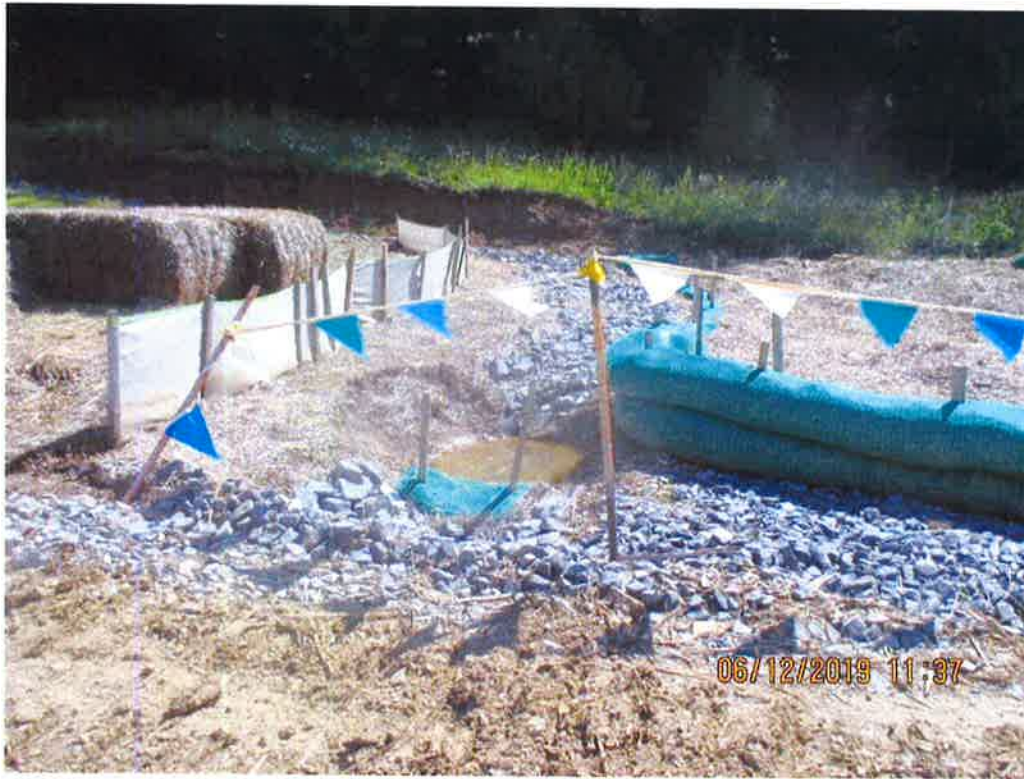
French drain installed at base of cut slope. Drain terminated into sump with controls and conveys under ROW to outlet that has sump present with controls.

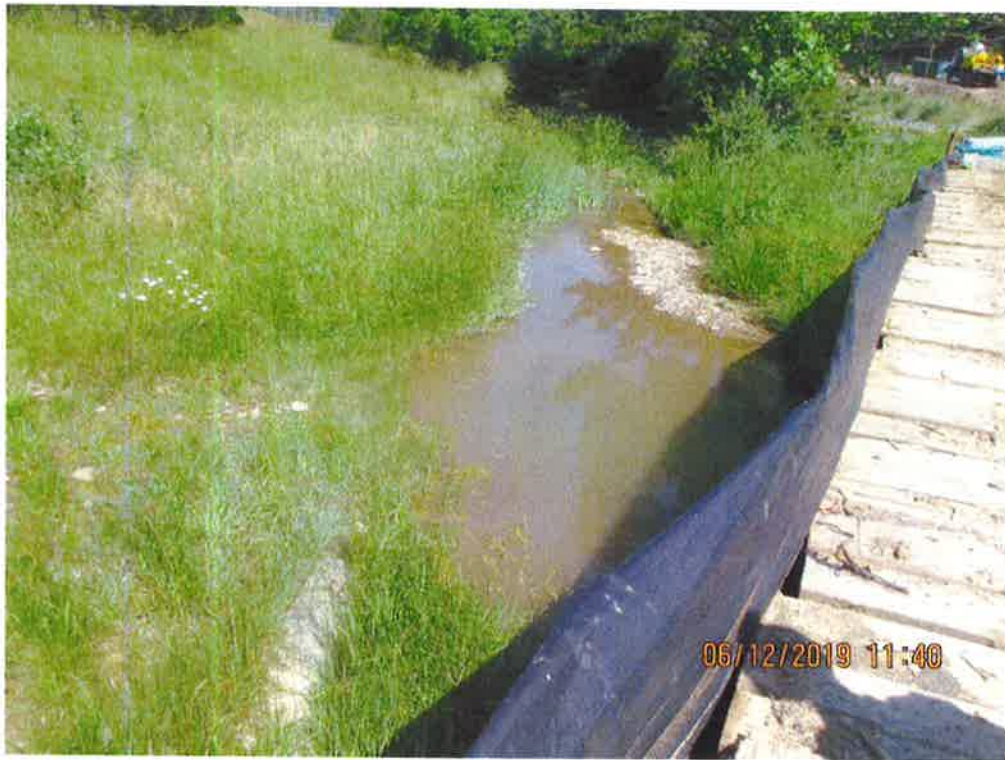
Anne's Branch crossing near station No. 9744+00 facing downstream. Past disturbance observed from land owner traffic across stream.

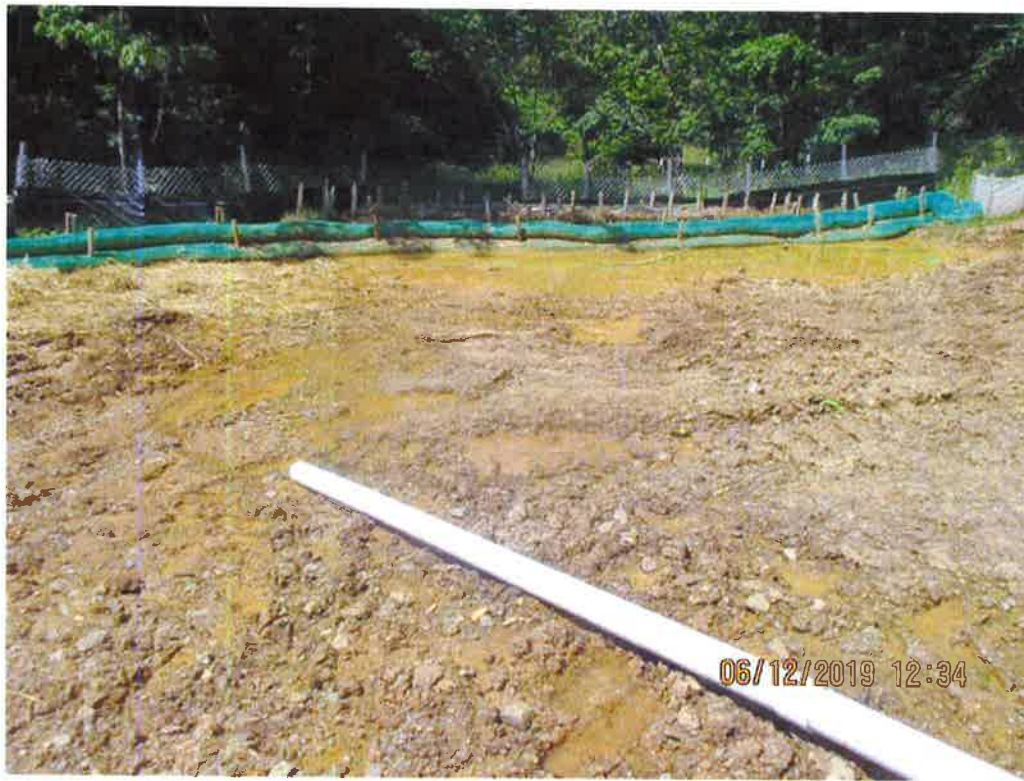
Pipe slope drain terminating onto ROW above controls (Dargo silt fence).
