Re: Mountain Valley Pipeline, LLC
Docket No. CP16-10-000
Weekly Status Report No. 90

Docket No. CP16-10-000
Weekly Report No. 90
Report Period: 07/13/19- 07/19/19

**Re: Mountain Valley Pipeline Project (Permit No. WVR310667)
Response to Notice of Violation No. W19-34-014-JTL**

STATE OF WEST VIRGINIA
Department of Environmental Protection
Environmental Enforcement
NOTICE OF VIOLATION

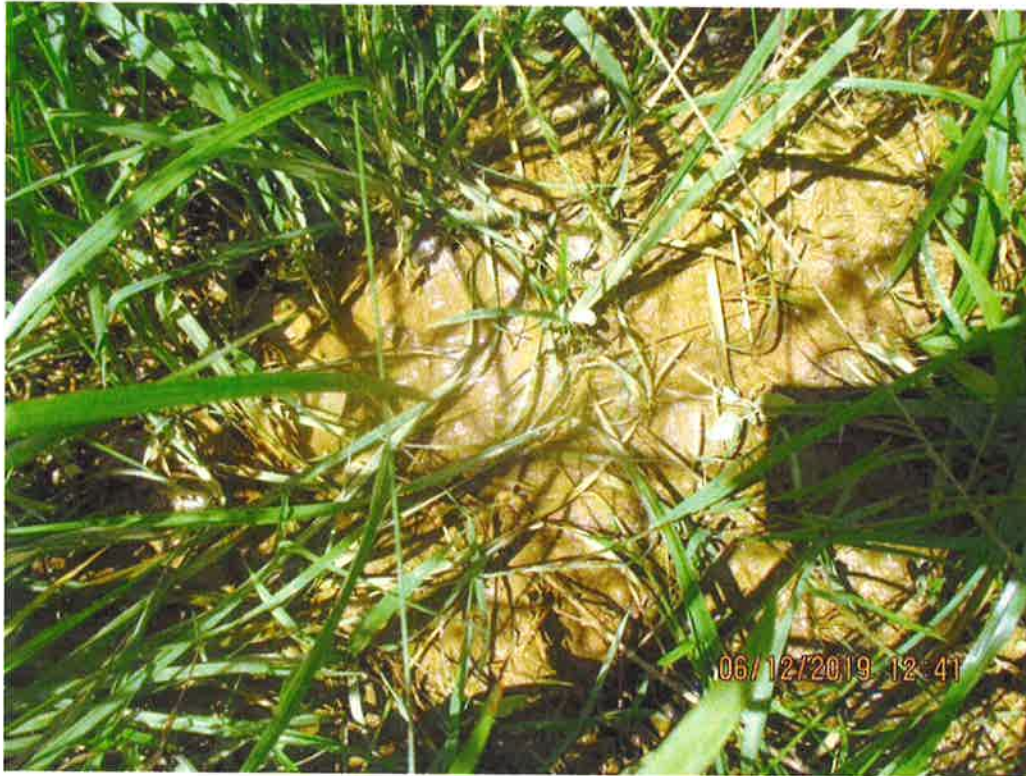
Below Dargo silt fence. Sediment deposits observed past LOD and low-lying area not delineated as a wetland.

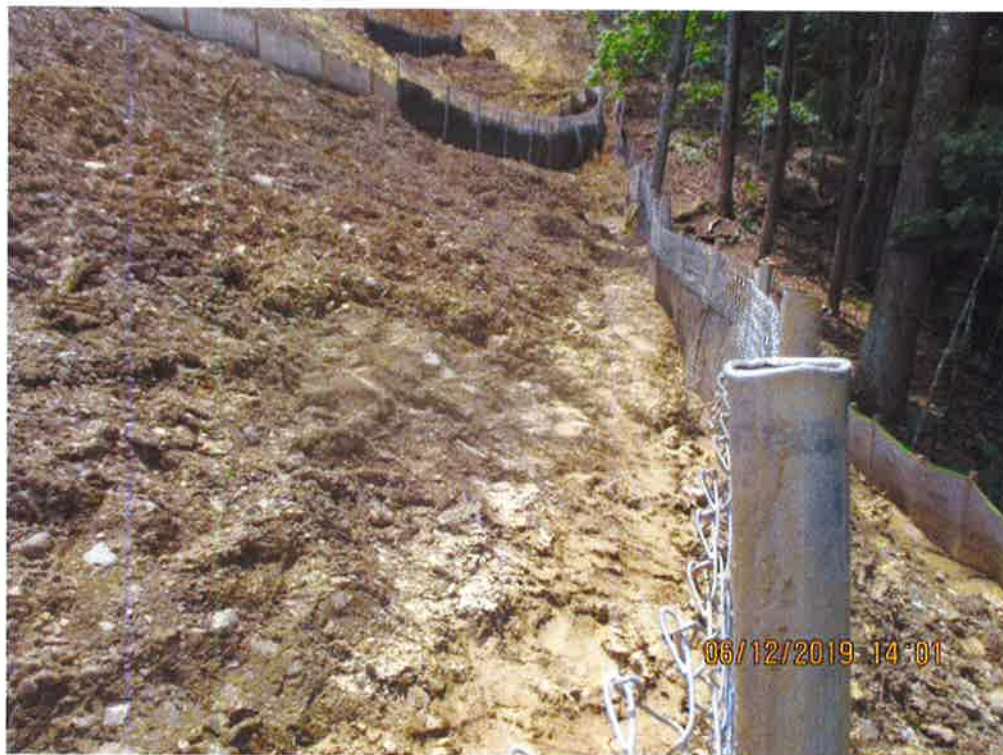
Controls below where dozer work was taking place. Sediment deposits observed below these controls at station No. 9780+00.

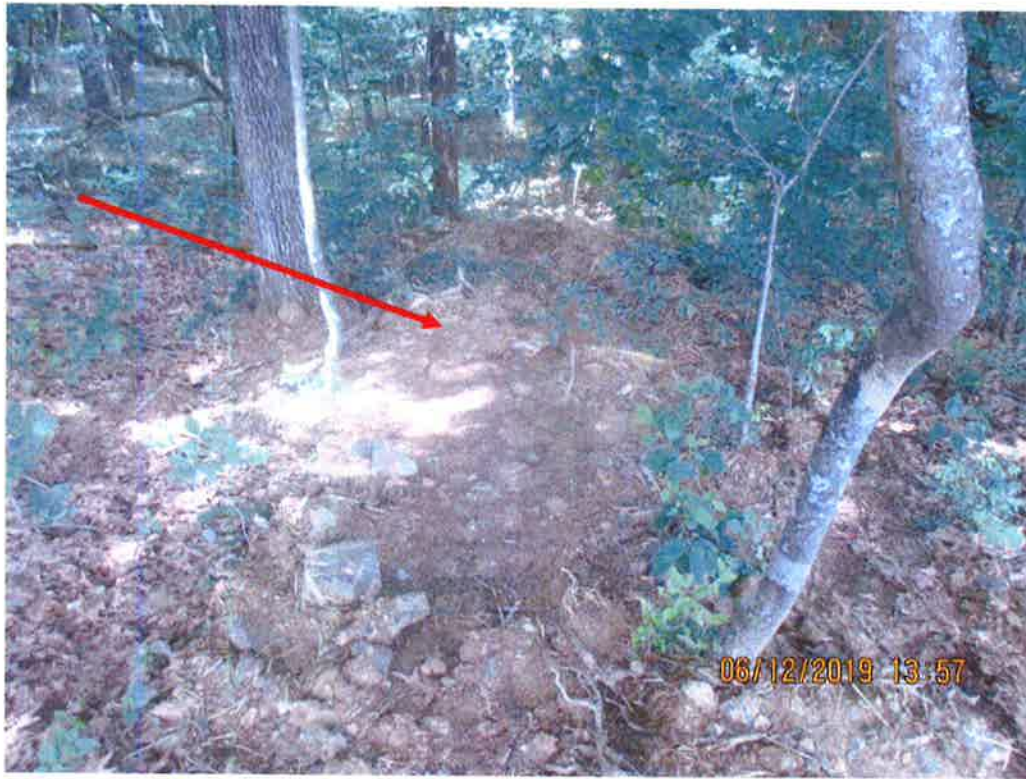
Below controls at station No. 9780+00 facing downslope at sediment deposits and scouring of leaf litter. Arrow depicts deposits.

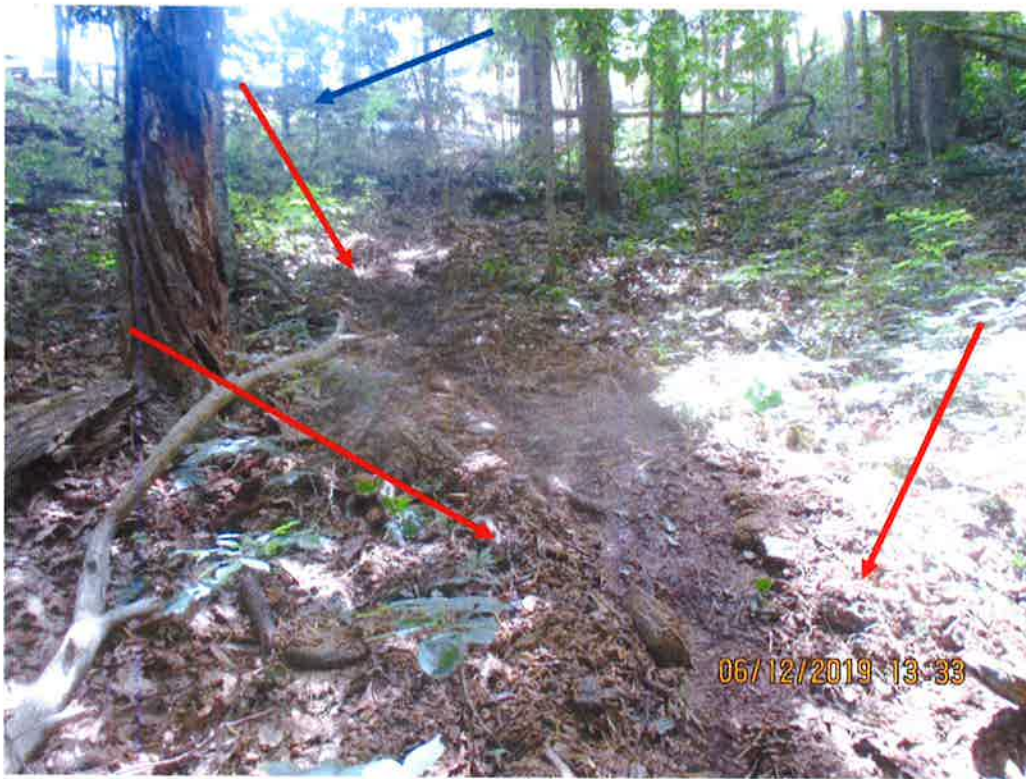
Scoring and sediment deposits below controls at station No. 9780+00. Red Arrow depicts deposits. Blue arrow depicts controls at edge of LOD.

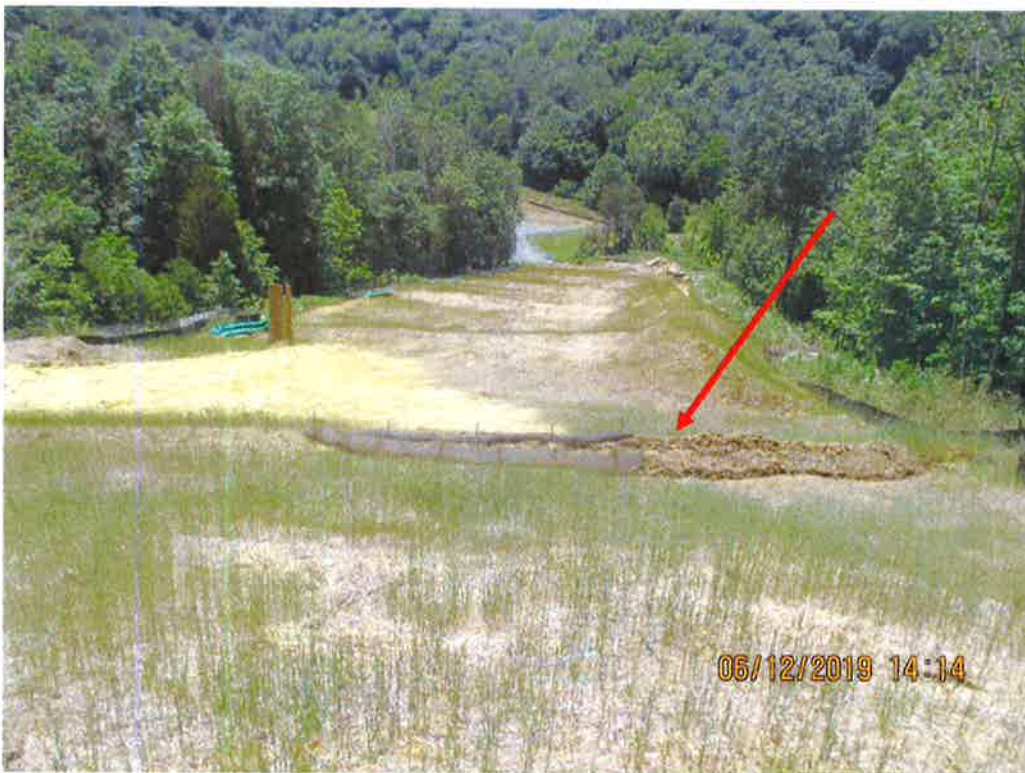
Facing South towards Ellison Ridge Road. Waterbar blow out and repair observed where AR-221 comes onto ROW.

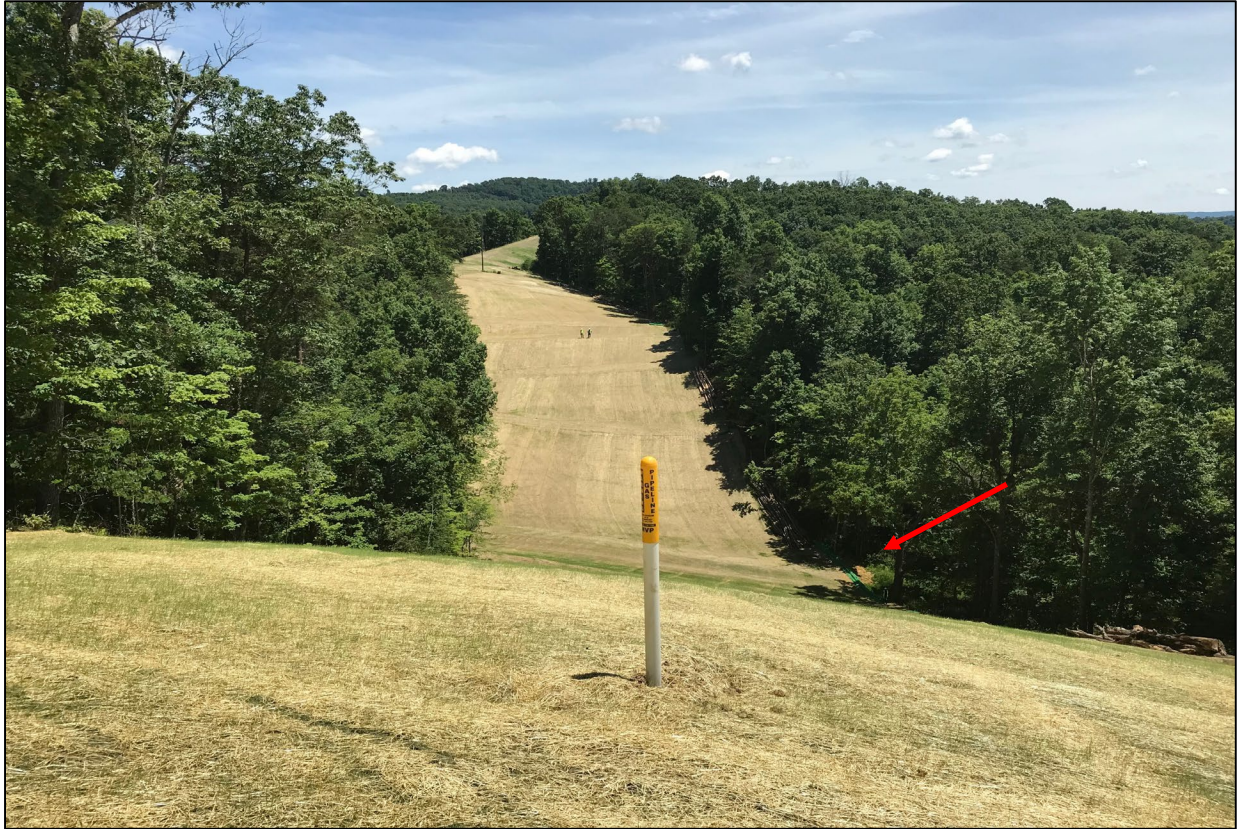
Photo 1: Photo illustrates the stabilized slope near the Dargo Pond. The pipe has been installed in this area. The red arrow is the drainage swale in the valley, leading to the Dargo Pond.

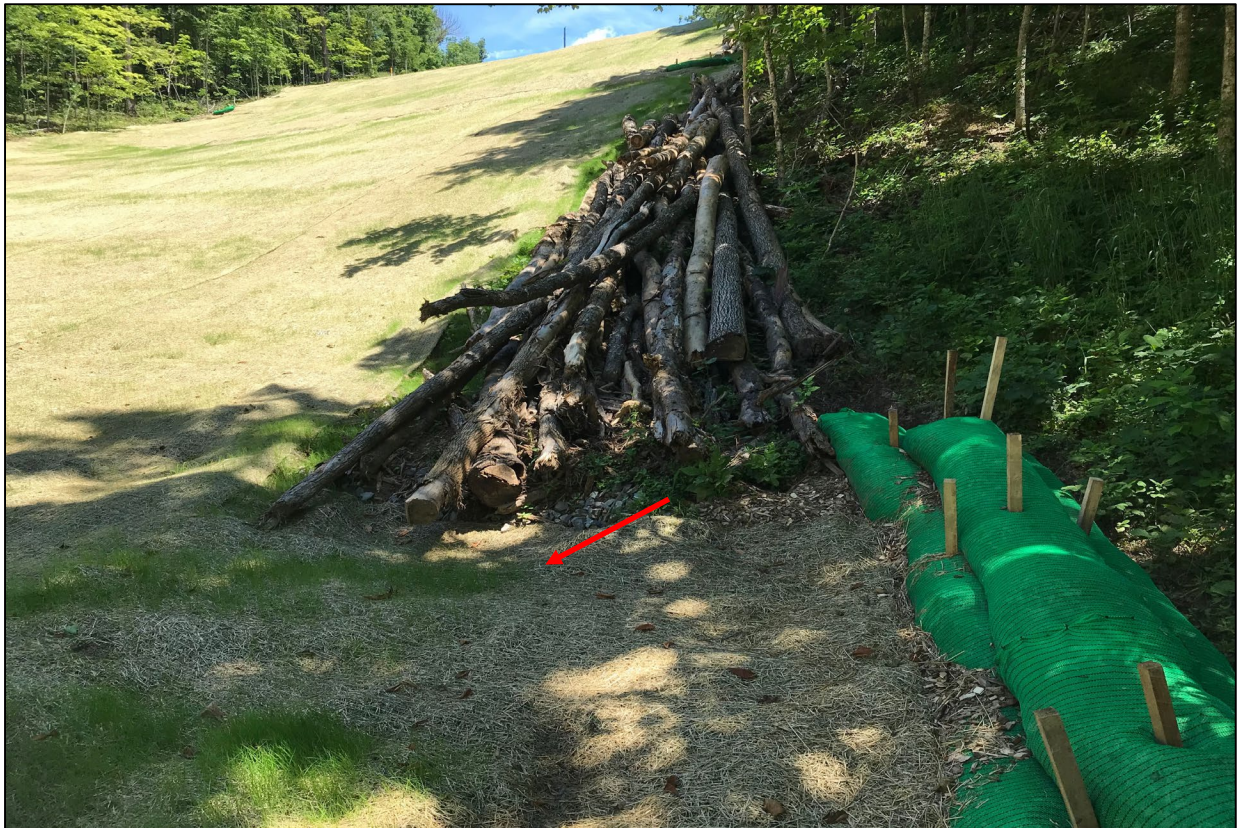
Photo 2: Photo illustrates another view of the slope near Dargo Pond. The red arrow is the approximate location of a subterranean drain.

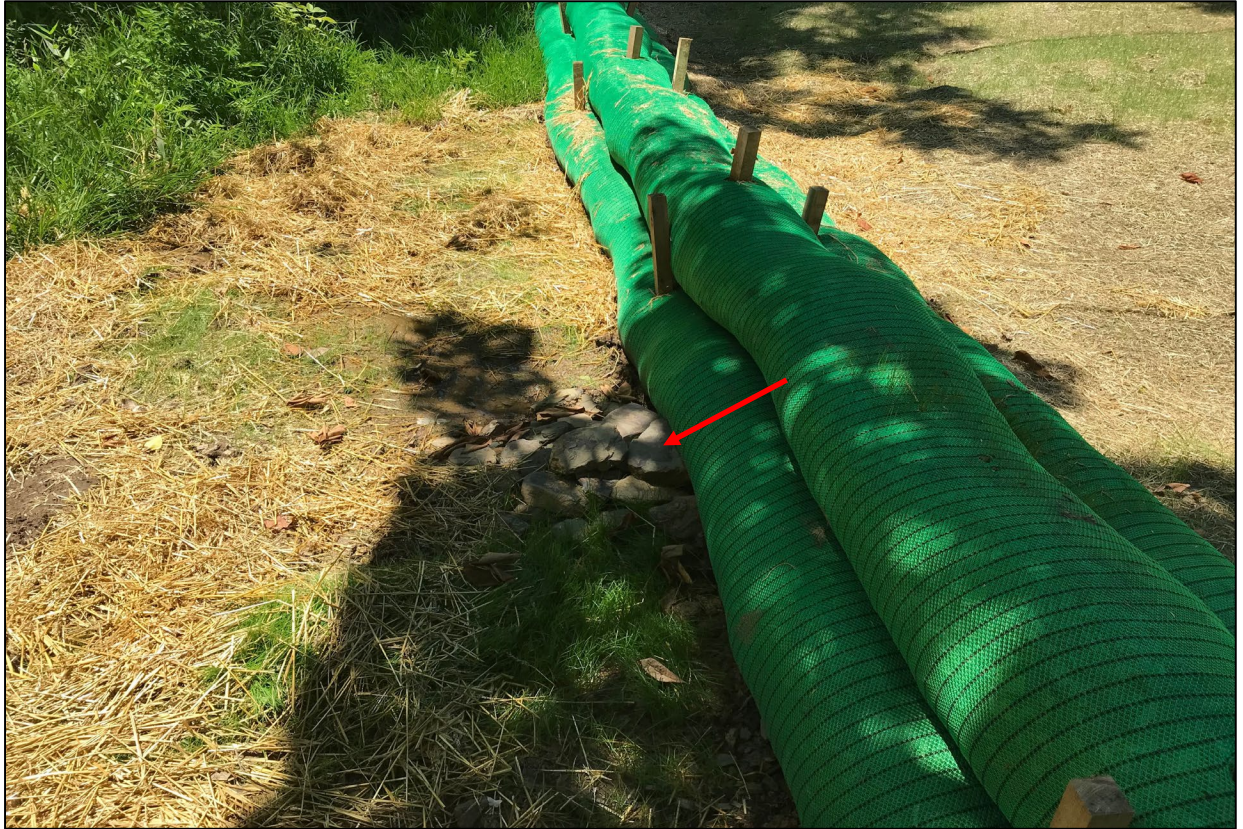
Photo 3: The rock energy dissipater shown in the photo is the outlet of the subterranean drains near the Dargo pond.

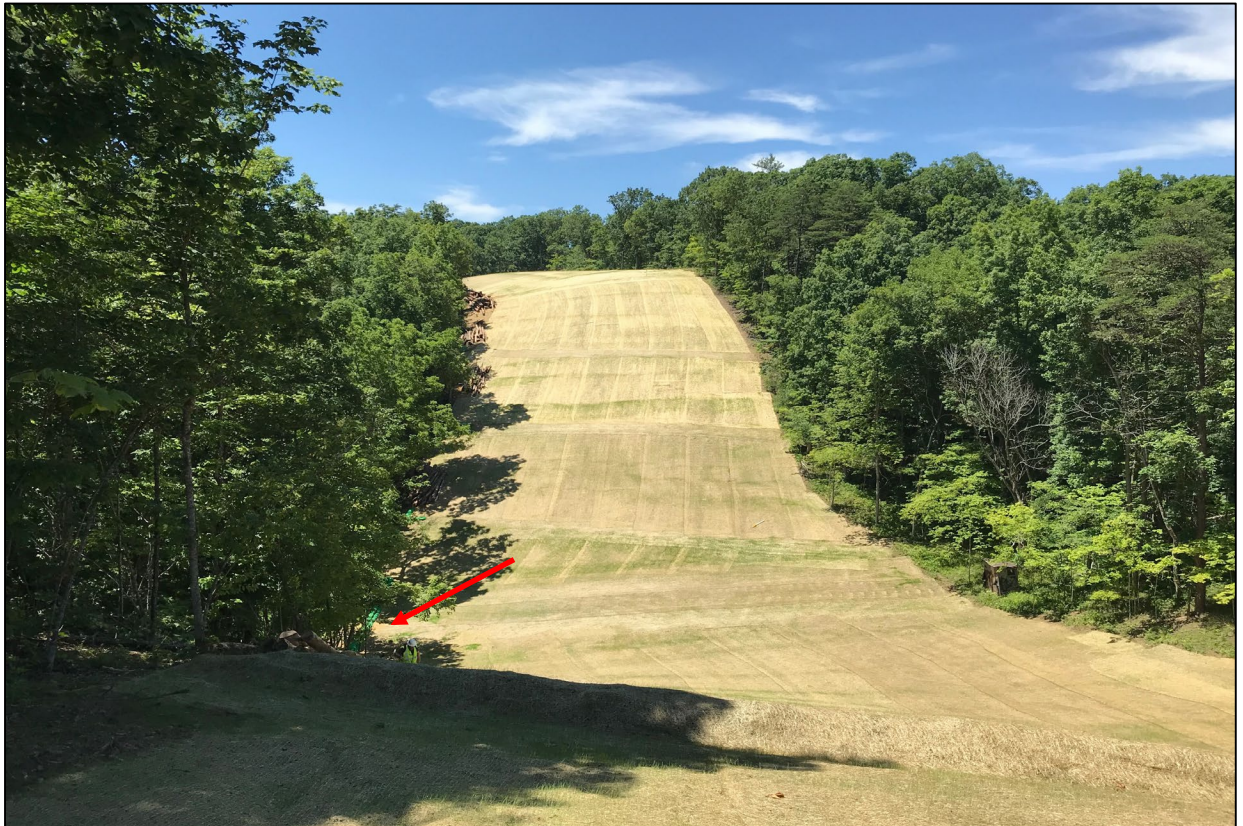
Photo 4: Another view of the Dargo Pond area. The red arrow is the location of the compost filter socks in Photo 3.

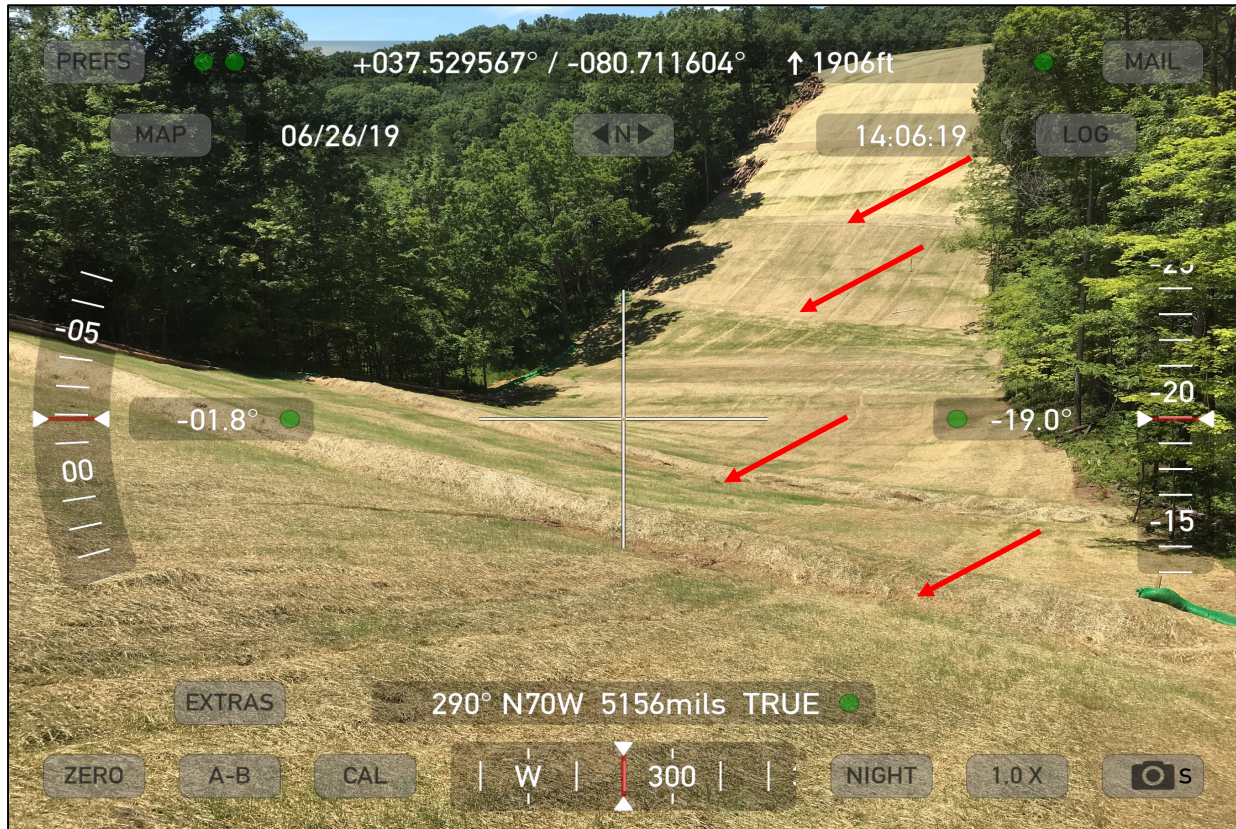
Photo 5: Photo illustrates the stabilization and permanent water bars that have been installed near Dargo Pond.

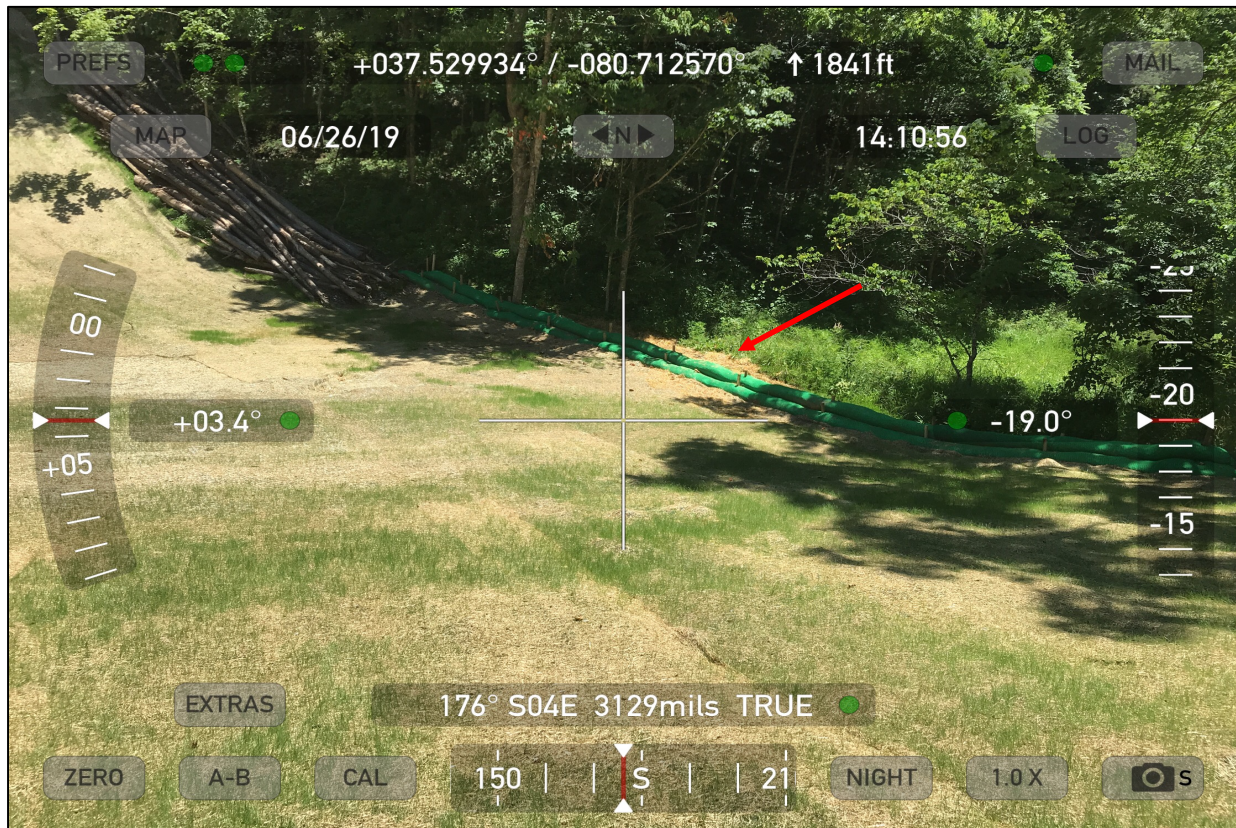
Photo 6: Photo illustrates the CFS and temporary stabilization that have been installed in the area upslope of Dargo Pond.

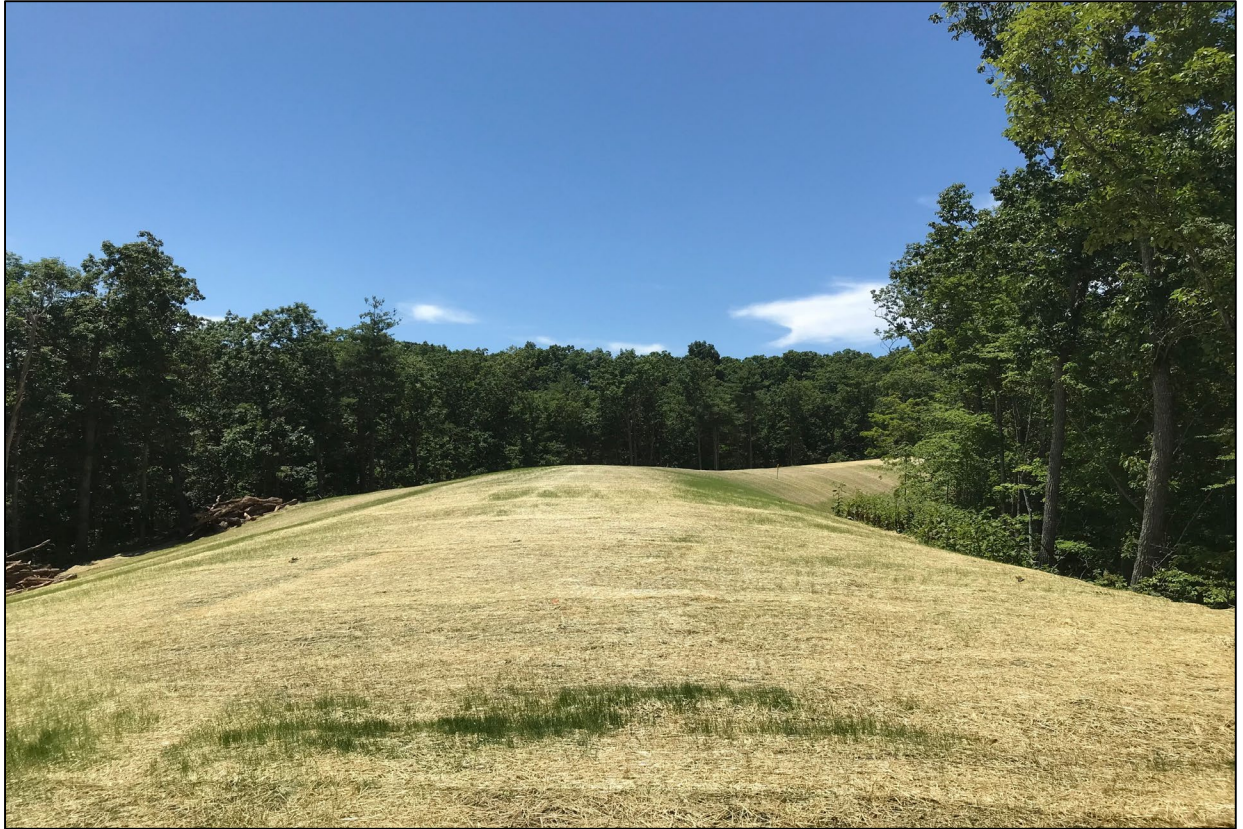
Photo 7: Photo illustrates the permanent stabilization that has been installed near Station 9780+00.

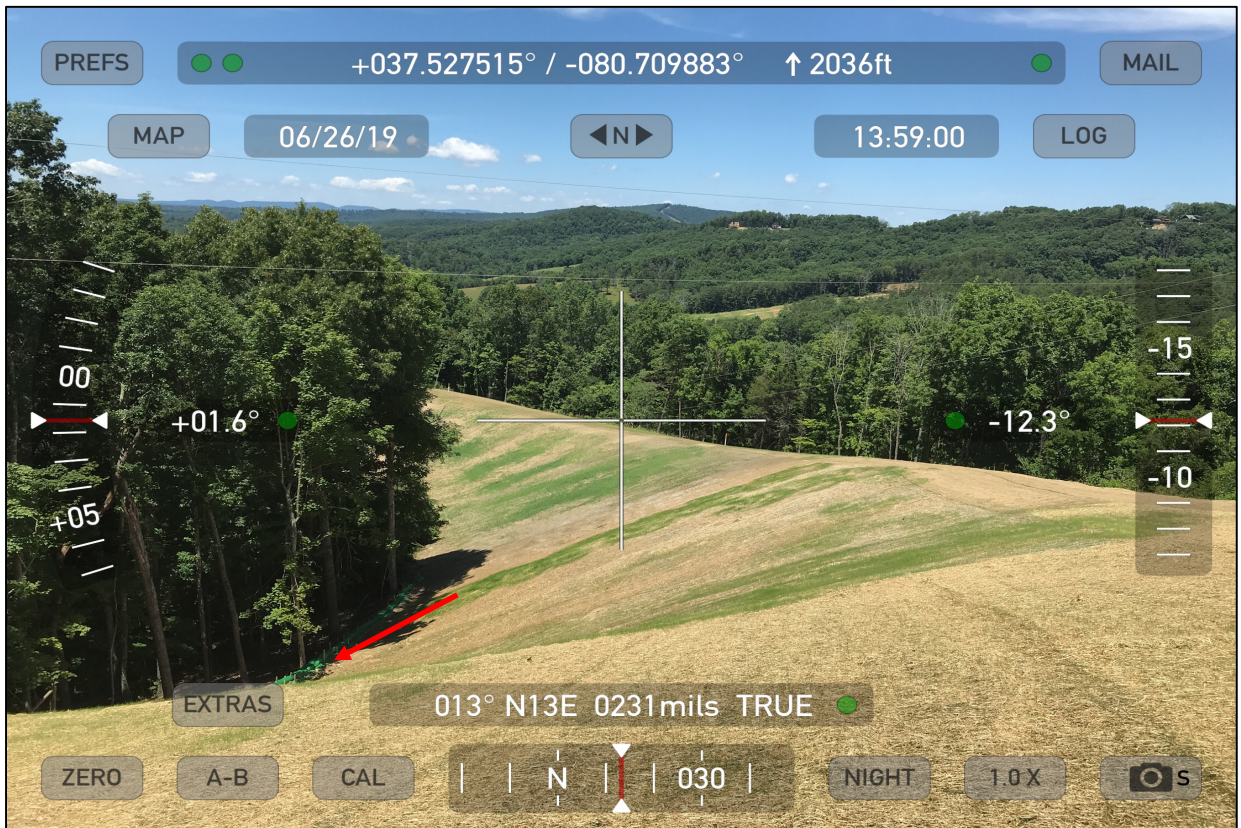
Photo 8: Photo illustrates the permanent stabilization and CFS that have been installed near Station 9780+00.
