August 15, 2019

Re: Mountain Valley Pipeline, LLC
Docket No. CP16-10-000
Weekly Status Report No. 92

NOTICE OF VIOLATION

Violation No W19-51-024-JTL

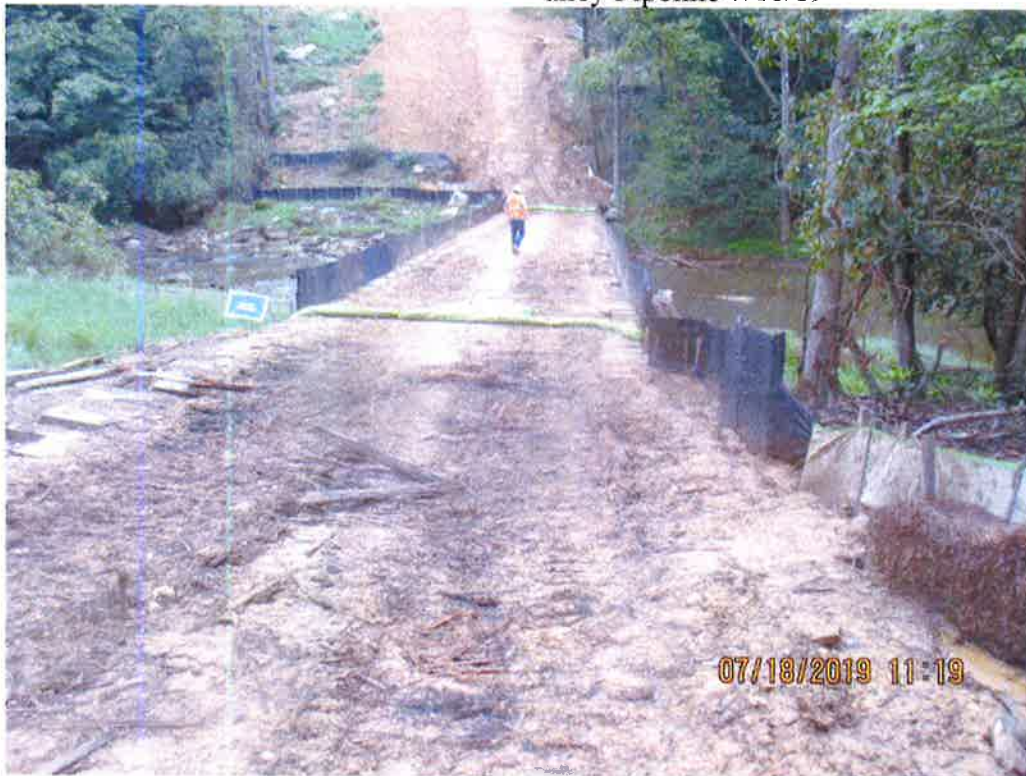
Holly River ROW crossing at station No. 4440+00 facing South.

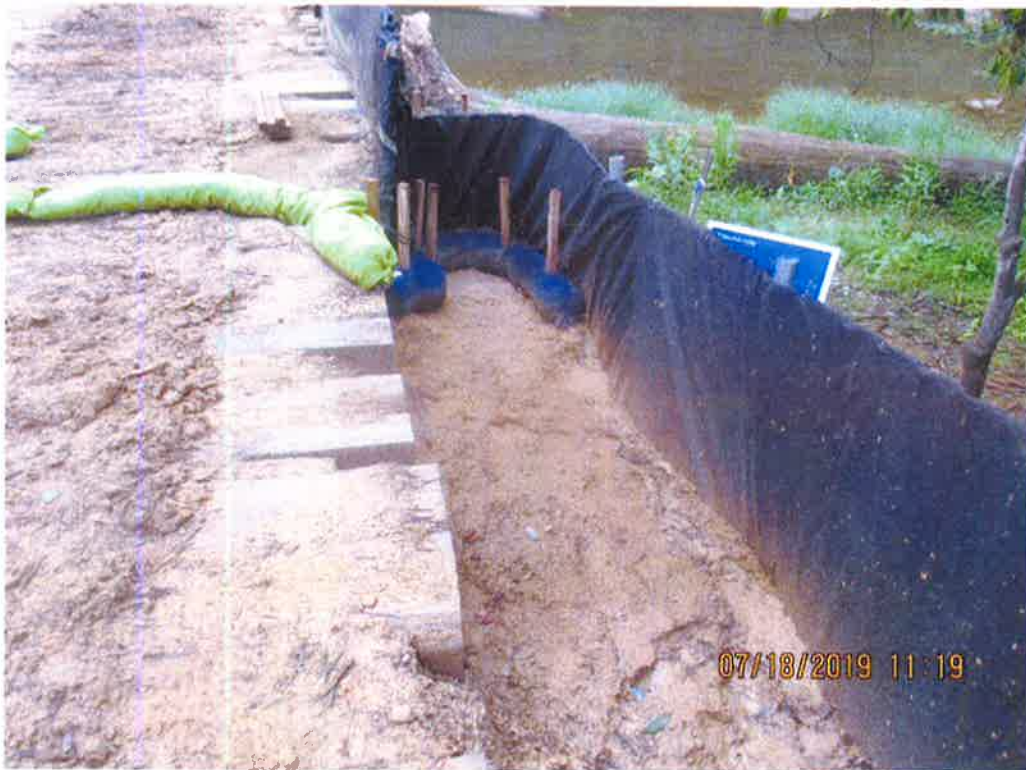
Sediment deposited behind controls on NW side of Bridge.

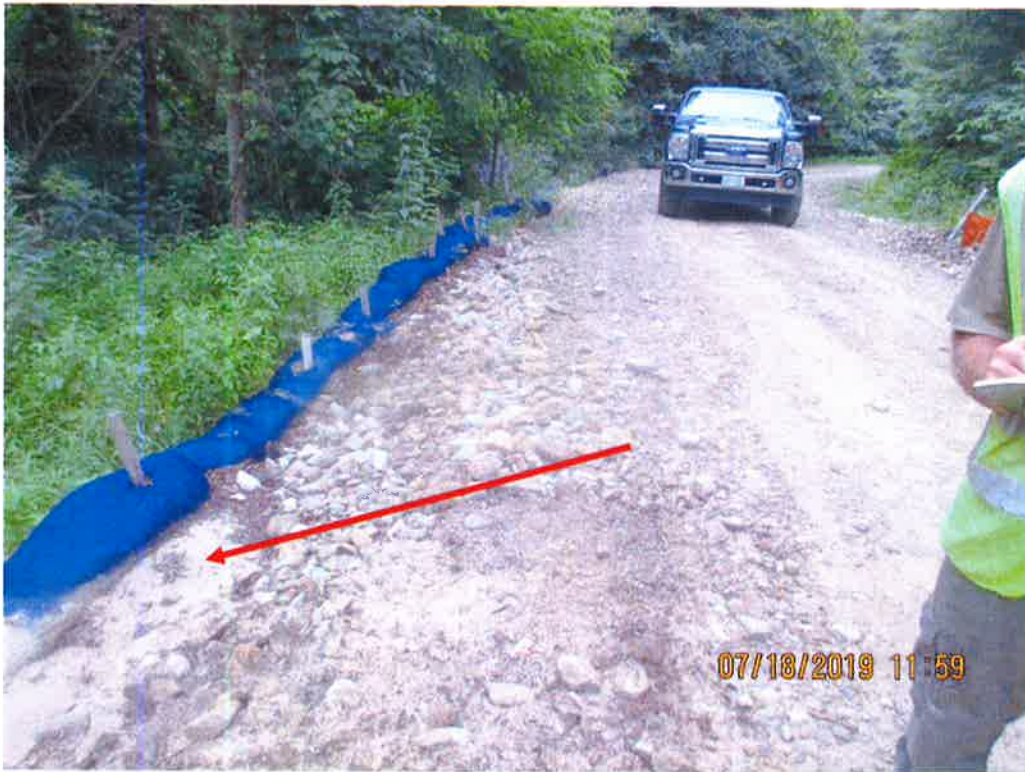
Facing perimeter controls along access road MVP-WB-119. Controls were overwhelmed with sediment.

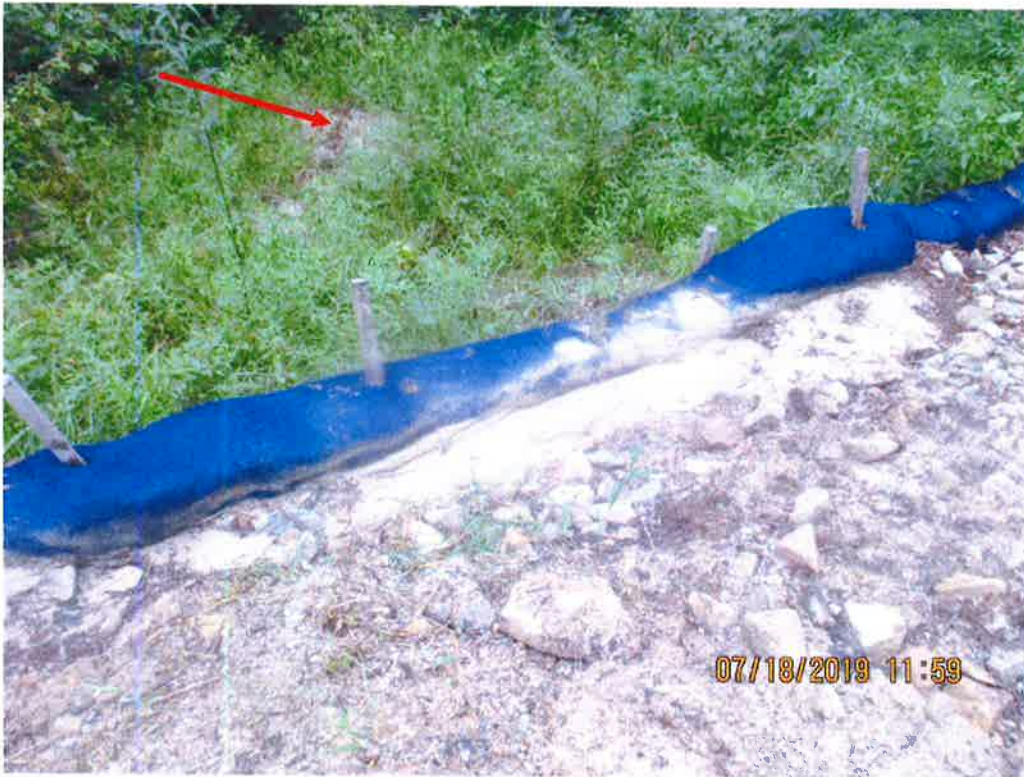
Perimeter controls overwhelmed with sediment with sediment deposits past the LOD. Arrow depicts sediment deposits.

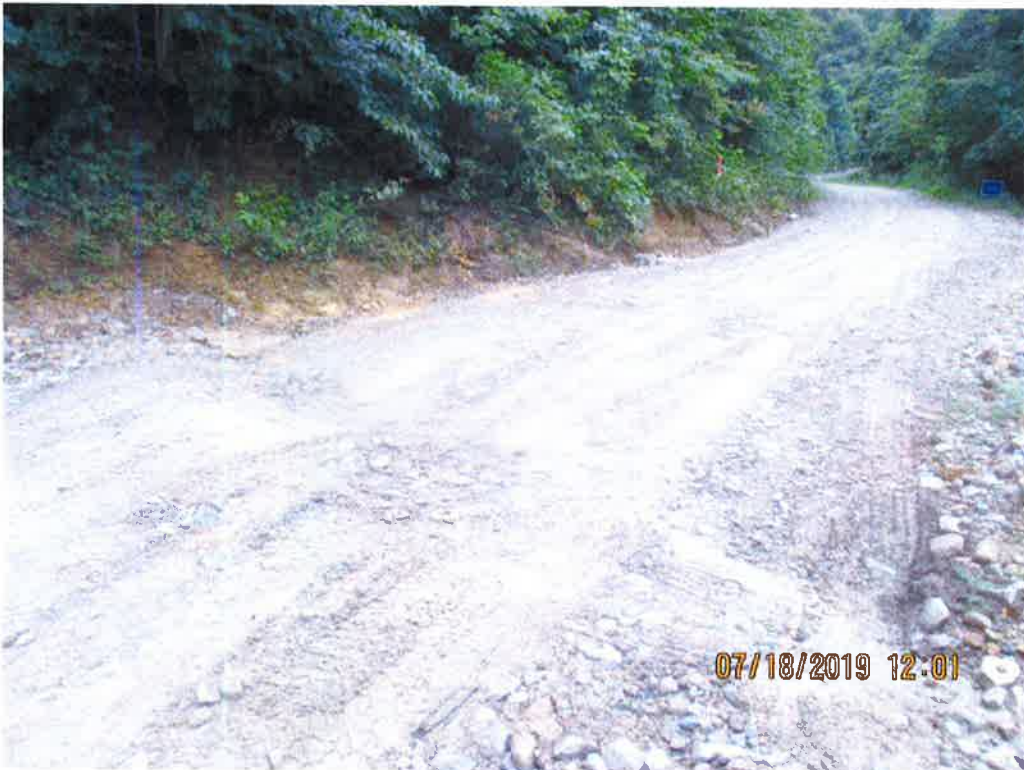
Waterbar installed on Access Road MVP-WB-119. Ditch line had rock checks present. Sediment deposits overwhelmed perimeter controls downslope of Waterbar.

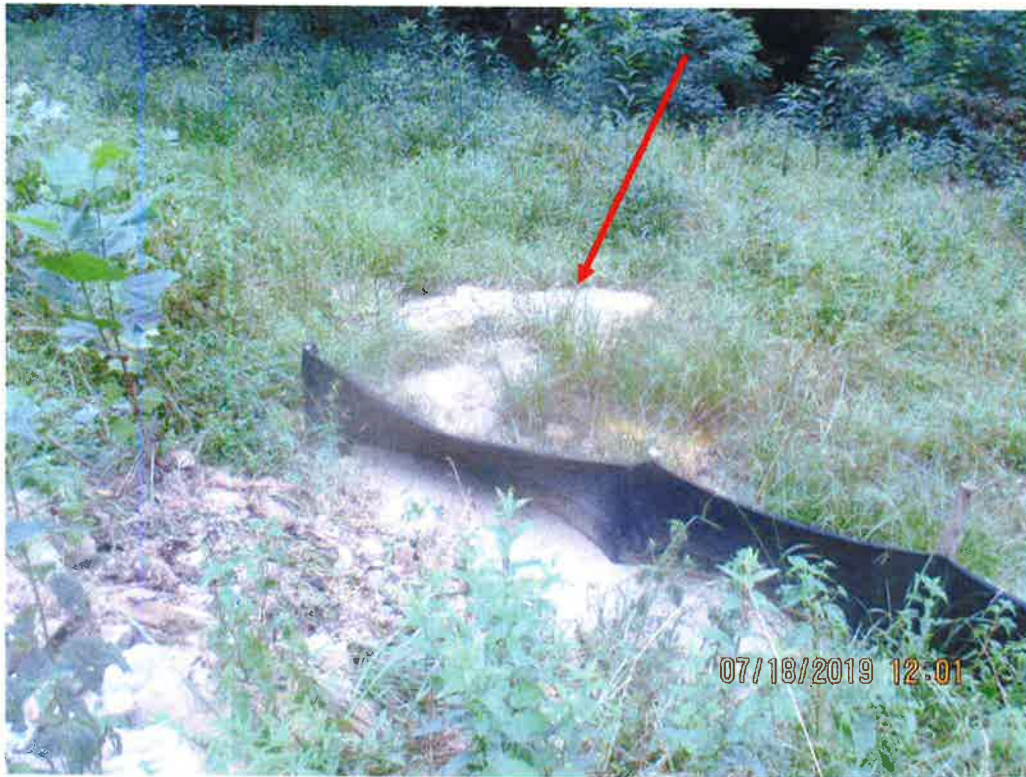
Downslope of Waterbar outlet terminating on slope. Controls overwhelmed with sediment and deposits were present past the LOD and Controls. Arrow depicts sediment deposits.

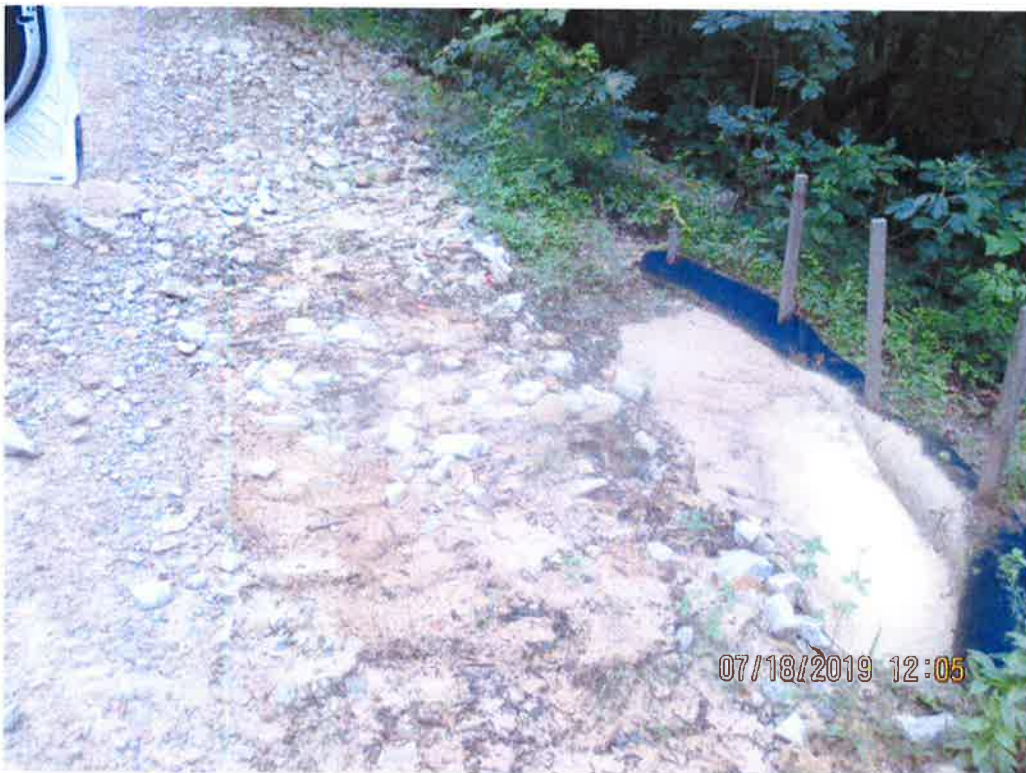
Perimeter controls overwhelmed with sediment along access road MVP-WB-119

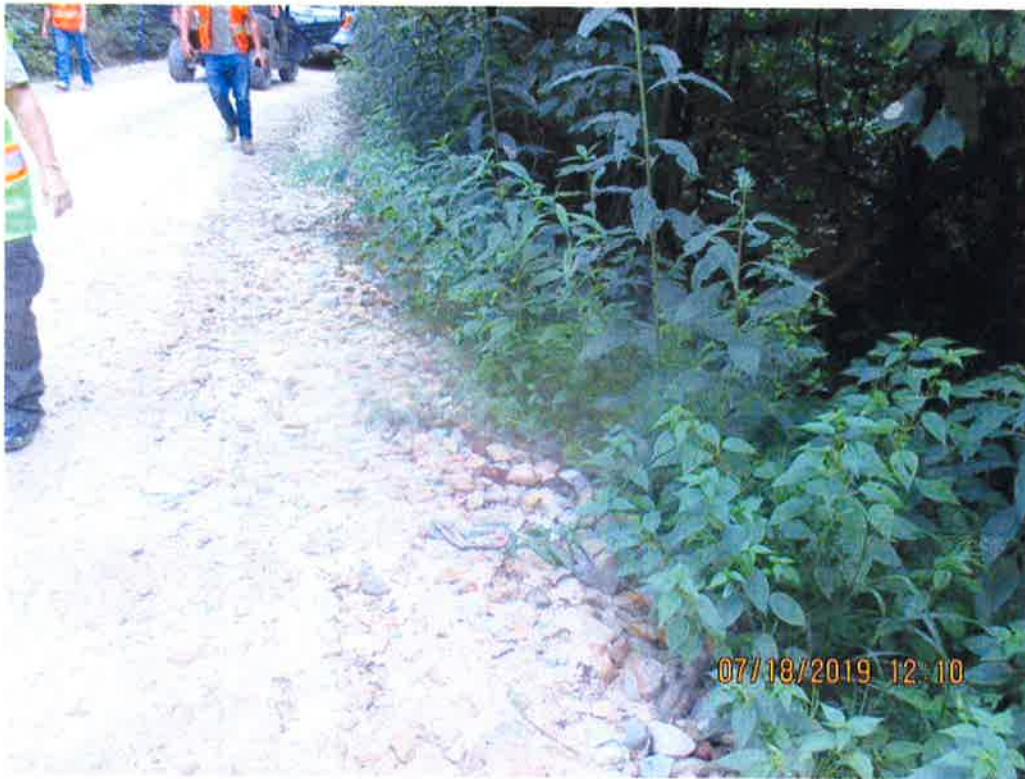
Section of MVP-WB-119 with no perimeter controls installed. Sediment deposits were observed past the LOD.

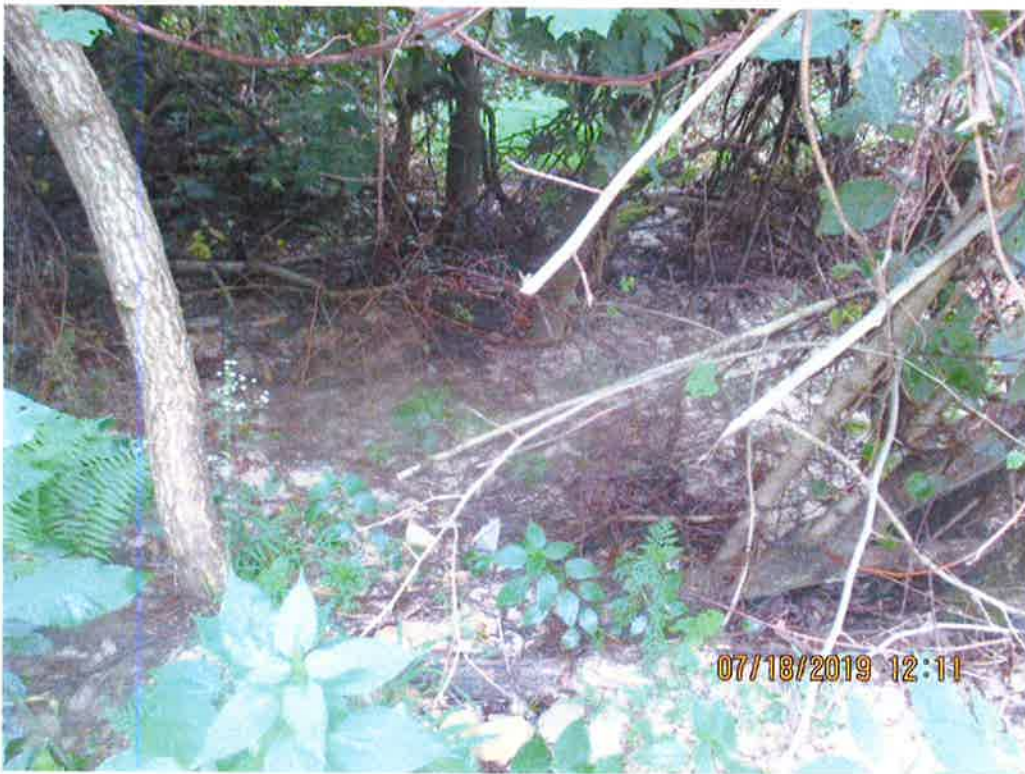
Section of MVP-WB-119 with no perimeter controls installed. Significant Sediment deposits were observed past the LOD throughout the vegetated area downslope of the road.

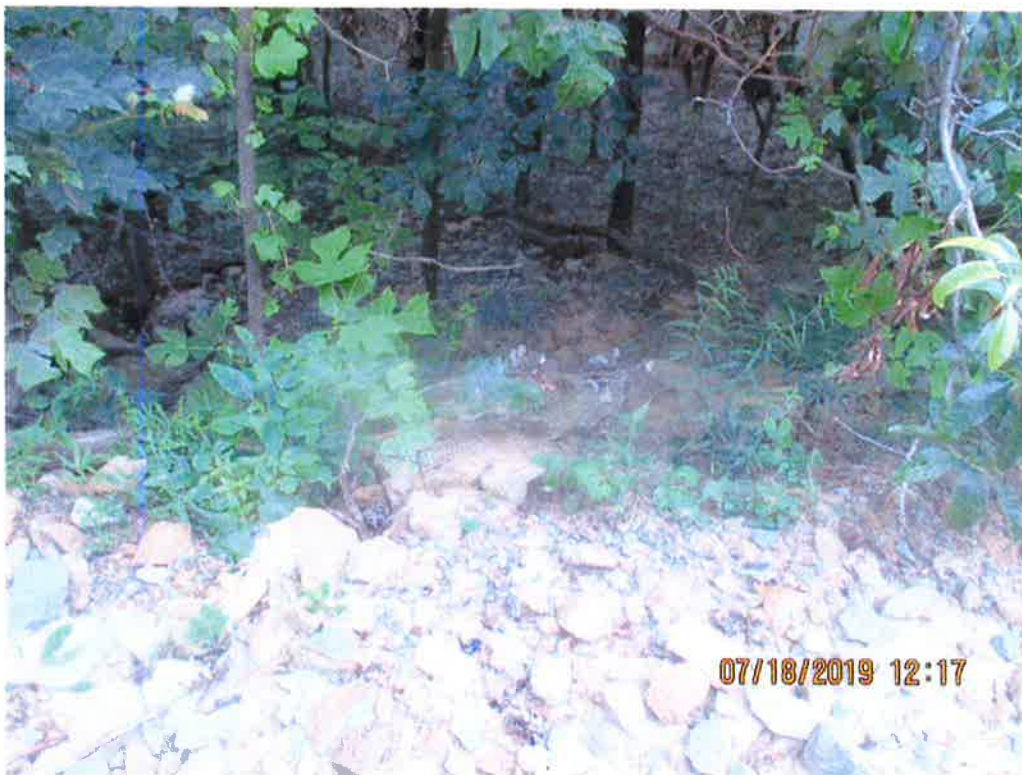
Section along Access road MVP-WB-119 where rock washed out past LOD. No controls present on downslope edge of road.
Sediment deposits observed past LOD.

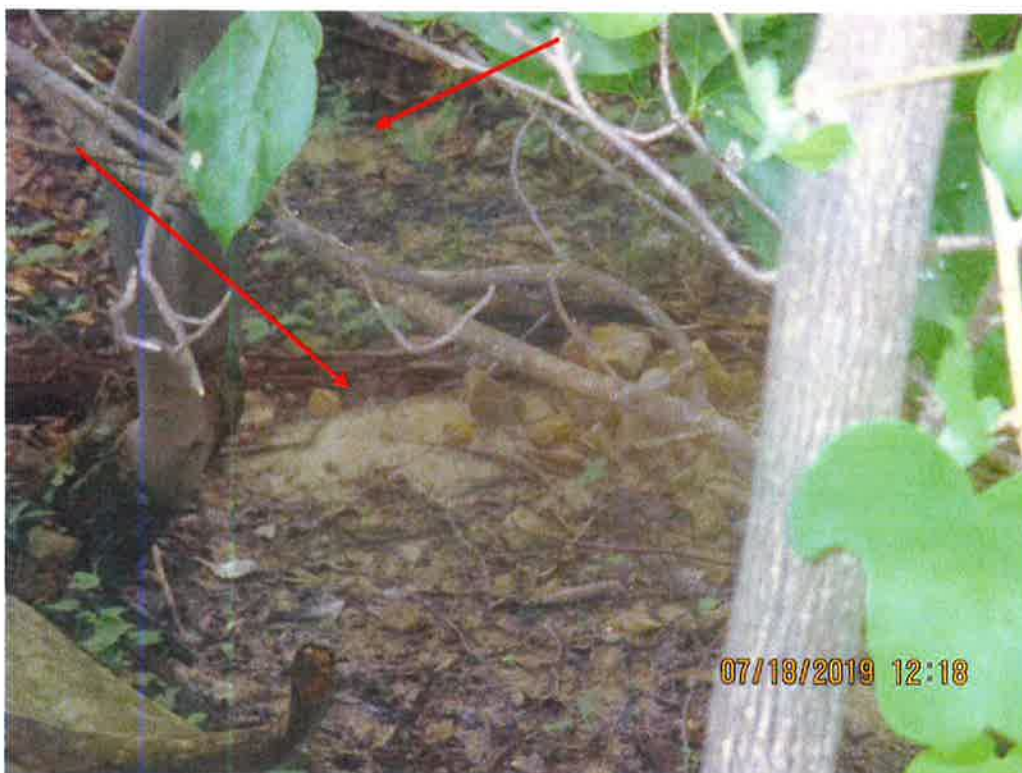
Section along Access road MVP-WB-119 where rock washed out past LOD. No controls present on downslope edge of road.
Sediment deposits observed past LOD. Arrow depicts deposits.

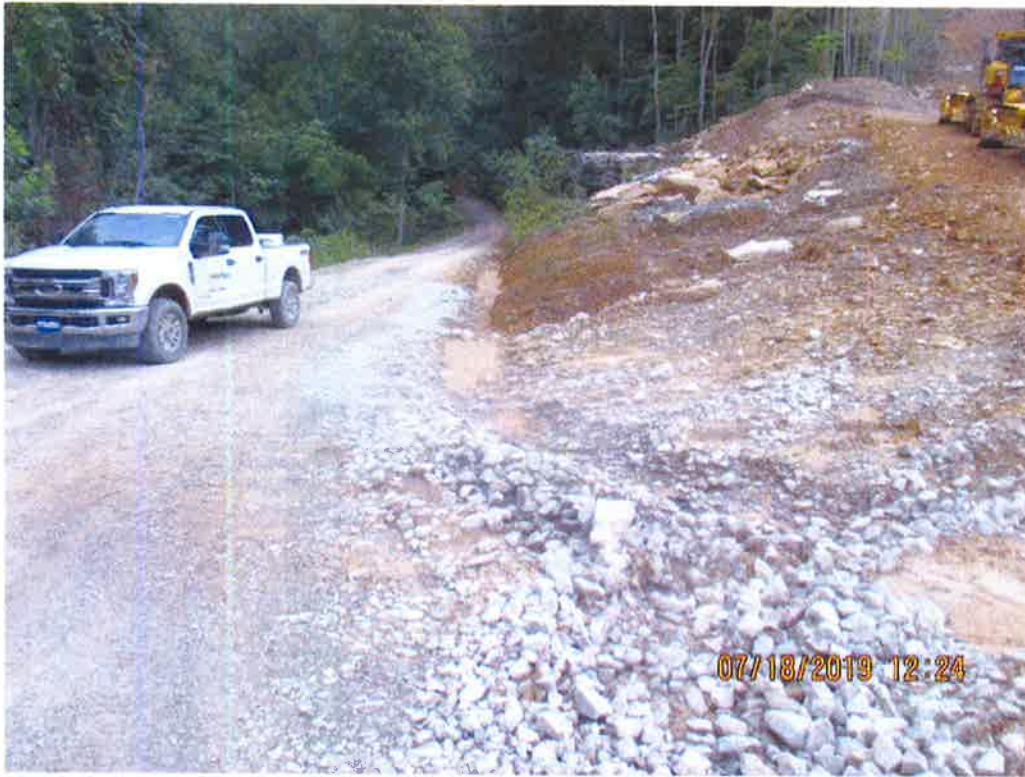
Standing at station No. 4559+96 facing Access Road MVP-WB-119. Sediment deposits present in roadside ditch.

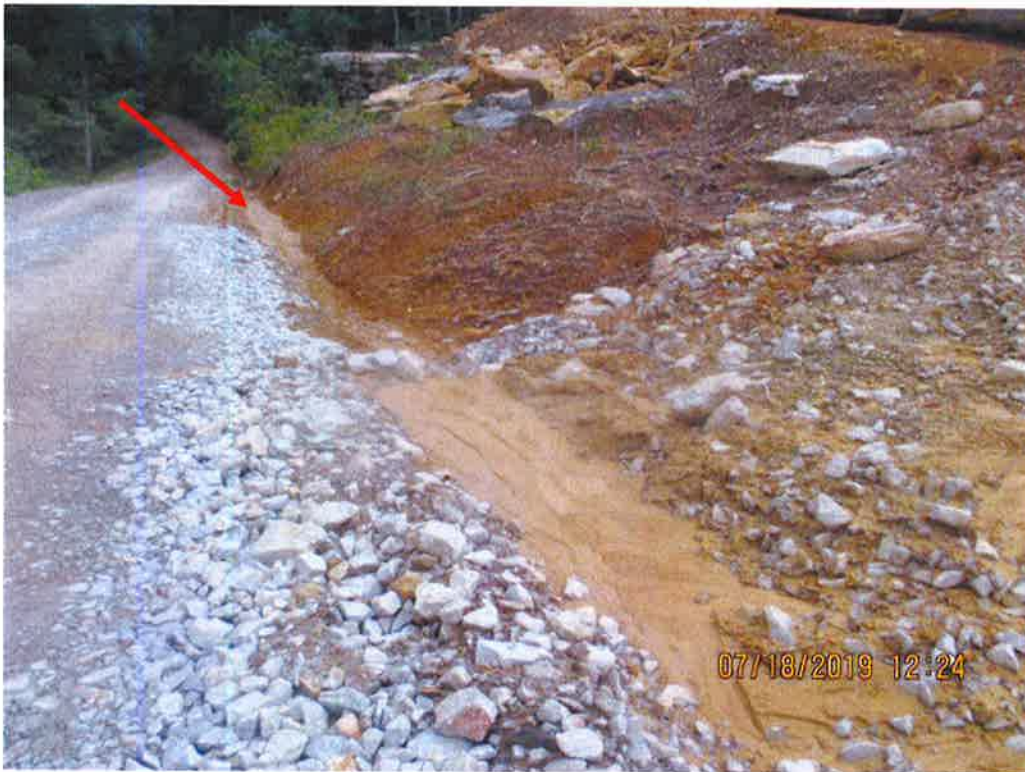
Standing at station No. 4559+96 facing Access Road MVP-WB-119. Sediment deposits present in roadside ditch.

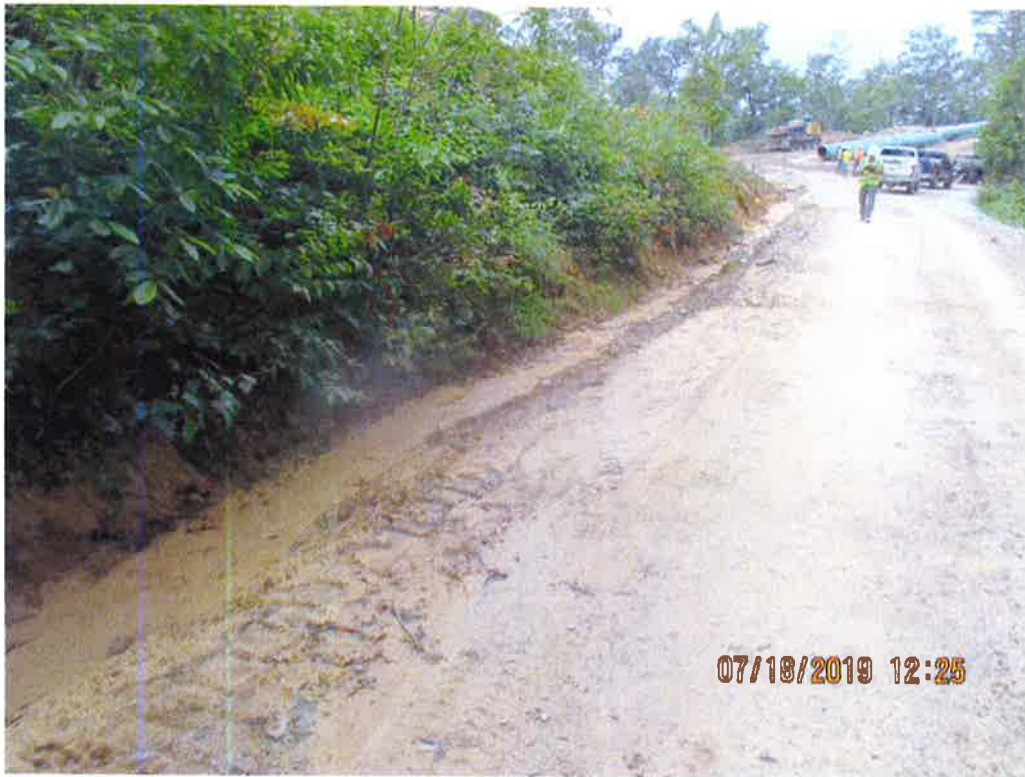
Standing downslope from station No. 4559+96 from Access Road MVP-WB-119 facing towards MVP ROW. Sediment deposits present in roadside ditch.

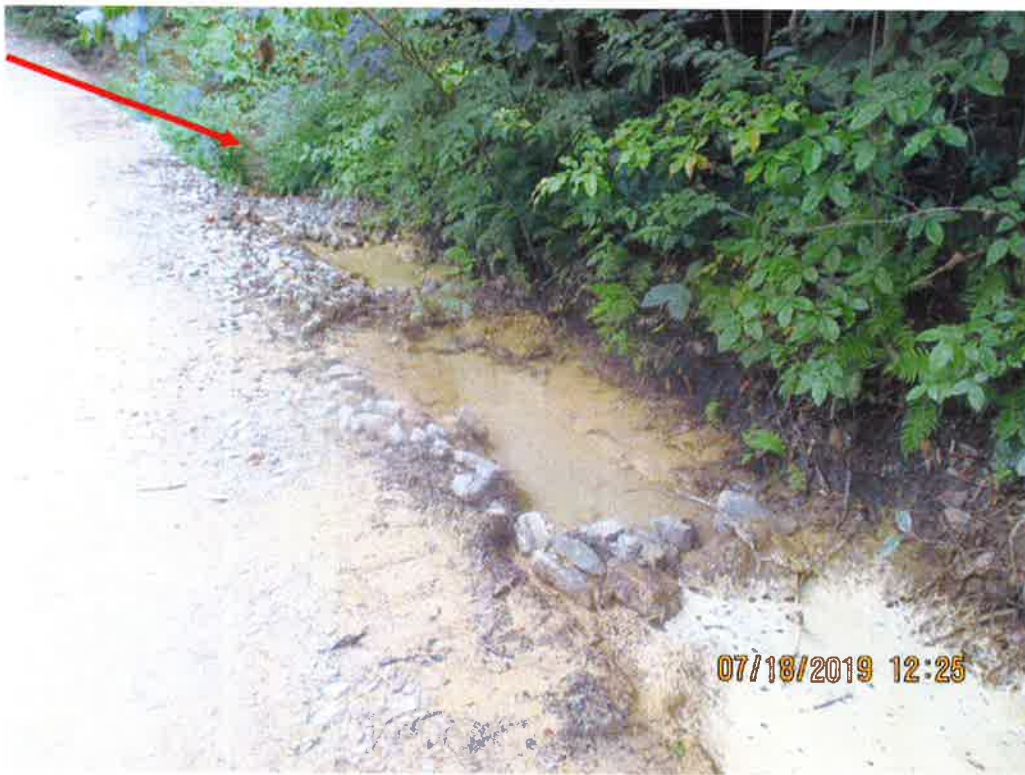
Standing downslope of Station No. 4559+96 on Access Road MVP-WB-119. Sediment deposits present in roadside ditch and conveying to culvert inlet. Arrow depicts approximate location of culvert inlet.

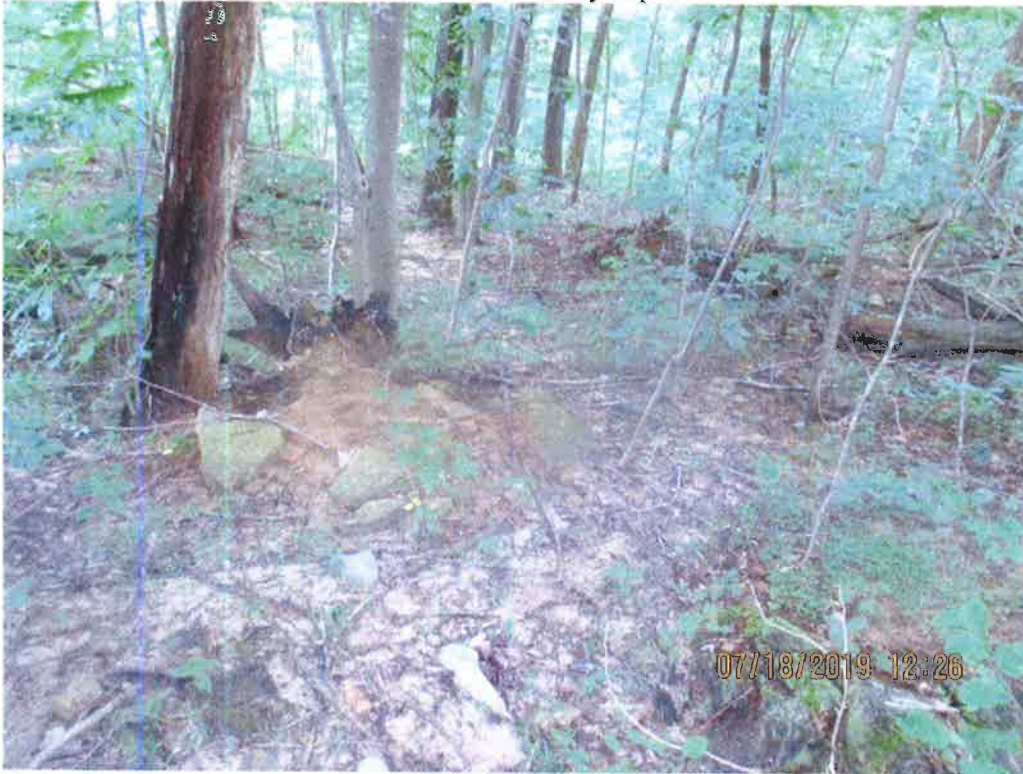
Downslope of culvert outlet. Significant sediment deposits present past controls and LOD.

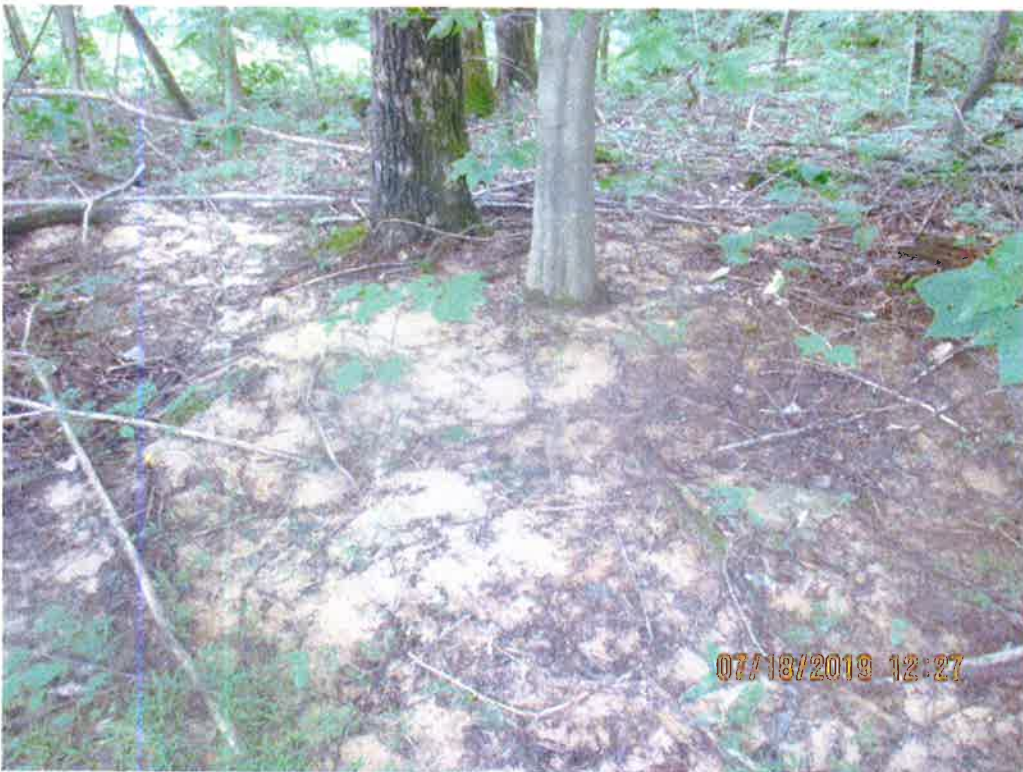
Downslope of culvert outlet. Significant sediment deposits present past controls and LOD.

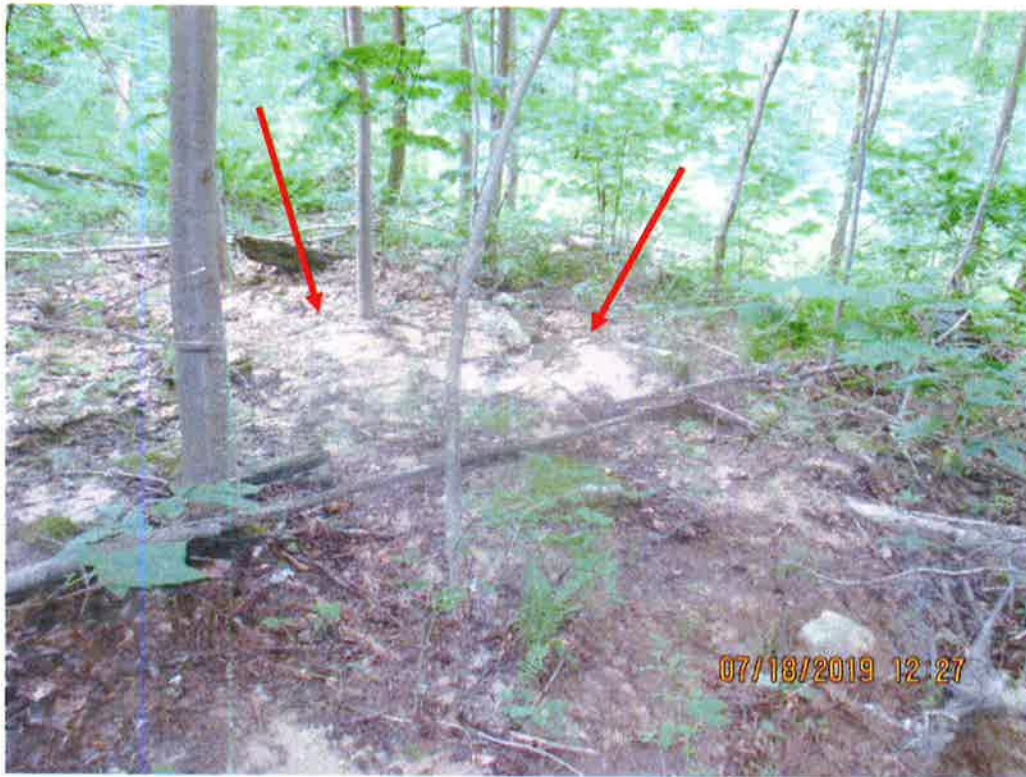
Downslope of culvert outlet. Significant sediment deposits present past controls and LOD. Arrow depicts examples of deposits observed.

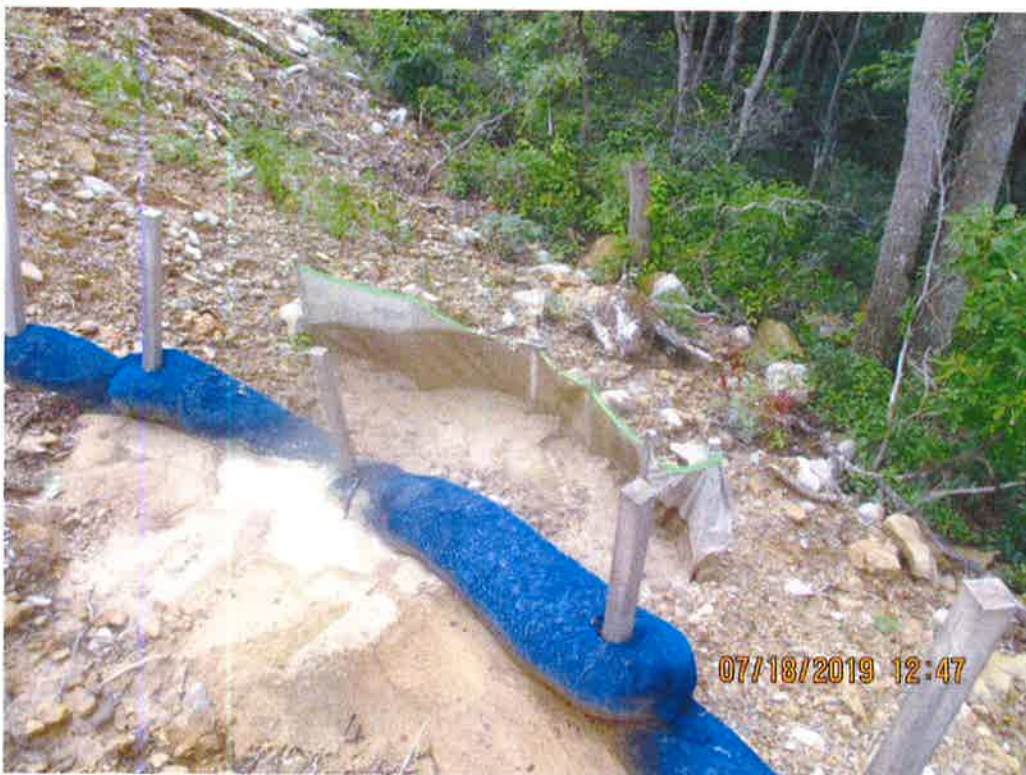
Waterbar outlet on opposite side of ROW at station no. 4559+96. Controls undercut and sediment deposits observed past controls and LOD.

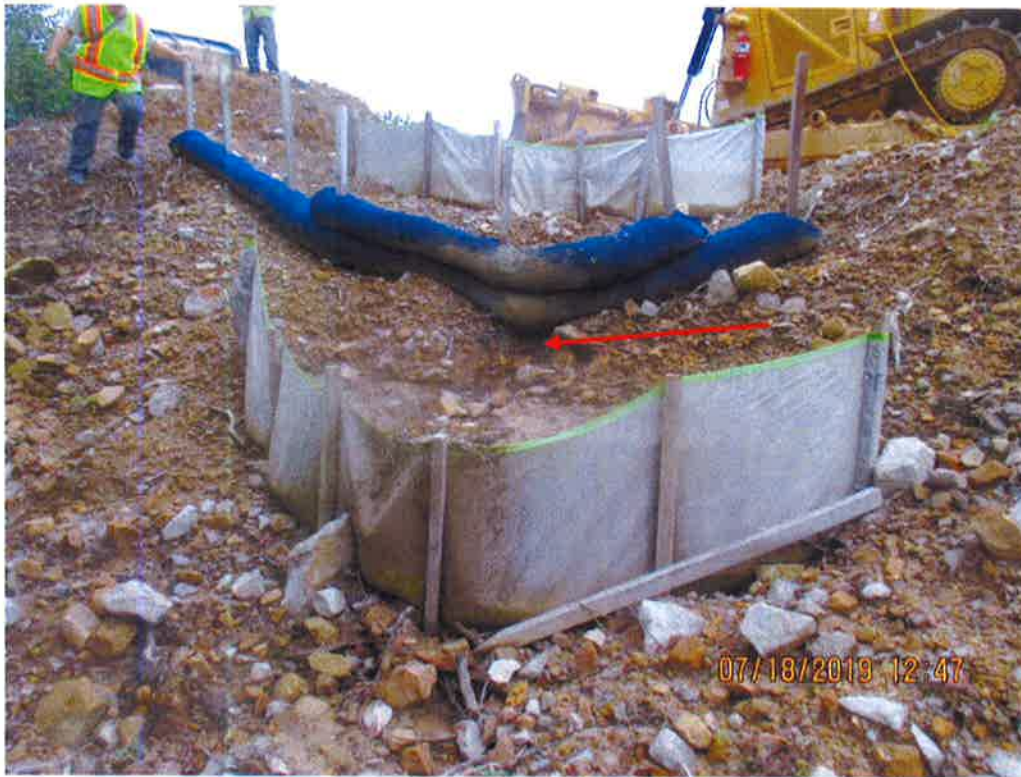
Waterbar outlet on opposite side of ROW at station no. 4559+96. Controls undercut and sediment deposits observed past controls and LOD. Arrow depicts undercut controls.

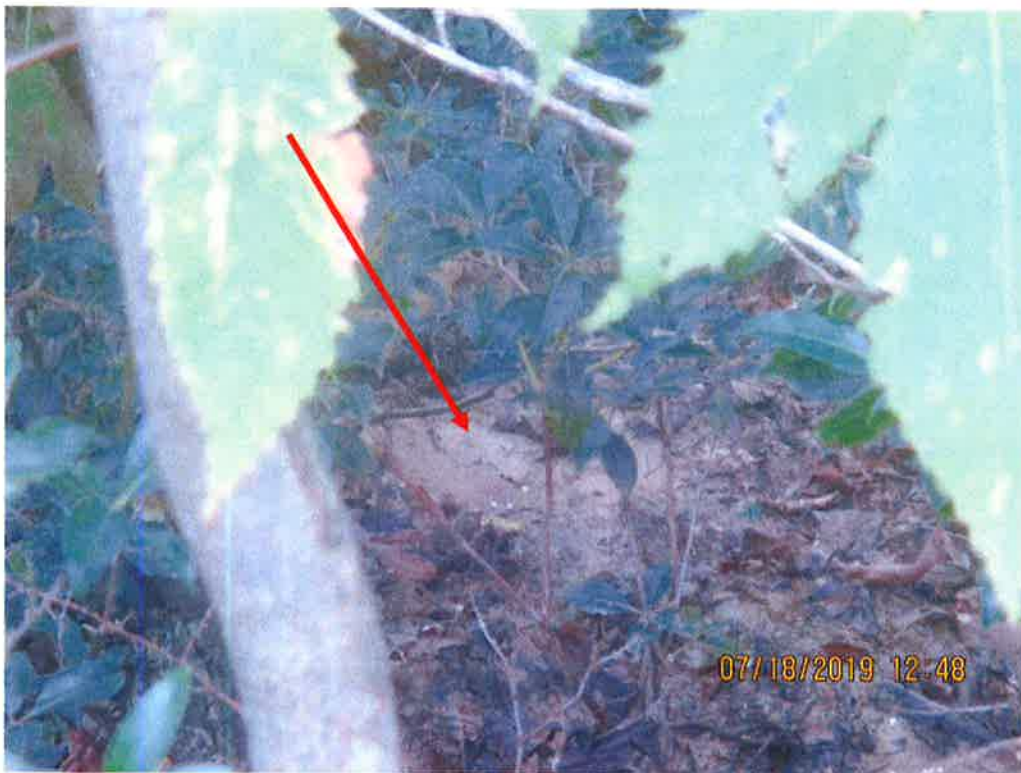
Waterbar outlet on opposite side of ROW at station no. 4559+96. Controls undercut and sediment deposits observed past controls and LOD.

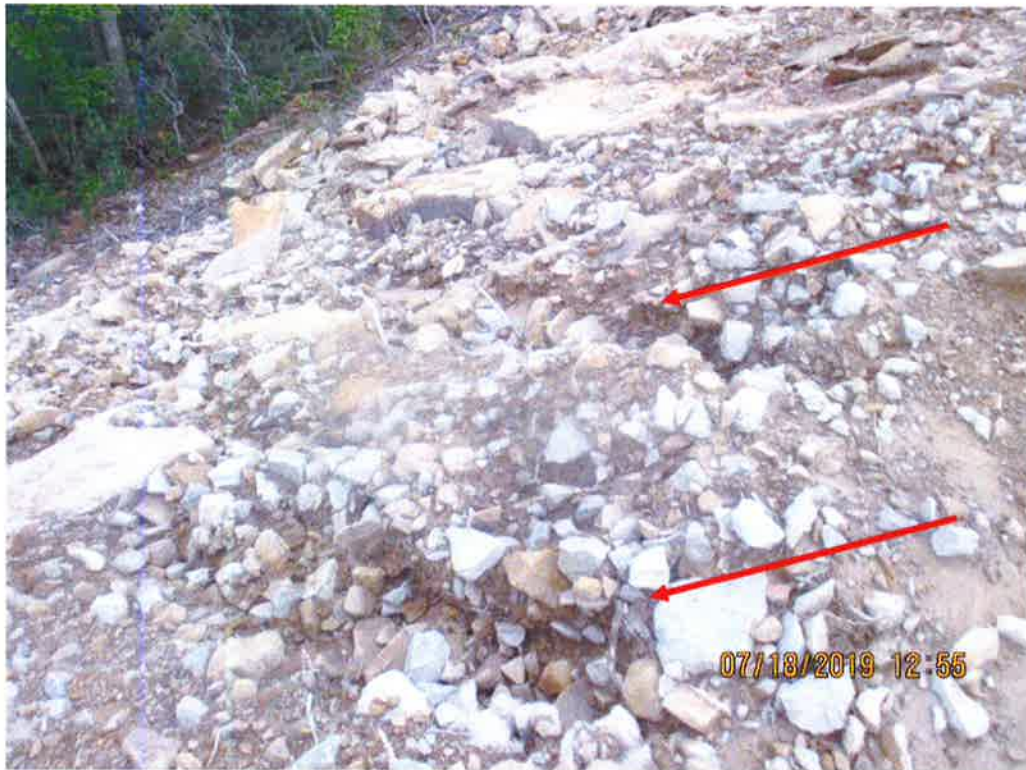
Near station No. 4559+96 erosion present on fill slope. Arrows depict erosion that was observed.

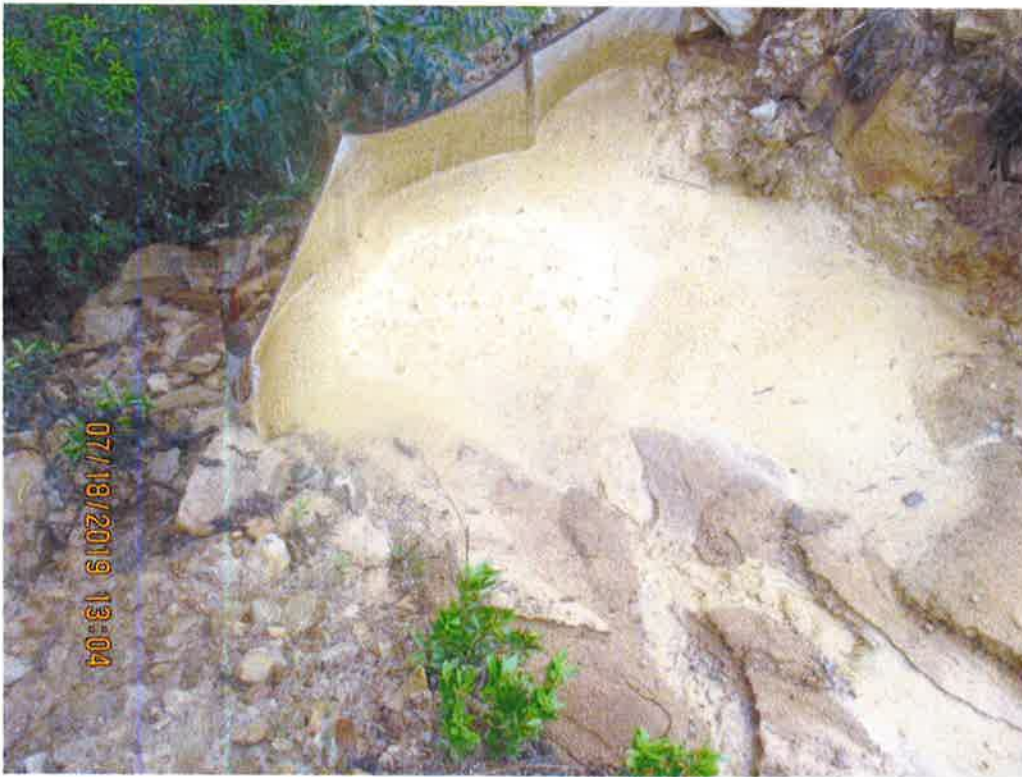
Above station No. 4539+00 during rain event. Sump full of sediment and in need of maintenance. Sediment laden water undercutting silt fence and flowing past LOD.

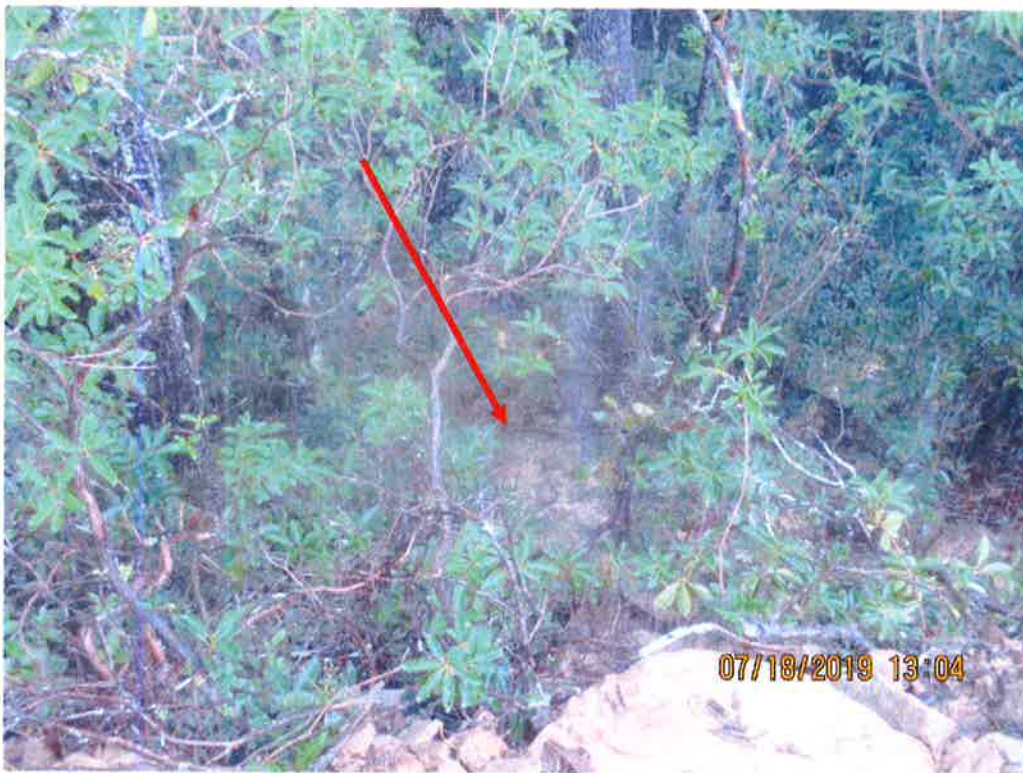
Above station No. 4539+00 during rain event. Sediment laden water undercutting silt fence and flowing past LOD. Arrow depicts SLW leaving site.

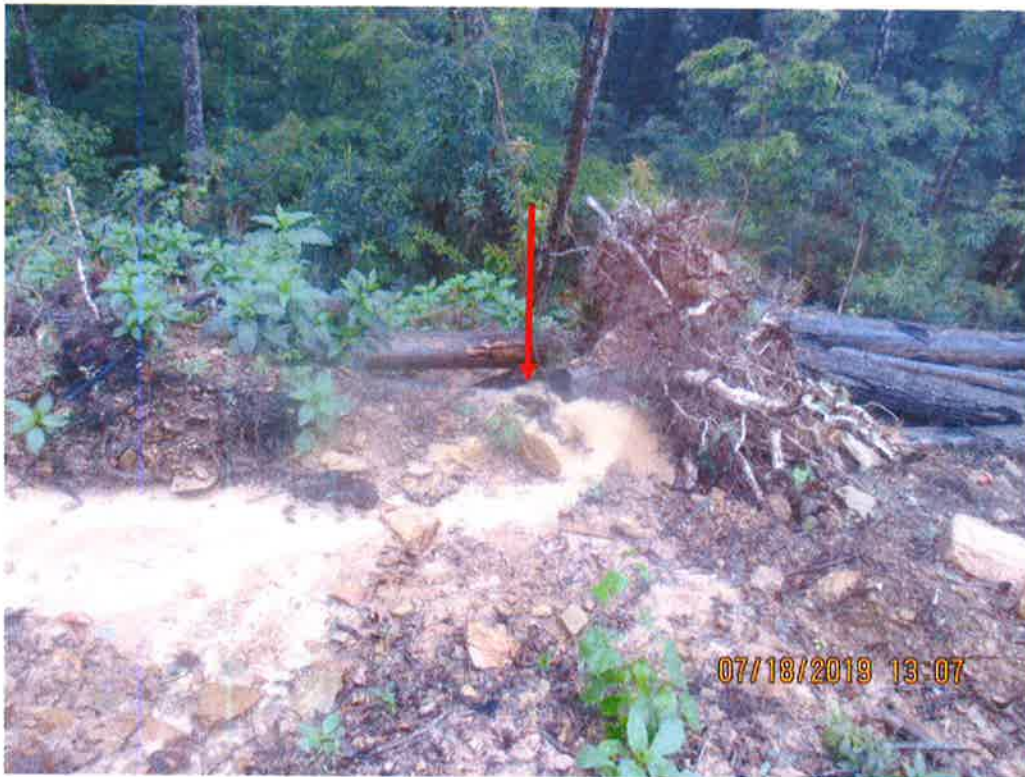
Sediment laden water flowing off ROW and through log pile during rain event. No perimeter controls were present at the base of the slope. Arrow depicts where SLW was flowing through log pile.

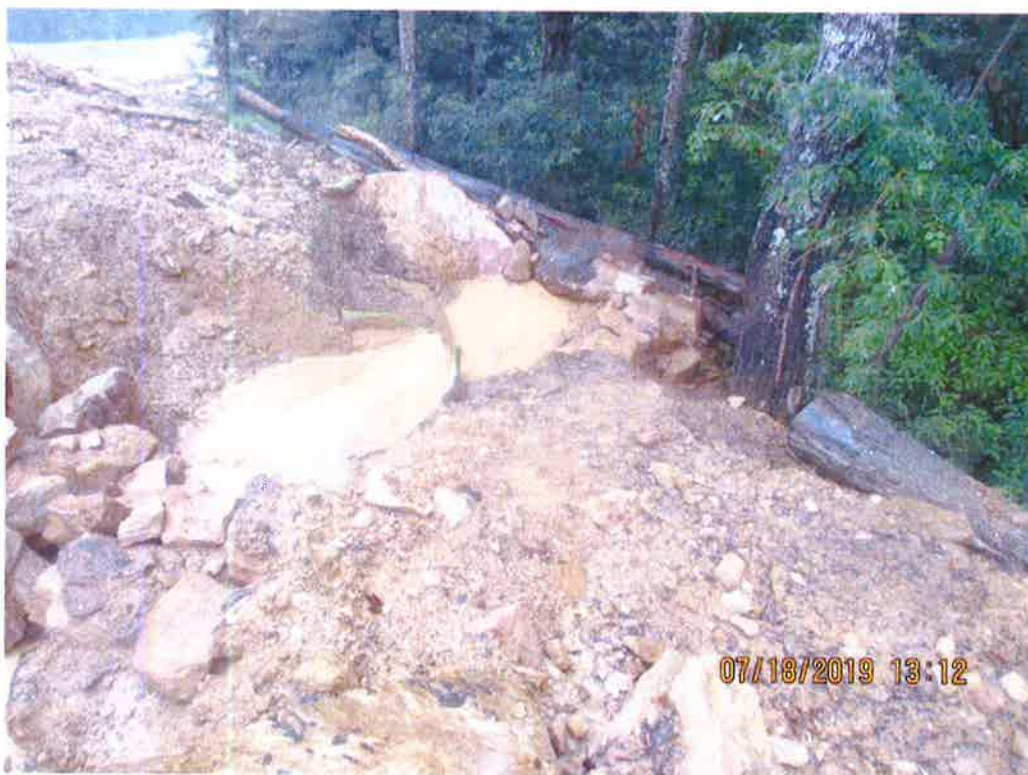
Waterbar terminating onto fill slope at station No. 4539+00. Large rocks installed as checks in eroded channel. SLW was flowing under and through these checks overwhelming controls.

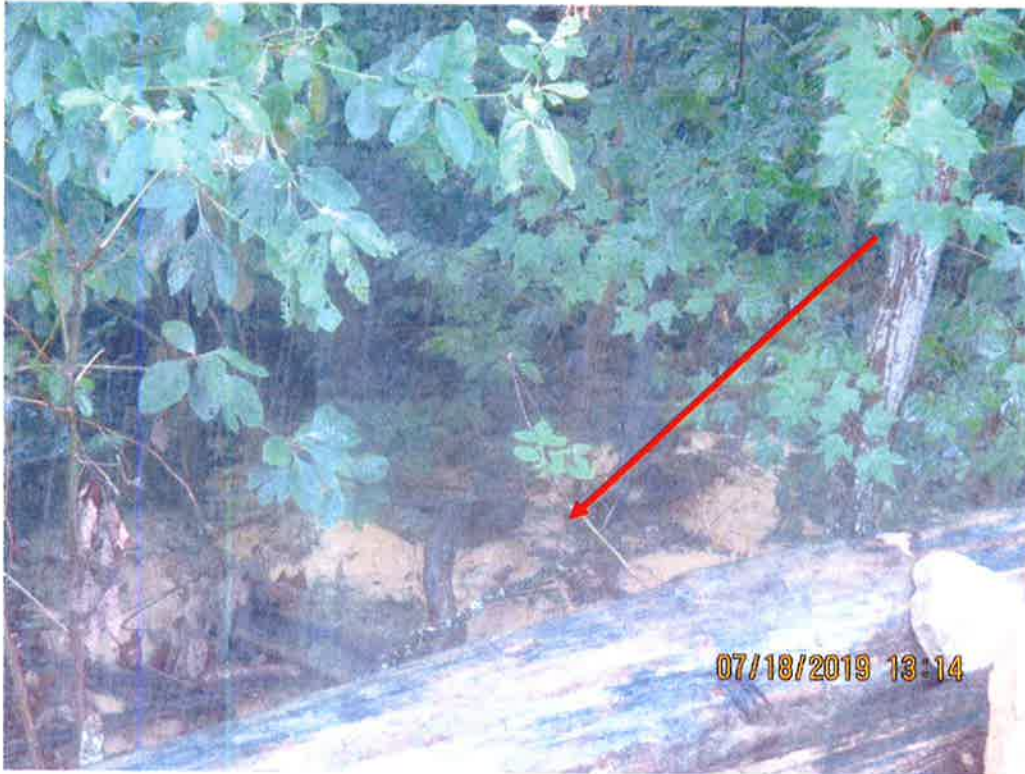
Downslope from Waterbar terminating onto fill slope at station No. 4539+00. SLW observed past controls and LOD conveying downslope.

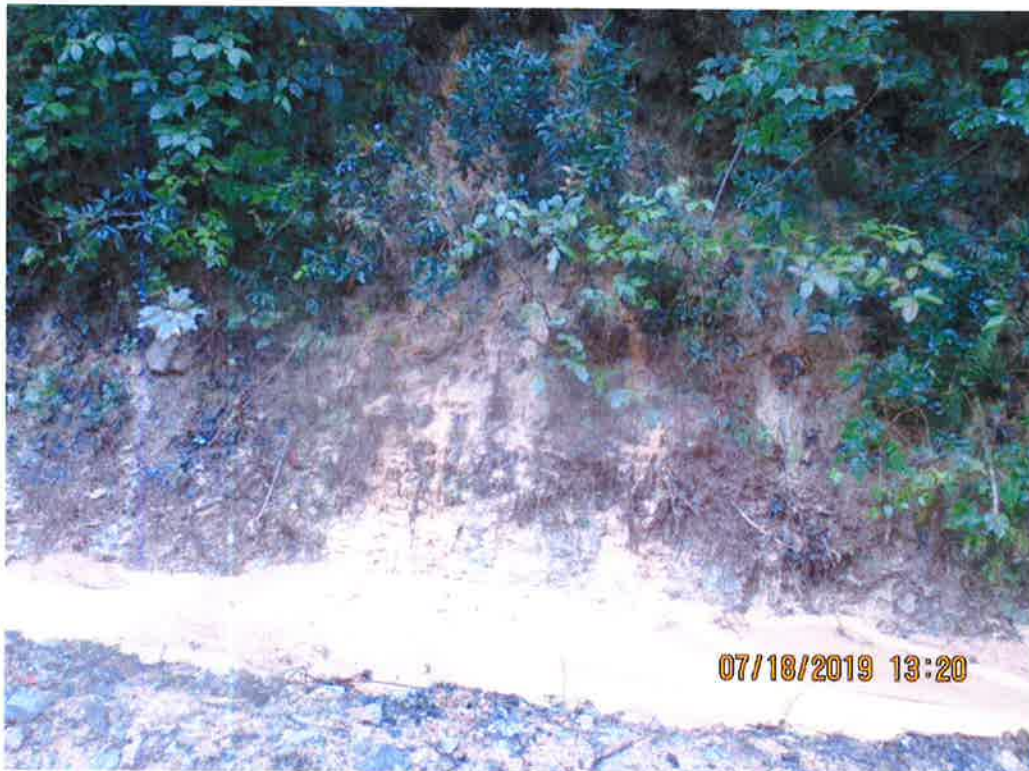
Downslope of failed controls post rain event along Access Road MVP-WB-119. SLW was entering/cascading into the ditch that conveys back downslope towards ROW crossing with access road.
