August 15, 2019

Re: Mountain Valley Pipeline, LLC
Docket No. CP16-10-000
Weekly Status Report No. 92

NOTICE OF VIOLATION

Violation No W19-51-024-JTL

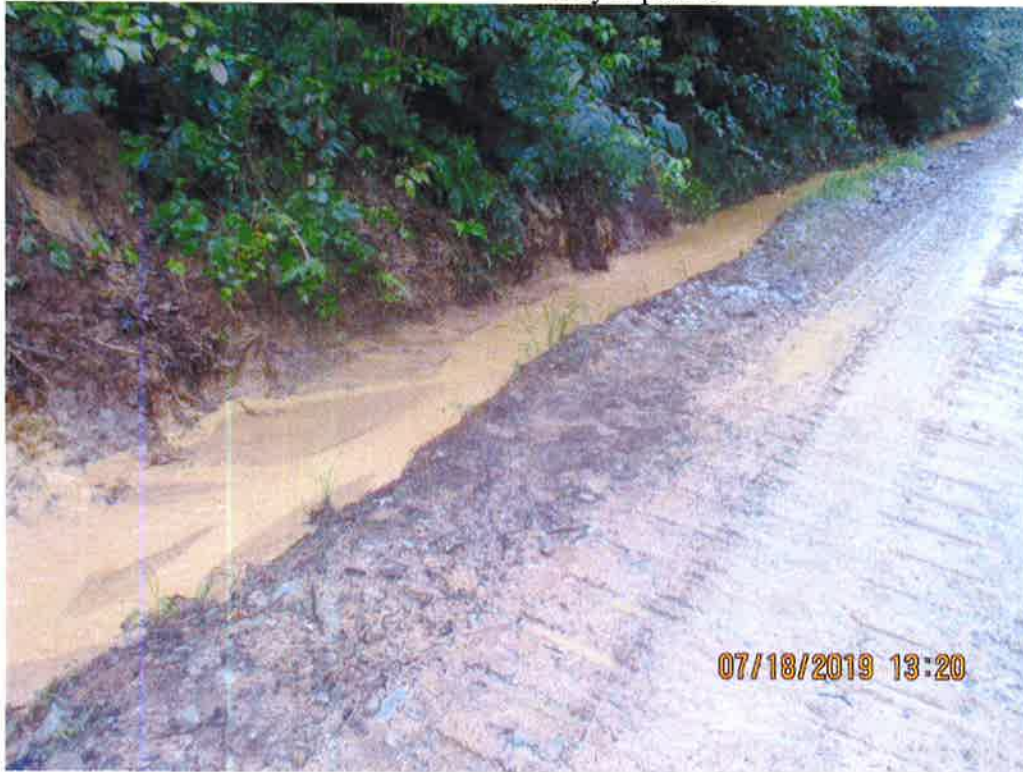
Downslope of failed controls post rain event along Access Road MVP-WB-119. SLW was entering/cascading into the ditch that conveys back downslope towards ROW crossing with access road.

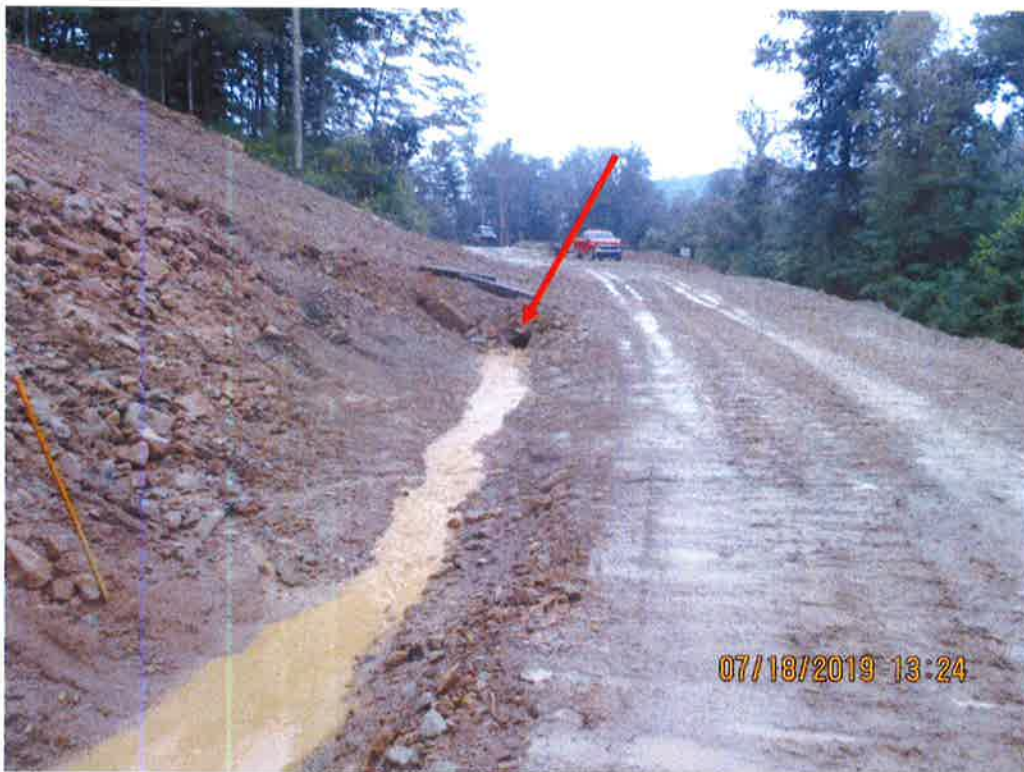
Downslope from where SLW was entering ditch. Arrow depicts culvert that conveys under ROW crossing. No controls present upslope of ditch below station No. 4539+00.

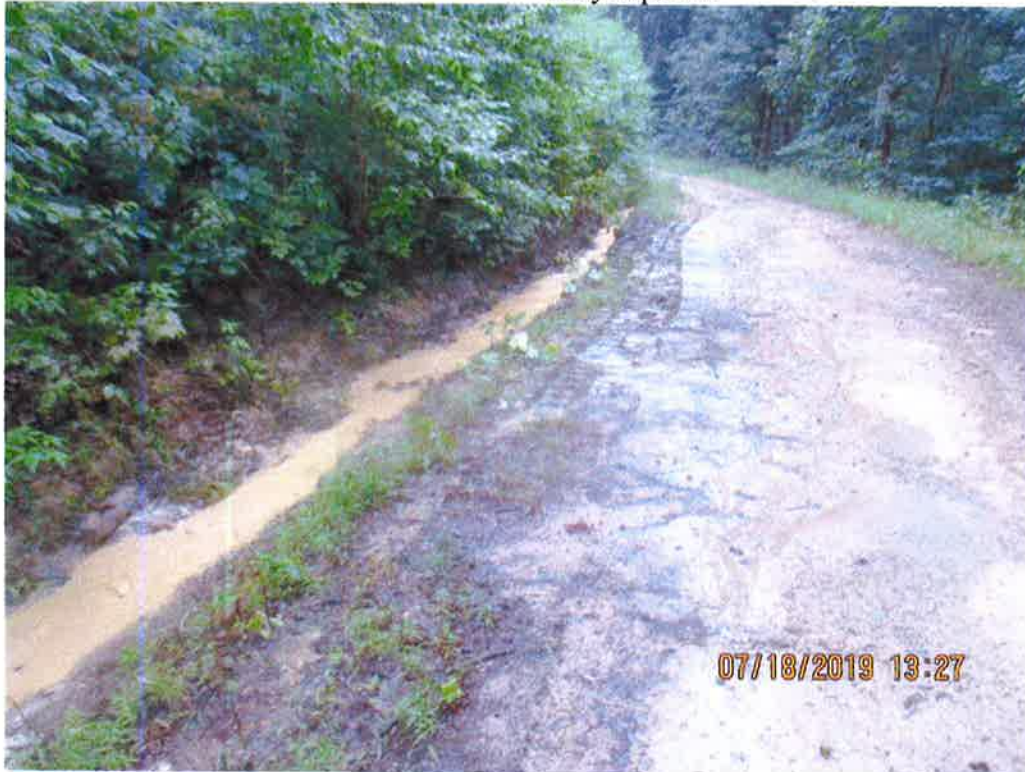
Approximately 200 feet downslope of ROW crossing with MVP-WB-119. SLW being conveyed to culvert.

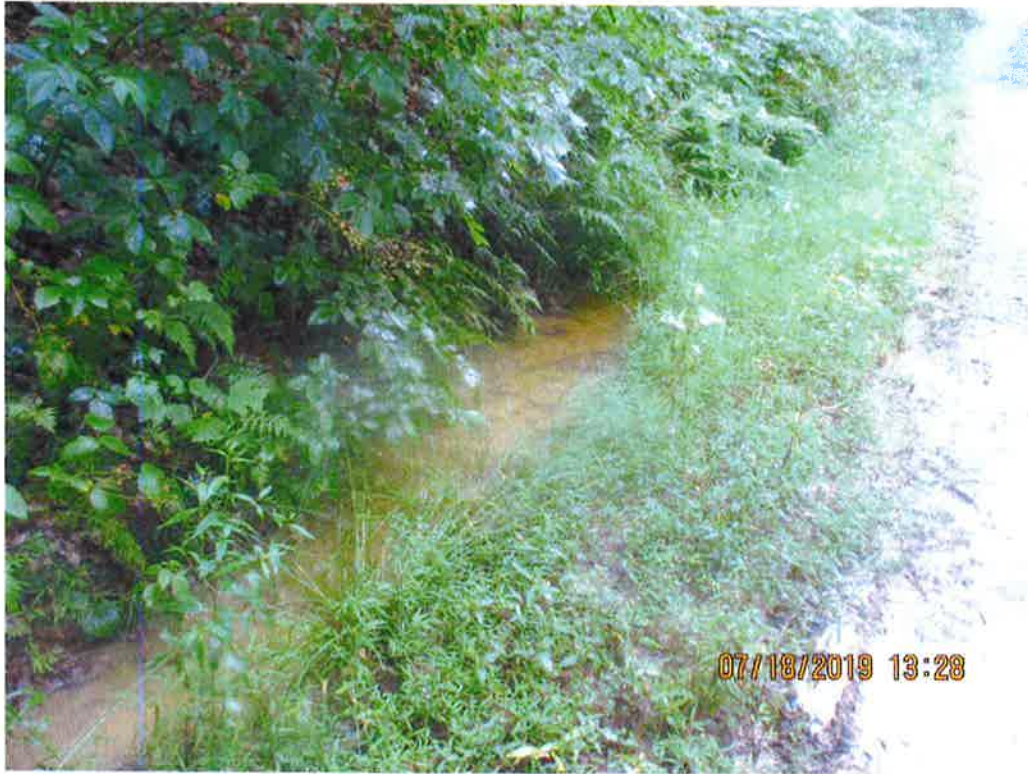
Upslope of culvert inlet receiving sediment laden water. Run-off present in ditch line distinguishably different than what was originating from upslope and entering culvert.

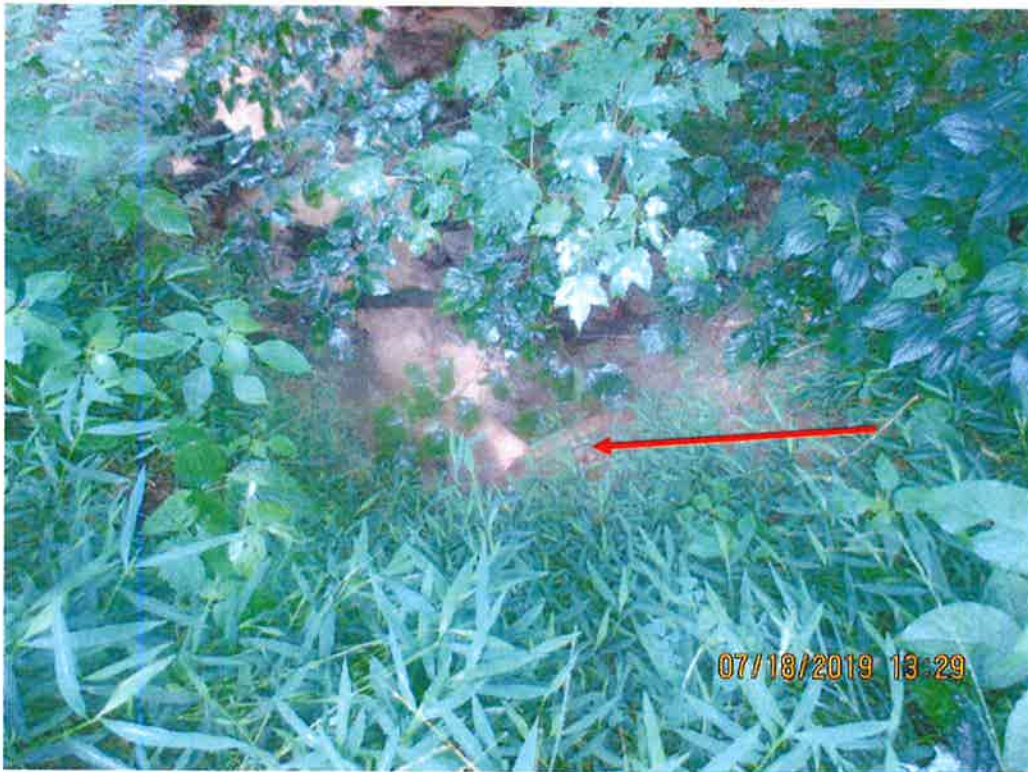
Culvert outlet conveying SLW downslope towards Fall Run a tributary of Holly River. Arrow depicts culvert.

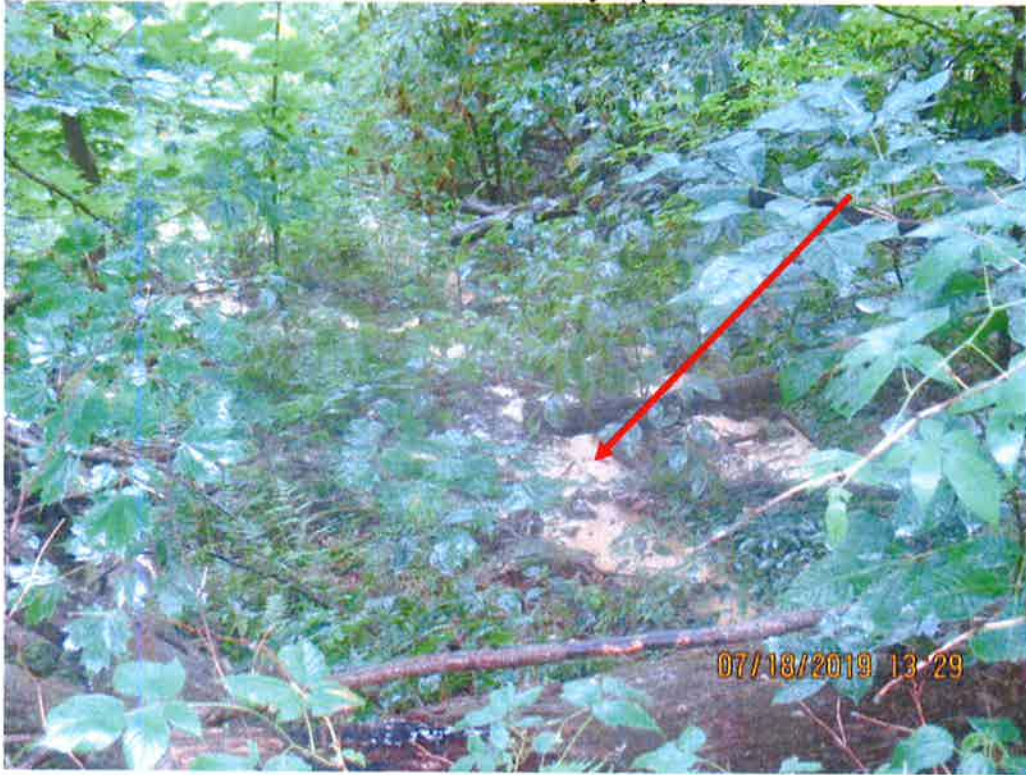
SLW conveying downslope towards Fall Run a tributary of the Holly River.

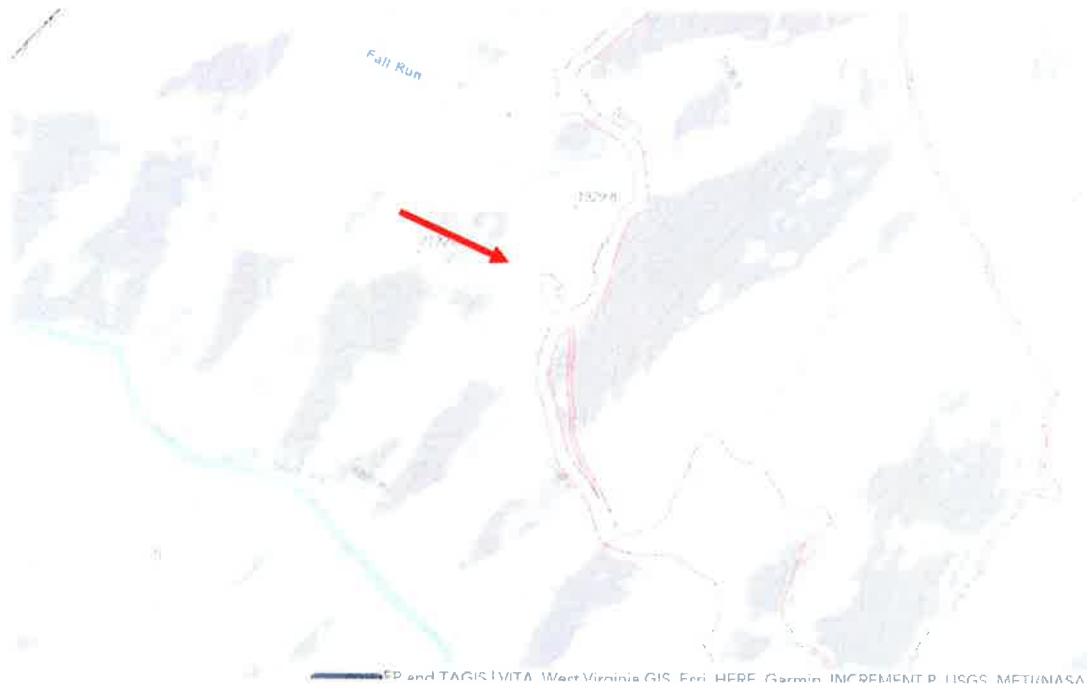
Arrow depicts where unapproved access road is located and SLW conveyed under road and towards Fall Run at 38.629N, 80.501W.

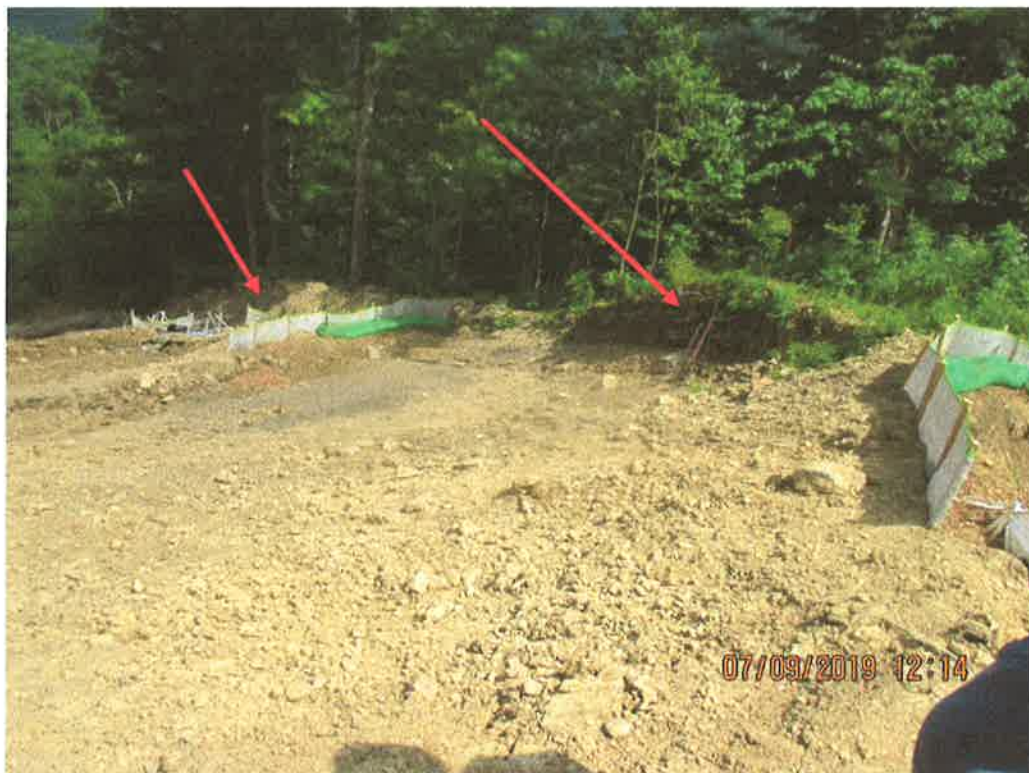
Standing above Stream S-T35A near station No. 8634+00 facing towards the East side of LOD. Arrows depict how the original cut to grade ROW created a wall preventing proper Waterbar outlet installation.

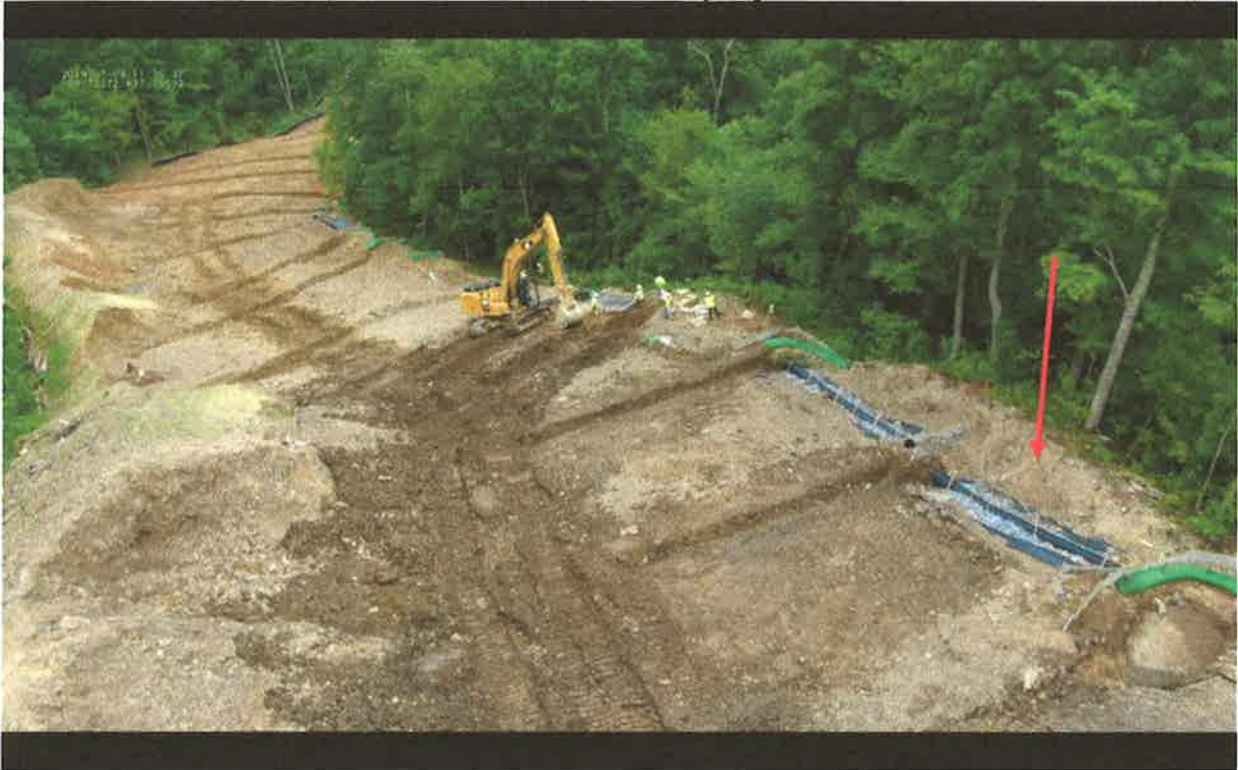
Overview of upper portion of slope near station No. 8634+00. Flume pipe system actively being maintained and enhanced during inspection. Arrow depicts cut original cut that created a “wall” effect not allowing for proper Waterbar outlets to be installed per SWPPP.

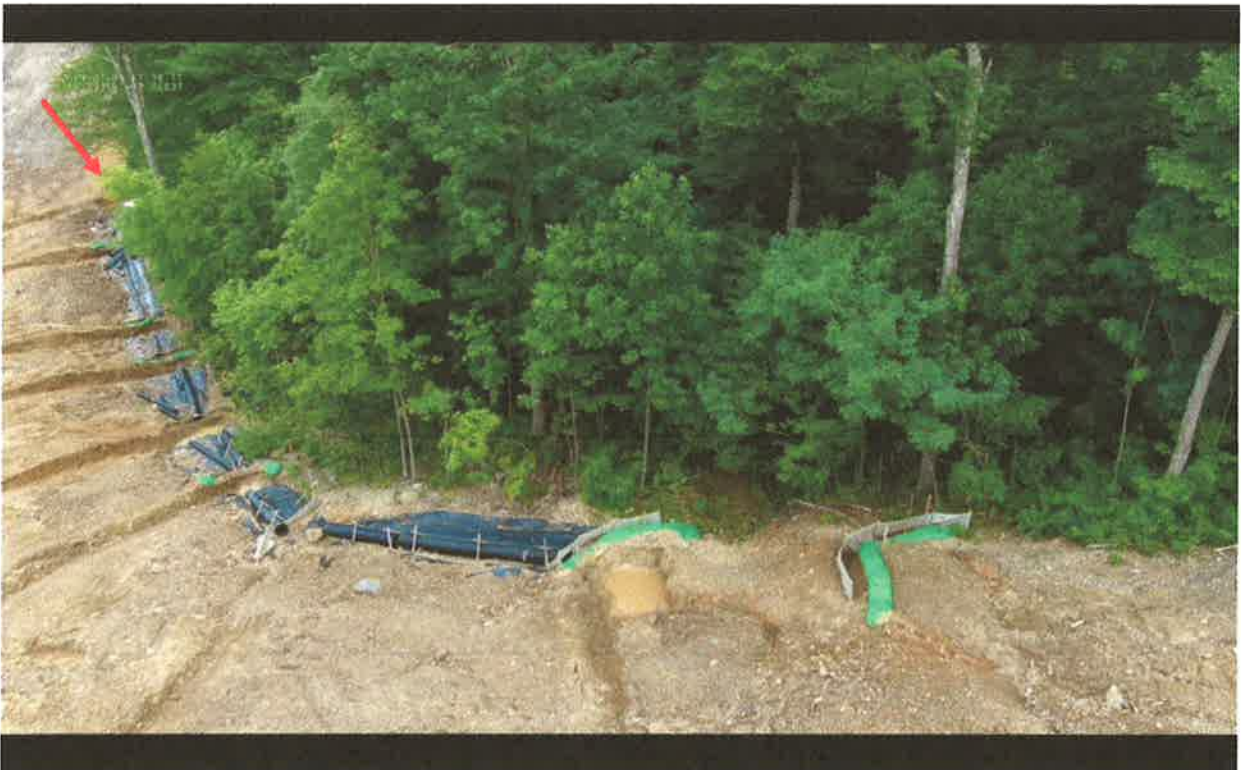
Lower Portion of Slope with flume pipe system. Arrow depicts where single outlet received concentrated flow from Run off and impacts occurred to East side of LOD.

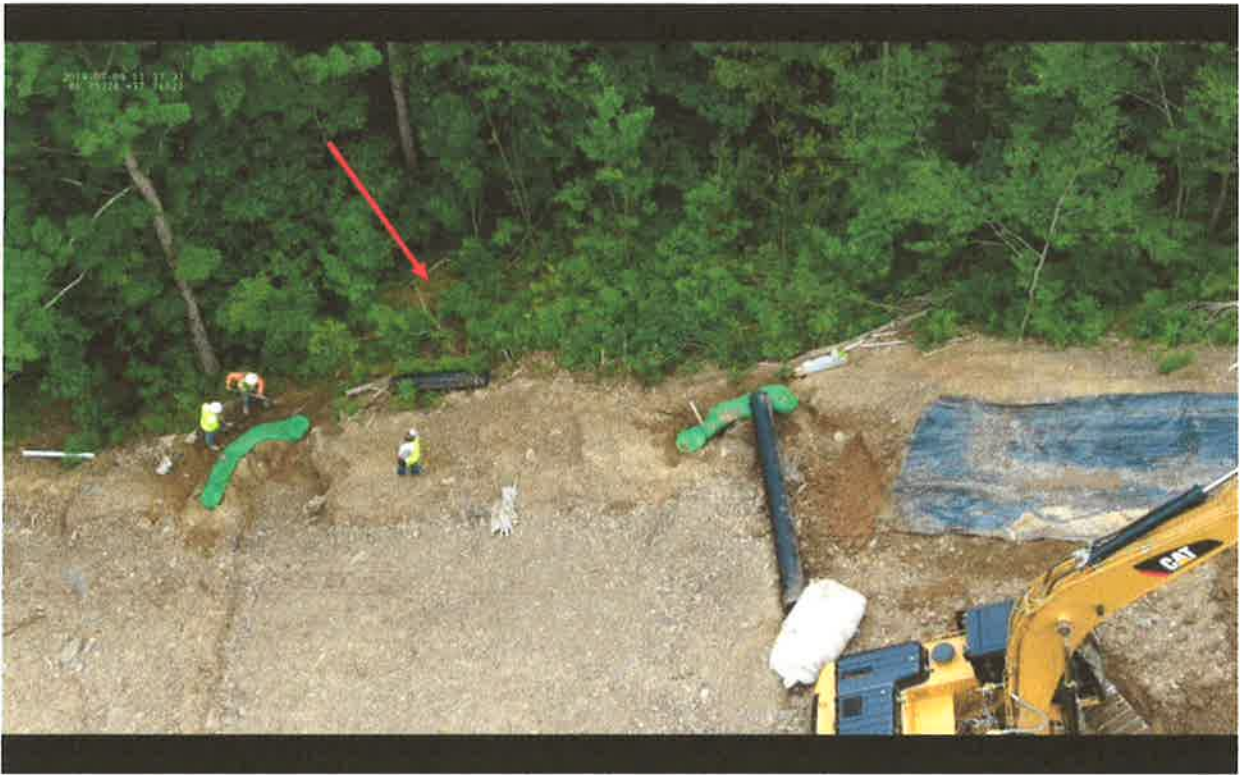
View above Stream S-T35A and station No. 8634+00 facing East side of LOD. Arrow depicts off site impacts observed.

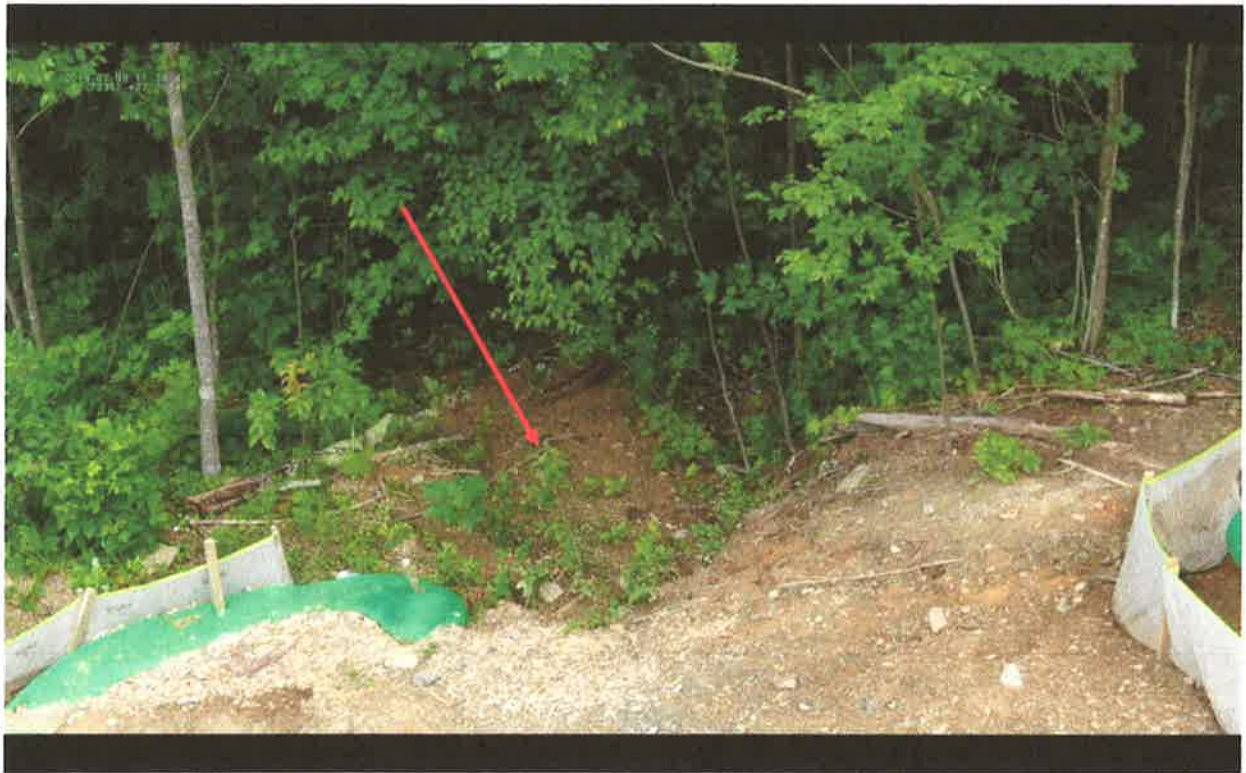
View above Stream S-T35A and station No. 8634+00 facing East side of LOD. Arrow depicts off site impacts observed.

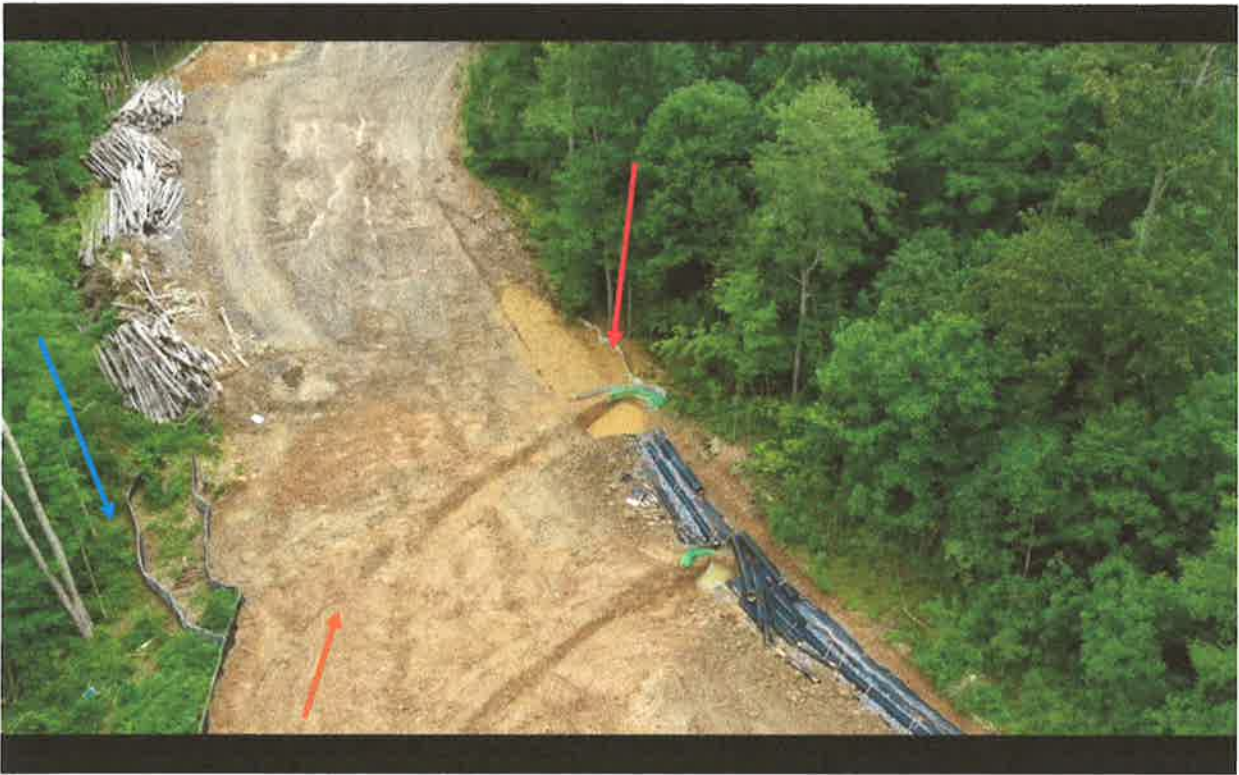
View of East and west side of MVP ROW and LOD. Red arrow depicts where last Waterbar at base of slope was overwhelmed and impacts occurred. Blue arrow depicts stream S-T35A. Orange arrow depicts where additional waterbars were installed to redirect run-off towards East side of LOD.

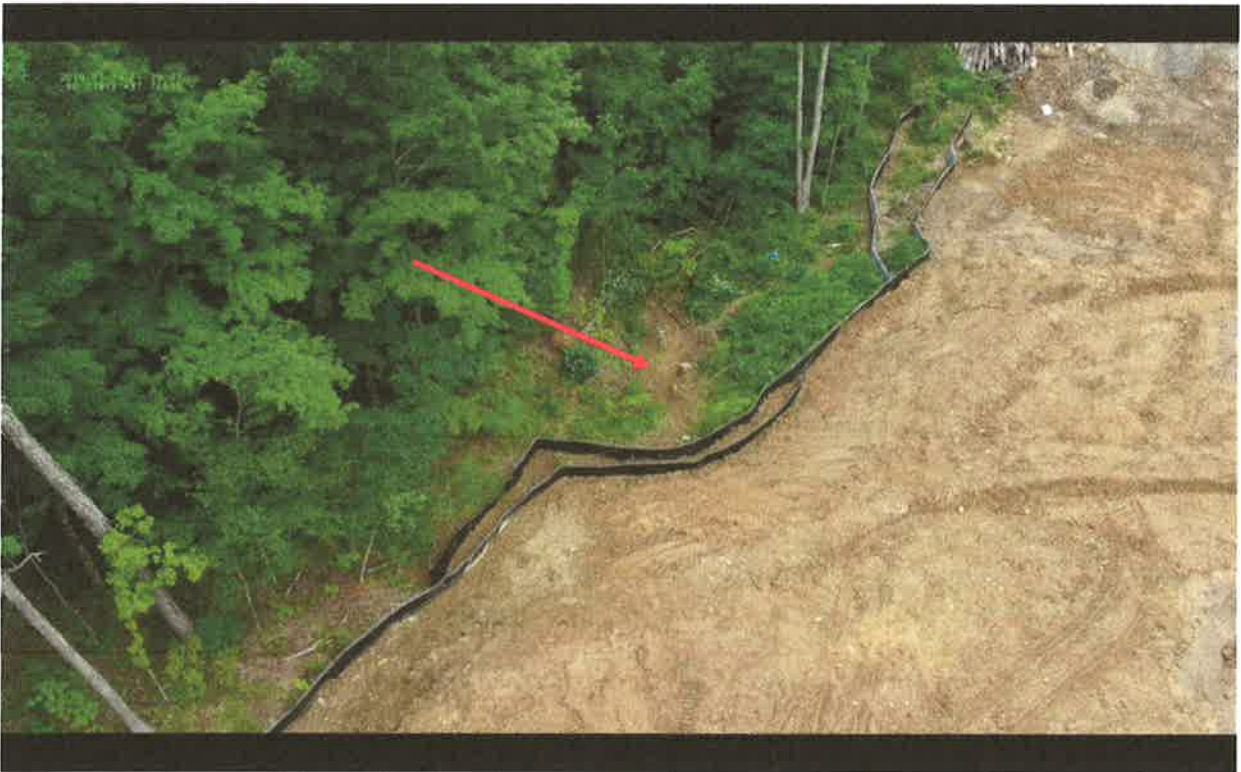
View of Stream S-T35A at station No. 8634+00 at the West side of the LOD. Arrow depicts additional super silt fence installed post impacts. Sediment deposits observed in Stream at time of inspection.

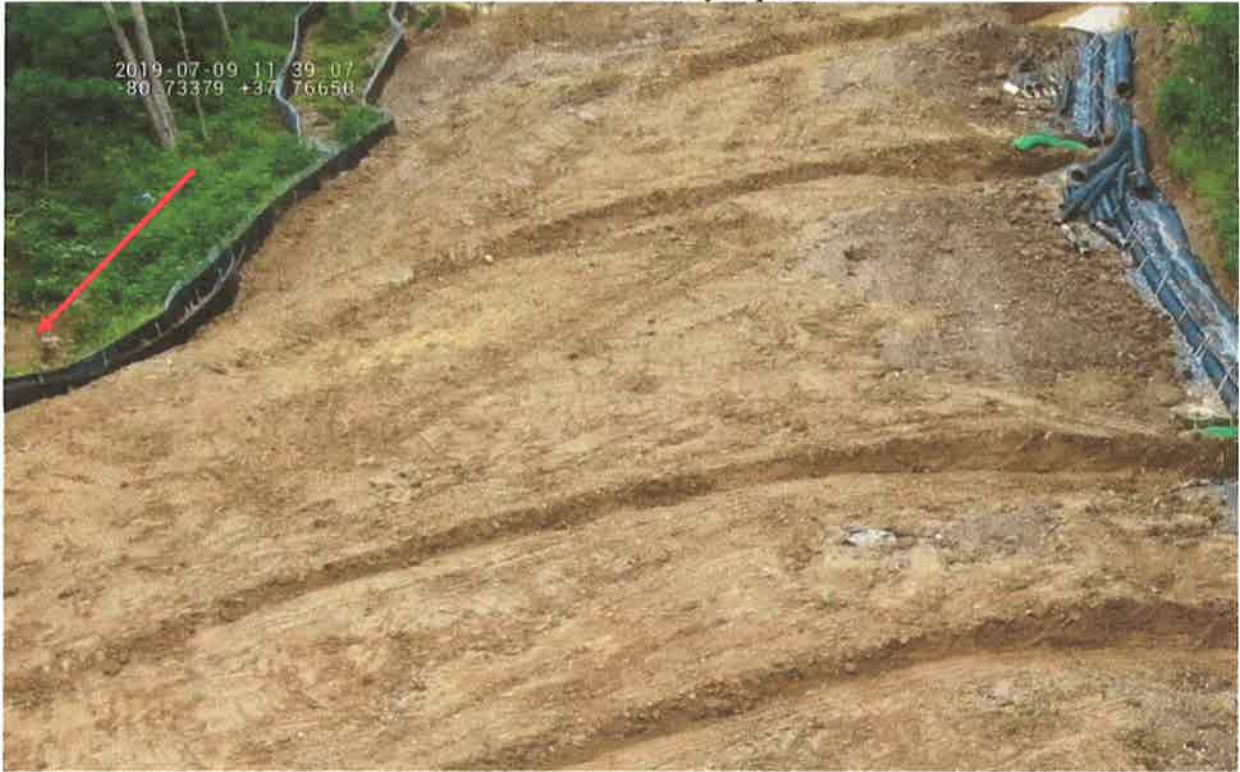
Close up view of additional waterbars added to re-direct run-off to East side of LOD. Arrow depicts deposits of sediment in stream S-T35A.

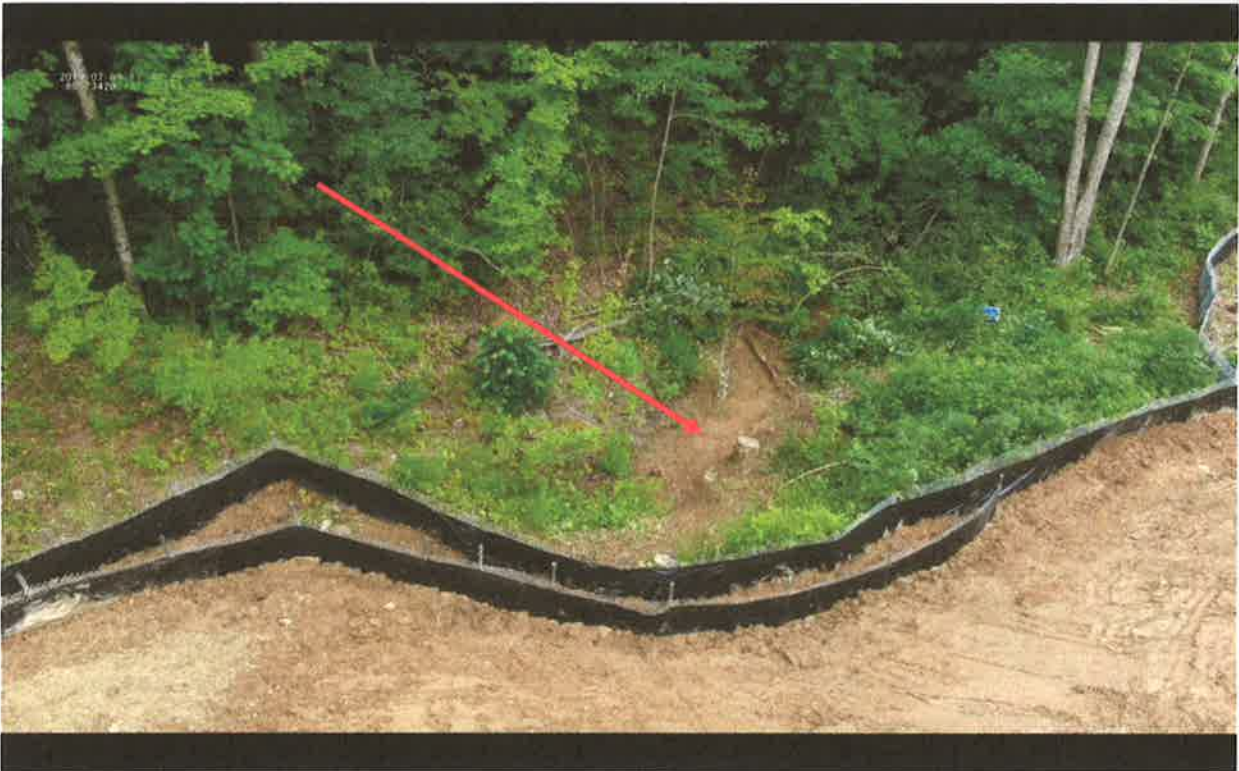
Close up view of additional waterbars added to re-direct run-off to East side of LOD. Arrow depicts photo of sediment deposits in stream S-T35A.
