Visual Site Inspection Report

Project Name	H-600 Pipeline Spread I	AFE	124300139	Spread	H-600 Pipeline Spread I
Contractor	Precision			Report #	13030
Inspector	Glenn Mike Renfro			Date/Time	1/16/2019 11:31 AM
Permit #	TBD	Inspection Type	VA SWPP	Station Begin	0000+00
State	VA	Inspection Area	Full	Station End	0000+00
County	Franklin	Ground	Frozen	Temperature (°F)	37.00
Municipality	N/A	Weather	Sunny	Rain Gauge (in)	0.50
GPS Location	36.9718527545243, -79.8699512522364			Rain Accumulation Time (days)	6.00

Project Name	Transco Interconnect Station		AFE	124300113	Spread	Transco Interconnect Station	
Contractor	MEC				Report #	13025	
Inspector	Dave Burkhart				Date/Time	1/16/2019 9:01 AM	
Permit #	TBD	Inspection Type	VA SWPP		Station Begin	0+00	
State	VA	Inspection Area	Full		Station End	0+00	
County	Pittsylvania	Ground	Frozen		Temperature (°F)	33.00	
Municipality	Chatham	Weather	Sunny		Rain Gauge (in)	0.00	
GPS Location	36.8347817943505, -79.3421161027197				Rain Accumulation Time (days)	1.00

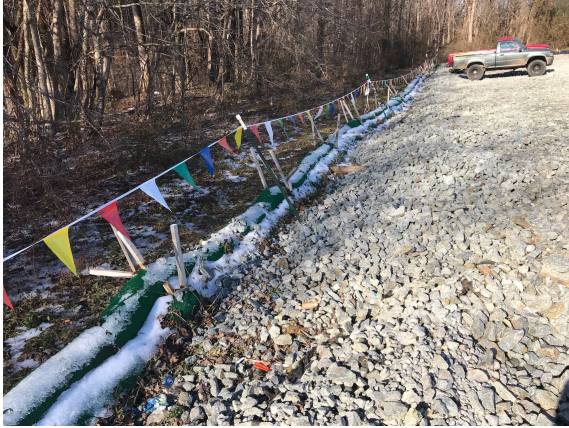
GPS Location	36.9717453230264, -79.8698677406979	GPS Location	36.9720147690149, -79.8699417897313		
Description	Perimeter ECD's in good condition near employee parking in gravel yard.	Description	Perimeter ECD's in good condition on south end of paved yard.

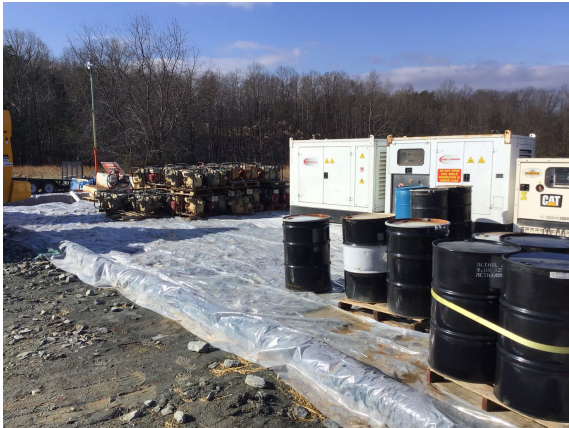
GPS Location	36.9719760027127, -79.8699528538434	GPS Location	36.9721641764389, -79.8699142132698		
Description	Secondary containment structure for drums and equipment in compliance.	Description	Perimeter ECD's in good condition but supplies have fallen outside the LOD.		
Insert image here		Insert image here			
GPS Location		GPS Location			
Description		Description

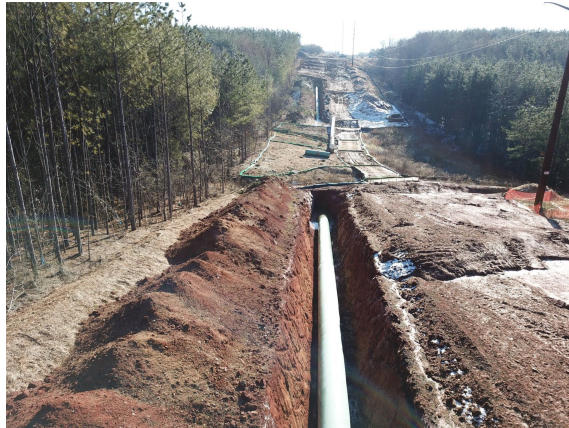
GPS Location	36.9557664078073, -79.5821418520804	GPS Location	36.9557664078073, -79.5821418520804		
Description	Sweeping Armstrong Rd #2 sta 15619+50	Description	Cleanup crew preparing ROW for seed and mulch sta 15261+61

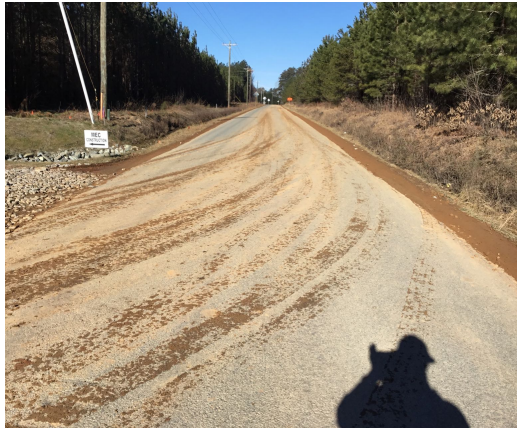
GPS Location		36.8347998289734, -79.3422485143685		GPS Location		36.8347998289734, -79.3422485143685	
Description		Transco Road at site entrance		Description		Banks of sediment basin

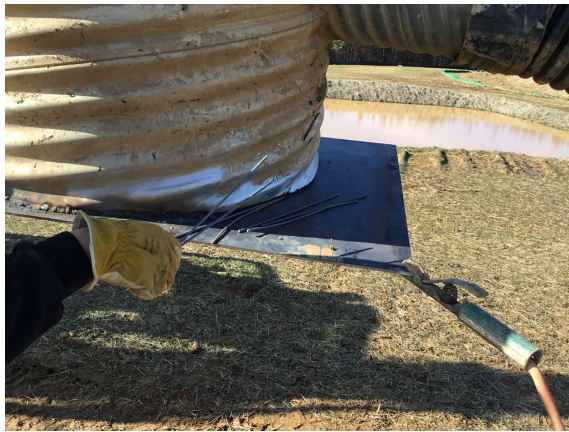
GPS Location		36.8347816723143, -79.3421162101964		GPS Location		36.8347049877391, -79.342278773039	
Description		Welding plate onto bottom of riser in sediment basin		Description		Waterproof seal around welded plate at bottom of riser

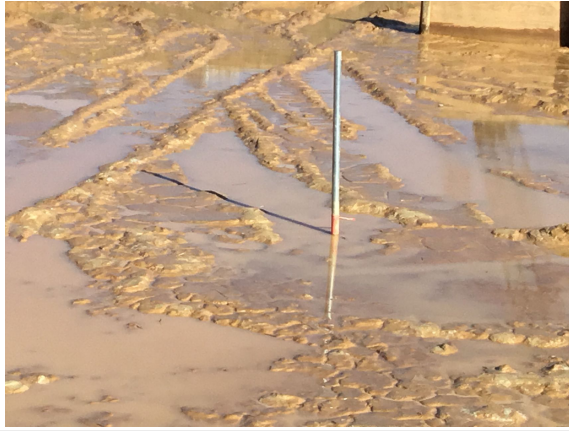
GPS Location		36.8347817775587, -79.3421161263081		GPS Location		36.8347814245905, -79.3421166106837	
Description		Clean out stake in sediment basin. Orange paint is clean out level.		Description		Replaced riser after installing bottom plate.
