Visual Site Inspection Report

Project Name	H-600 Pipeline Spread I		AFE	124300139	Spread	H-600 Pipeline Spread I	
Contractor	Precision				Report #	13419	
Inspector	Glenn Mike Renfro				Date/Time	1/28/2019 10:59 AM	
Permit #	TBD	Inspection Type	VA SWPP		Station Begin	0000+00	
State	VA	Inspection Area	Full		Station End	0000+00	
County	Franklin	Ground	Dry		Temperature (°F)	34.00	
Municipality	N/A	Weather	Sunny		Rain Gauge (in)	1.00	
GPS Location	36.9719275915588, -79.8700970176575				Rain Accumulation Time (days)	6.00

Project Name	H-600 Pipeline Spread I	AFE	124300139	Spread	H-600 Pipeline Spread I
Contractor	Precision			Report #	13574
Inspector	Glenn Mike Renfro			Date/Time	2/1/2019 11:29 AM
Permit #	TBD	Inspection Type	VA SWPP	Station Begin	0000+00
State	VA	Inspection Area	Full	Station End	0000+00
County	Franklin	Ground	Frozen	Temperature (°F)	29.00
Municipality	N/A	Weather	Cloudy	Rain Gauge (in)	0.10
GPS Location	36.9720648089768, -79.870078582391			Rain Accumulation Time (days)	4.00

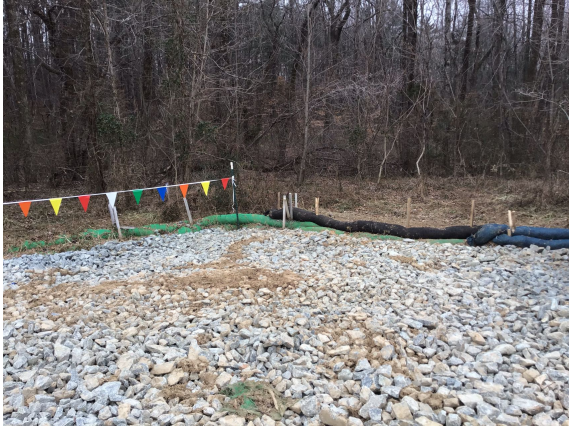
GPS Location	36.9717640767007, -79.8699857508764	GPS Location	36.9720275933267, -79.8700059112905		
Description	Issue from last inspection at northwest corner of employee parking was addressed.	Description	Issue from last inspection, materials beyond LOD was addressed.

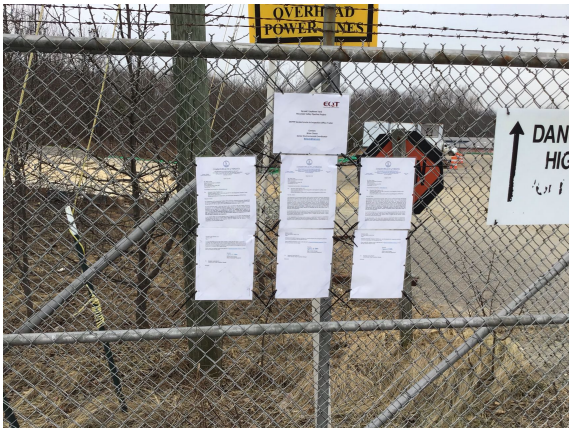
GPS Location	36.9721156871291, -79.8698541150241	GPS Location	36.9721135078342, -79.8701081705092		
Description	Construction permits posted at main entrance as required.	Description	Potential issue with hydraulic fluid container need to be placed in containment.

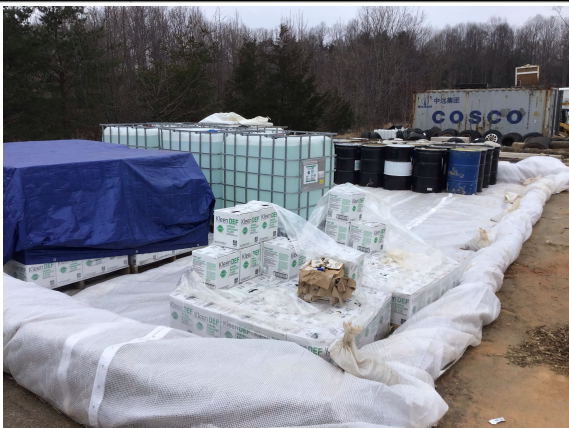
GPS Location	36.9719884079294, -79.870060058385	GPS Location	36.9717056025164, -79.8699619901179		
Description	Issue from last inspection, secondary containment structure repaired and BlueDef placed in containment.	Description	Issue from last inspection needs to be addressed at southwest corner of paved yard, rock and soil beyond LOD.

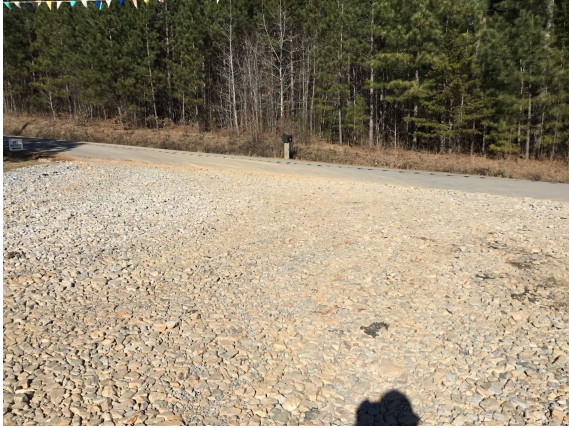
GPS Location	36.8347964762122, -79.3423947785789	GPS Location	36.8347964762122, -79.3423947785789		
Description	RCE at entrance	Description	Transco road and RCE

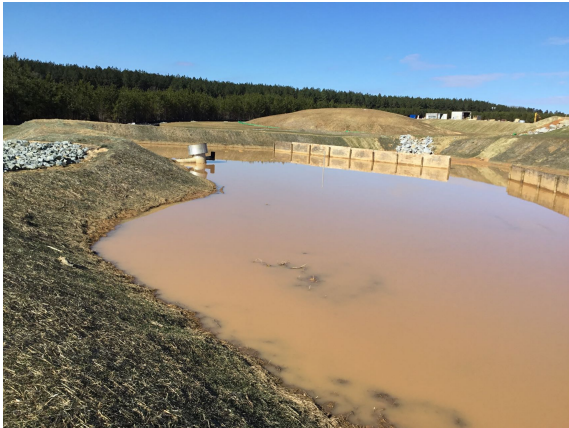
GPS Location	36.8347820178788, -79.3421138172171	GPS Location	36.8347175186843, -79.3424032443011		
Description	Sediment basin #1 and riser	Description	Water exiting riser from sediment basin #1

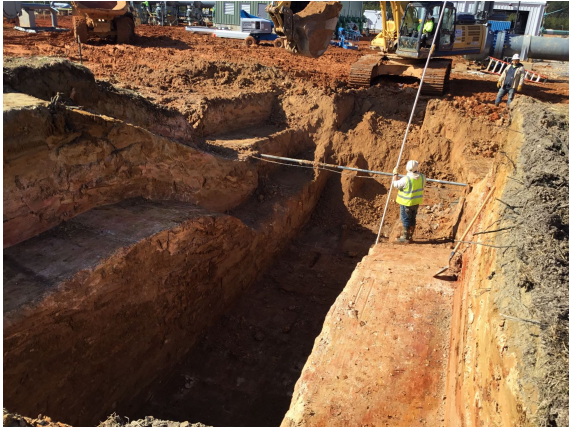
GPS Location	36.834782001546, -79.3421138311369	GPS Location	36.8347817479452, -79.3421140187855		
Description	Excavating on the pad for pipeline h603 receiver	Description	SSF and temp vegetation along west LOD

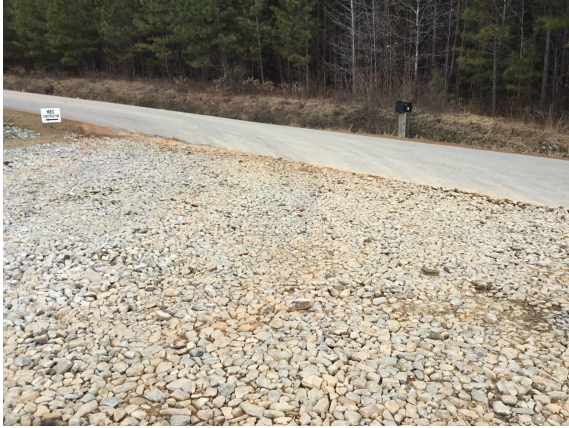
GPS Location	36.8349001603544, -79.3421647791558	GPS Location	36.8349001603544, -79.3421647791558		
Description	RCE and Transco Road	Description	Containment for sandblasting

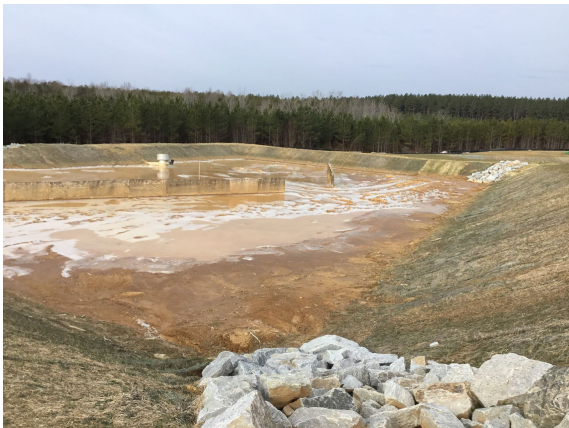
GPS Location	36.8348520901397, -79.342170562669	GPS Location	36.8348520901397, -79.342170562669		
Description	Sediment basin	Description	Riser in sed basin
