# Visual Site Inspection Report

<b>Project Name</b>	H-600 Pipeline Spread I	<b>AFE</b>	124300139	<b>Spread</b>	H-600 Pipeline Spread I
<b>Contractor</b>	Precision			<b>Report #</b>	12837
<b>Inspector</b>	Glenn Mike Renfro			<b>Date/Time</b>	1/10/2019 12:05 PM
<b>Permit #</b>	TBD	<b>Inspection Type</b>	VA SWPP	<b>Station Begin</b>	0000+00
<b>State</b>	VA	<b>Inspection Area</b>	Full	<b>Station End</b>	0000+00
<b>County</b>	Franklin	<b>Ground</b>	Dry	<b>Temperature (°F)</b>	34.00
<b>Municipality</b>	N/A	<b>Weather</b>	Sunny	<b>Rain Gauge (in)</b>	0.00
<b>GPS Location</b>	36.9717145668289, -79.8698324666216			<b>Rain Accumulation Time (days)</b>	6.00

<b>Project Name</b>	Transco Interconnect Station		<b>AFE</b>	124300113	<b>Spread</b>	Transco Interconnect Station	
<b>Contractor</b>	MEC				<b>Report #</b>	12833	
<b>Inspector</b>	Dave Burkhart				<b>Date/Time</b>	1/10/2019 10:28 AM	
<b>Permit #</b>	TBD	<b>Inspection Type</b>	VA SWPP		<b>Station Begin</b>	0+00	
<b>State</b>	VA	<b>Inspection Area</b>	Full		<b>Station End</b>	0+00	
<b>County</b>	Pittsylvania	<b>Ground</b>	Frozen		<b>Temperature (°F)</b>	34.00	
<b>Municipality</b>	Chatham	<b>Weather</b>	Sunny		<b>Rain Gauge (in)</b>	0.00	
<

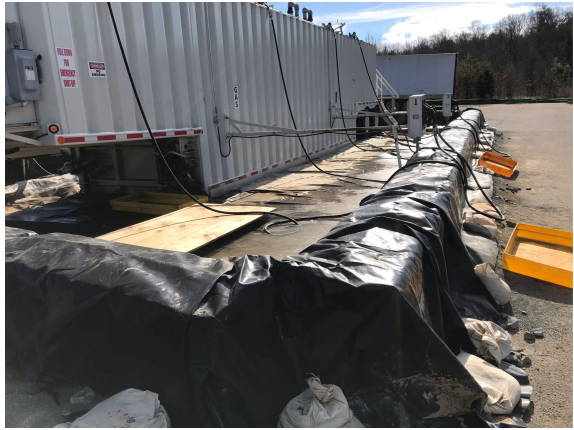
GPS Location	36.9717103547774, -79.8698285556278		GPS Location	36.9720505597414, -79.8699809332191	
Description	Secondary containment structure for the fuel cell in compliance.		Description	Inlet protection near equipment storage building in good condition.

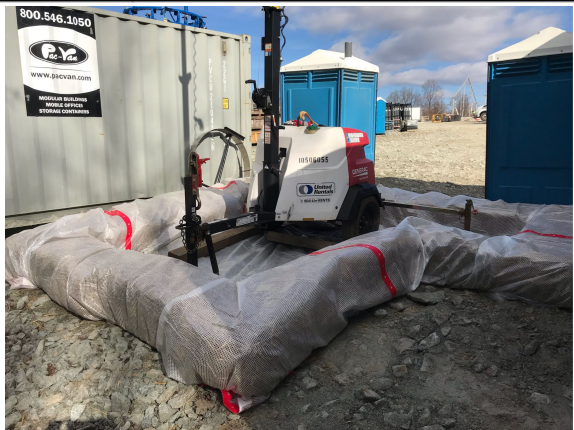
Insert image here		
GPS Location	36.9721596083017, -79.8699945957212		GPS Location		
Description	Secondary containment structure for light plant on north end of gravel yard in compliance.		Description

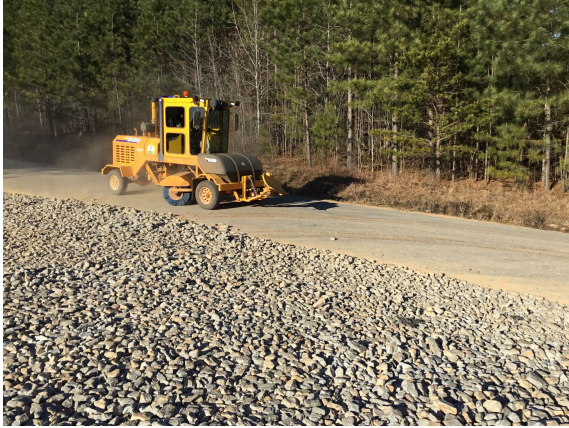
<b>GPS Location</b>	36.8348582927481, -79.3422289845341	<b>GPS Location</b>	36.8348582927481, -79.3422289845341		
<b>Description</b>	Sweeping Transco Road at site entrance	<b>Description</b>	CWO

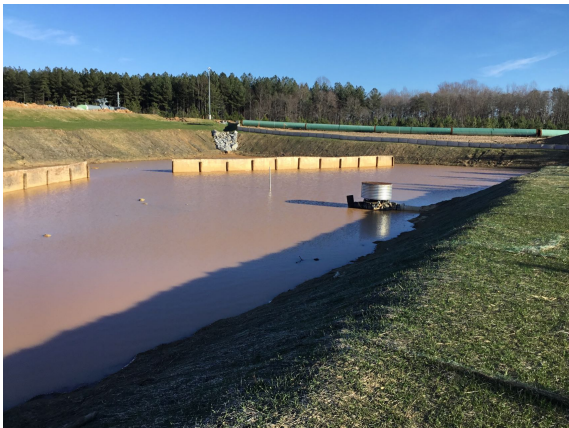
<b>GPS Location</b>	36.8348643277184, -79.3422386237228	<b>GPS Location</b>	36.8348617712379, -79.3422699720406		
<b>Description</b>	Sediment basin and riser	<b>Description</b>	Outfall from riser in sediment basin

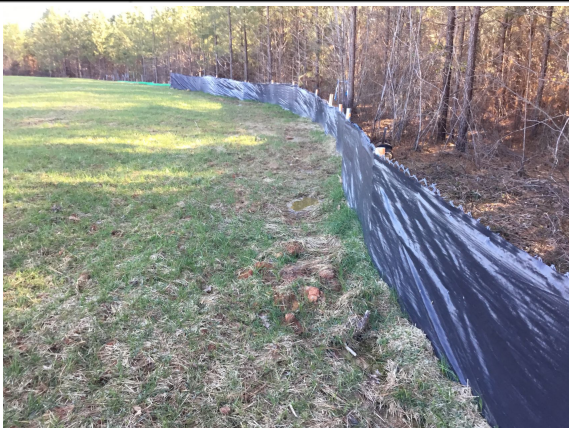
<b>GPS Location</b>	36.8347787103923, -79.342112232912	<b>GPS Location</b>	36.8347784637279, -79.3421123372721		
<b>Description</b>	Super silt fence along west LOD	<b>Description</b>	Channel G from temp pad to trap #1
