# Visual Site Inspection Report

<b>Project Name</b>	H-600 Pipeline Spread I	<b>AFE</b>	124300139	<b>Spread</b>	H-600 Pipeline Spread I
<b>Contractor</b>	Precision			<b>Report #</b>	13991
<b>Inspector</b>	Glenn Mike Renfro			<b>Date/Time</b>	2/13/2019 3:47 PM
<b>Permit #</b>	TBD	<b>Inspection Type</b>	VA SWPP	<b>Station Begin</b>	0000+00
<b>State</b>	VA	<b>Inspection Area</b>	Full	<b>Station End</b>	0000+00
<b>County</b>	Franklin	<b>Ground</b>	Wet	<b>Temperature (°F)</b>	52.00
<b>Municipality</b>	N/A	<b>Weather</b>	Sunny	<b>Rain Gauge (in)</b>	1.00
<b>GPS Location</b>	36.9719325844543, -79.8699444719403			<b>Rain Accumulation Time (days)</b>	6.00

<b>Project Name</b>	Transco Interconnect Station	<b>AFE</b>	124300113	<b>Spread</b>	Transco Interconnect Station
<b>Contractor</b>	MEC			<b>Report #</b>	13969
<b>Inspector</b>	Dave Burkhart			<b>Date/Time</b>	2/13/2019 7:52 AM
<b>Permit #</b>	TBD	<b>Inspection Type</b>	VA SWPP	<b>Station Begin</b>	0+00
<b>State</b>	VA	<b>Inspection Area</b>	Full	<b>Station End</b>	0+00
<b>County</b>	Pittsylvania	<b>Ground</b>	Damp	<b>Temperature (°F)</b>	42.00
<b>Municipality</b>	Chatham	<b>Weather</b>	Sunny	<b>Rain Gauge (in)</b>	0.19
<b>GPS Location</b>

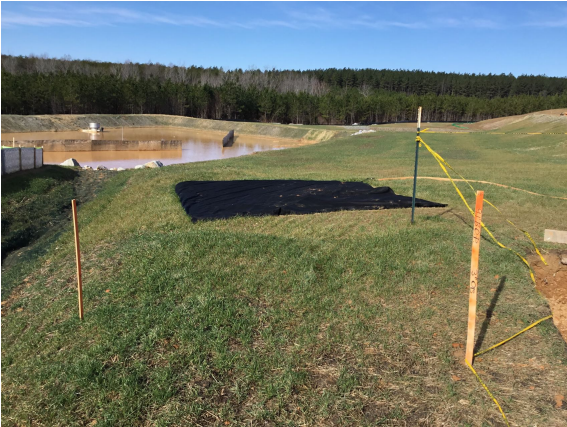
E&S BMPs	Compliance Level	Corrective Action	Corrective Time Frame	Date Repaired
Compost Filter Sock	Acceptable			
Concrete Washout	Acceptable			
Other	Problem Area	Riser in sed basin shifted		
Other	Acceptable			
Pumped Water Filter Bag	Acceptable			
Rock Construction Entrance	Acceptable			
Temporary Diversion Berm	Acceptable			
Vegetative Stabilization (Temporary)	Acceptable			
Silt Fence (Reinforced Filter Fabric Fence)	Acceptable

<b>GPS Location</b>	36.8348725419835, -79.3421670422697	<b>GPS Location</b>	36.8348725419835, -79.3421670422697		
<b>Description</b>	Sediment basin	<b>Description</b>	Riser in sed basin
