Visual Site Inspection Report

Project Name	H-600 Pipeline Spread I	AFE	124300139	Spread	H-600 Pipeline Spread I
Contractor	Precision			Report #	14169
Inspector	Glenn Mike Renfro			Date/Time	2/19/2019 12:32 PM
Permit #	TBD	Inspection Type	VA SWPP	Station Begin	0000+00
State	VA	Inspection Area	Full	Station End	0000+00
County	Franklin	Ground	Damp	Temperature (°F)	47.00
Municipality	N/A	Weather	Cloudy	Rain Gauge (in)	1.20
GPS Location	36.971771971142, -79.8700426839329			Rain Accumulation Time (days)	6.00

Project Name	H-600 Pipeline Spread I	AFE	124300139	Spread	H-600 Pipeline Spread I
Contractor	Precision			Report #	14161
Inspector	Casey McGaha			Date/Time	2/19/2019 5:00 PM
Permit #	TBD	Inspection Type	VA SWPP	Station Begin	13670+00
State	VA	Inspection Area	Full	Station End	16027+46
County	Pittsylvania	Ground	Wet	Temperature (°F)	38.00
Municipality	Chatham	Weather	Cloudy	Rain Gauge (in)	0.00
GPS Location	36.9105211459444, -79.4771912880982			Rain Accumulation Time (days)	0.00

Project Name	Transco Interconnect Station		AFE	124300113	Spread	Transco Interconnect Station	
Contractor	MEC				Report #	14195	
Inspector	Dave Burkhart				Date/Time	2/19/2019 9:54 AM	
Permit #	TBD	Inspection T

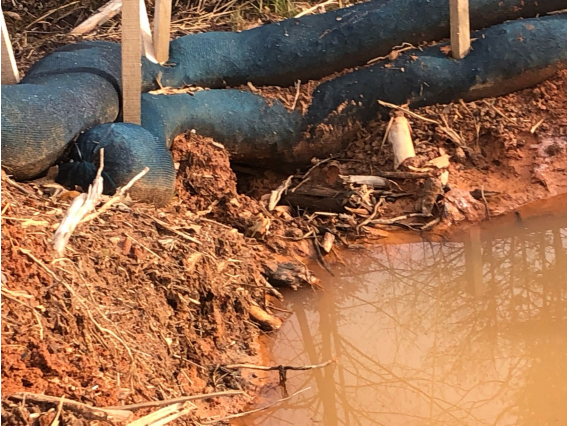
GPS Location	36.9104881631554, -79.4773194473977	GPS Location	36.9104881631554, -79.4773194473977		
Description	CFS undermined at sump sta 15436+50	Description	Maintenance required at CFS sta 15460+10

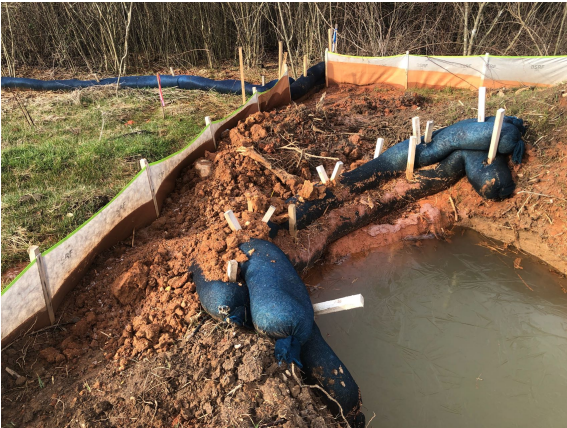
GPS Location	36.9106658595027, -79.477219786569	GPS Location	36.9717928026777, -79.8700894589974		
Description	Remove excess silt from CFS and P1 fence sta 15435+70	Description	SSF is undermined and damaged sta 15456+00

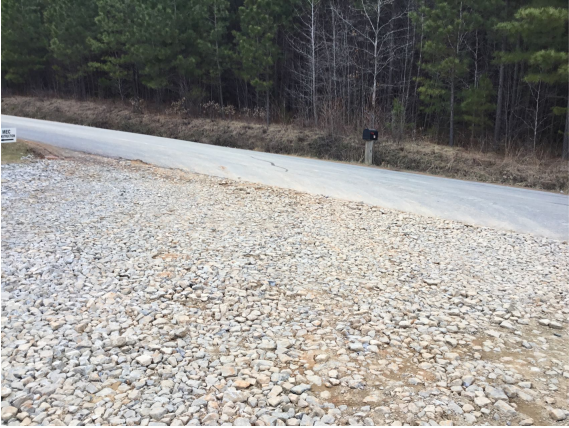
GPS Location	36.8347592617064, -79.3420441984653	GPS Location	36.8347813887865, -79.3423144799465		
Description	RCE	Description	CWO

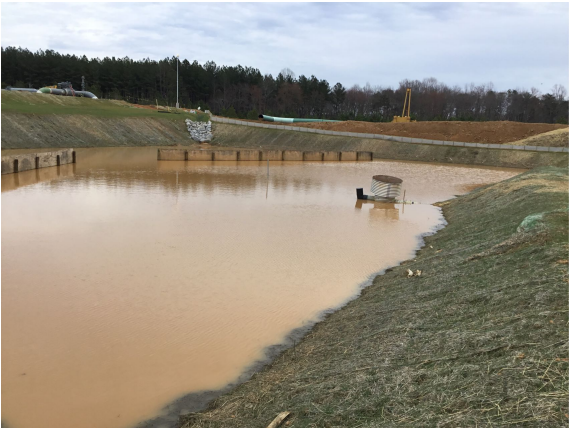
GPS Location	36.8347769882873, -79.3421675451839	GPS Location	36.8347769882873, -79.3421675451839		
Description	Sed basin	Description	Riser tilted in sed basin.

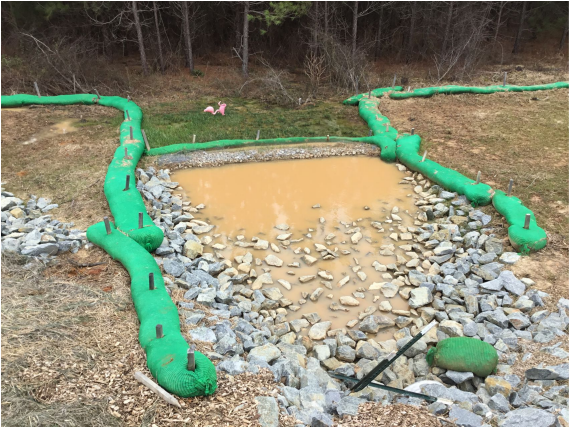
GPS Location	36.8347769882873, -79.3421675451839	GPS Location	36.8347479869023, -79.3422215246403		
Description	Sed basin outfall structure	Description	SSF and rock filters along west LOD
