# Visual Site Inspection Report

<b>Project Name</b>	H-600 Pipeline Spread I	<b>AFE</b>	124300139	<b>Spread</b>	H-600 Pipeline Spread I
<b>Contractor</b>	Precision			<b>Report #</b>	14357
<b>Inspector</b>	Glenn Mike Renfro			<b>Date/Time</b>	2/25/2019 1:10 PM
<b>Permit #</b>	TBD	<b>Inspection Type</b>	VA SWPP	<b>Station Begin</b>	0000+00
<b>State</b>	VA	<b>Inspection Area</b>	Full	<b>Station End</b>	0000+00
<b>County</b>	Franklin	<b>Ground</b>	Dry	<b>Temperature (°F)</b>	49.00
<b>Municipality</b>	N/A	<b>Weather</b>	Sunny	<b>Rain Gauge (in)</b>	5.00
<b>GPS Location</b>	36.9718590413854, -79.8701814294273			<b>Rain Accumulation Time (days)</b>	6.00

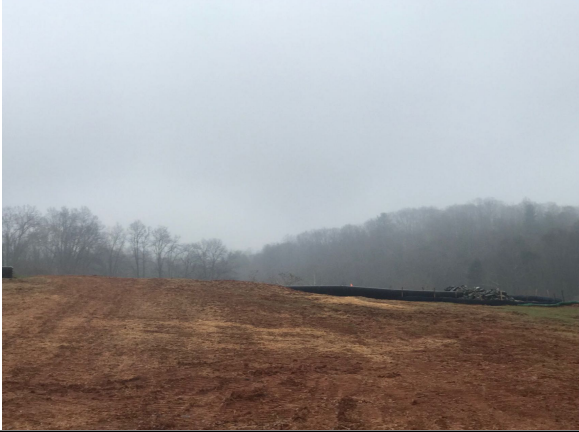
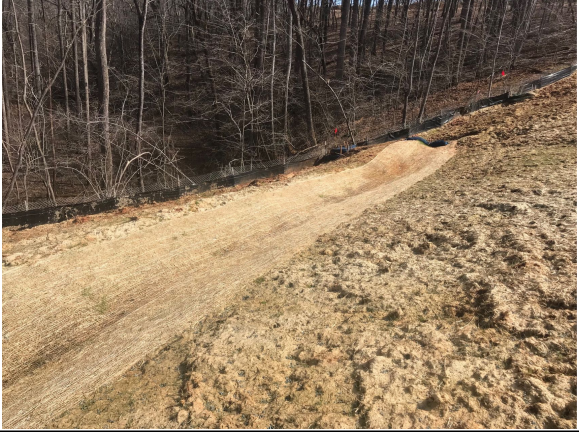
<b>GPS Location</b>	36.97	<b>Field Station#</b>	13970+15	<b>GPS Location</b>	36.97
<b>Description</b>	CWD functioning properly.		<b>Description</b>	Curlex installed along breaker.

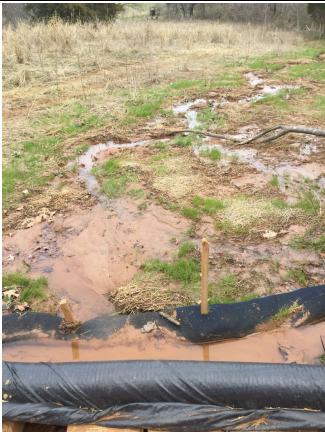
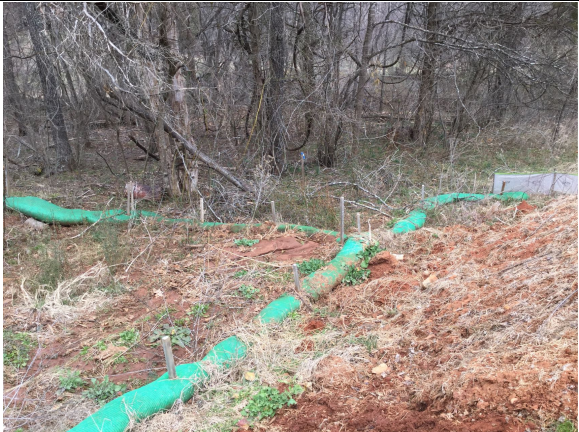
<b>GPS Location</b>	36.96	<b>Field Station#</b>	13770+69	<b>GPS Location</b>	36.96
<b>Description</b>	Maintenance required on CFS		<b>Description</b>	Maintenance required on CFS.

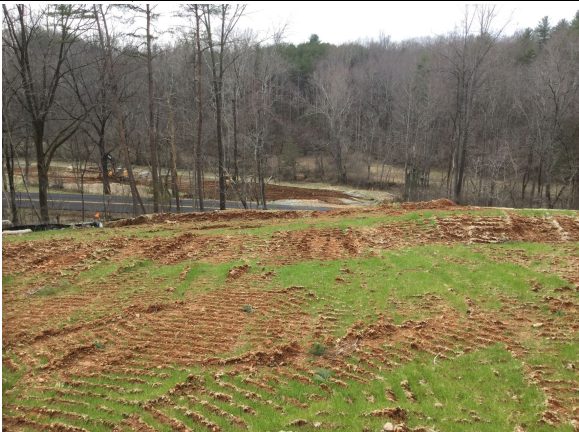
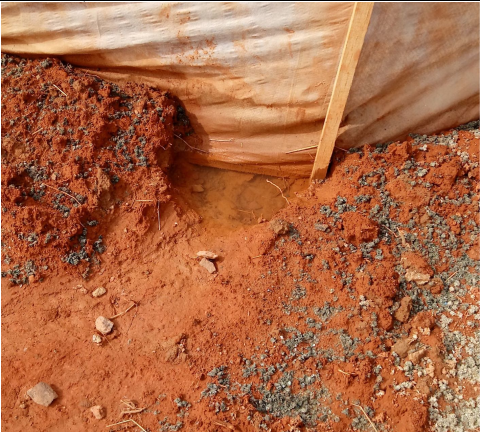
<b>GPS Location</b>	36.96	<b>Field Station#</b>	13747+00	<b>GPS Location</b>	36.96
<b>Description</b>	Build breaker to spec.		<b>Description</b>	Maintenance required at P1 fence.
