Visual Site Inspection Report

Project Name	H-600 Pipeline Spread I	AFE	124300139	Spread	H-600 Pipeline Spread I
Contractor	Precision			Report #	15472
Inspector	Glenn Mike Renfro			Date/Time	4/4/2019 3:06 PM
Permit #	TBD	Inspection Type	VA SWPP	Station Begin	+0
State	VA	Inspection Area	Full	Station End	+0
County	Franklin	Ground	Dry	Temperature (°F)	63.00
Municipality	N/A	Weather	Sunny	Rain Gauge (in)	0.00
				Rain Accumulation Time (days)	6.00

Project Name	H-600 Pipeline Spread I	AFE	124300139	Spread	H-600 Pipeline Spread I
Contractor	Precision			Report #	15538
Inspector	Casey McGaha			Date/Time	4/4/2019 5:00 PM
Permit #	TBD	Inspection Type	VA SWPP	Station Begin	13670+00
State	VA	Inspection Area	Full	Station End	16027+46
County	Franklin/Pittsylvania	Ground	Dry	Temperature (°F)	73.00
Municipality	Chatham	Weather	Sunny	Rain Gauge (in)	0.00
				Rain Accumulation Time (days)	0.00

Project Name	Transco Interconnect Station		AFE	124300113	Spread	Transco Interconnect Station	
Contractor	Kanahwa				Report #	15457	
Inspector	Dave Burkhart				Date/Time	4/4/2019 8:46 AM	
Permit #	TBD	Inspection Type	VA SWPP		Station Begin	+1	
State	VA	Inspection Area	Full		Station End	+1	
County	Pittsylvania

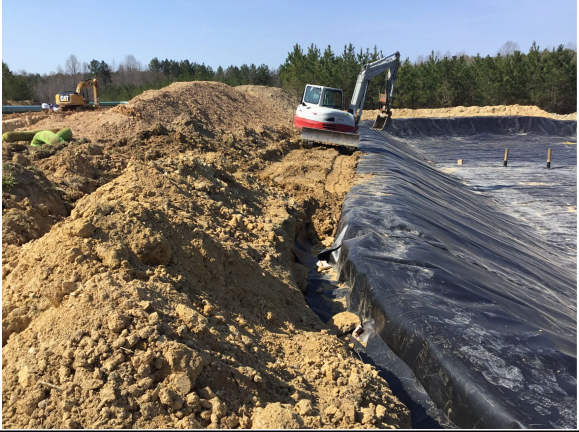
GPS Location 36.83		Field Station# +1		GPS Location 36.83	
Description		Proper trench and anchoring of liner		Description	
				Backfilling liner trench.

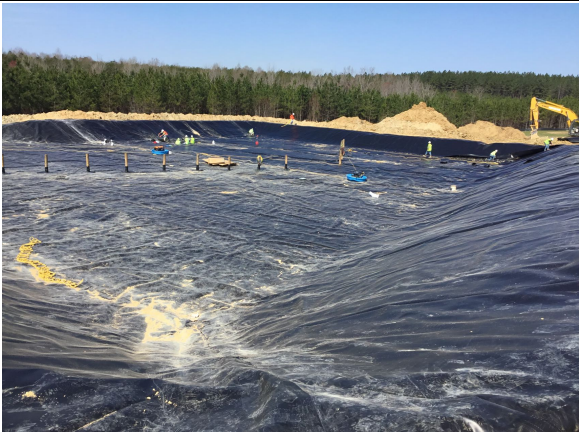
GPS Location 36.83		Field Station# +1		GPS Location 36.83	
Description		Finalizing liner install in sed basin		Description	
				Applied ECM to banks of temp pad	
Insert image here			Insert image here		
GPS Location		Field Station#		GPS Location	
Description				Description
