Visual Site Inspection Report

Project Name	H-600 Pipeline Spread G	AFE	124300137	Spread	H-600 Pipeline Spread G
Contractor	Precision			Report #	15871
Inspector	Garrett Barclay			Date/Time	4/15/2019 9:31 AM
Permit #	TBD	Inspection Type	VA SWPP	Station Begin	11023+00
State	VA	Inspection Area	Partial	Station End	11130+00
County	Giles	Ground	Muddy	Temperature (°F)	42.00
Municipality	N/A	Weather	Sunny	Rain Gauge (in)	2.20
				Rain Accumulation Time (days)	1.00

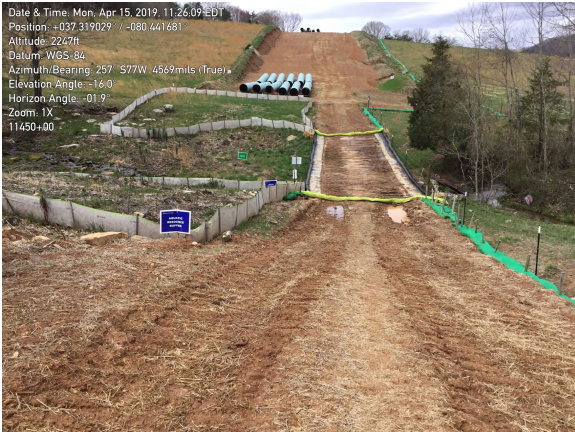
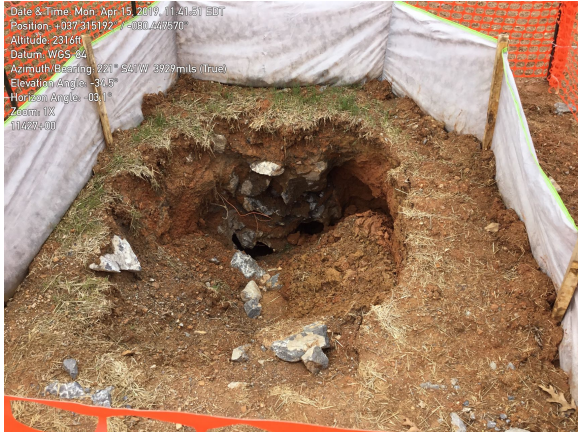
GPS Location	37.33	Field Station#	11450+00	GPS Location	37.33	Field Station#	11427+00
Description	ECD around stream crossing in good condition			Description	Sink from blast area

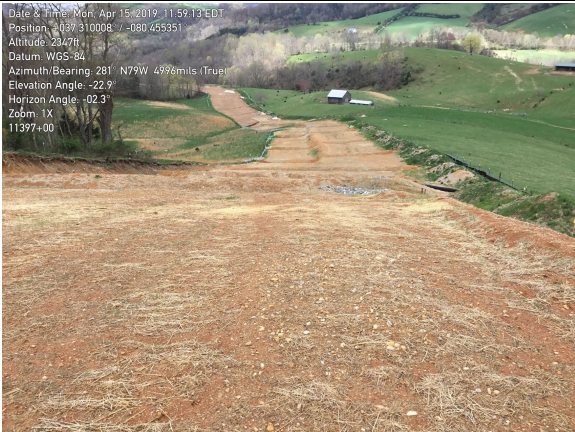
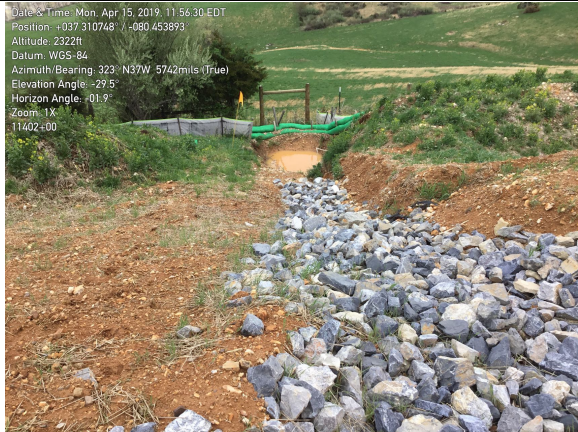
GPS Location	37.33	Field Station#	11397+00	GPS Location	37.33	Field Station#	11402+00
Description	Row temporary stabilized			Description	End treatment on water breaker

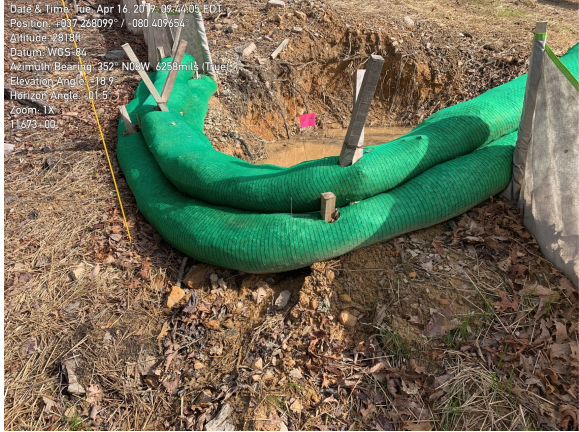
<p>Date & Time: Tue, Apr 16, 2019, 09:44:05 EDT Position: +037 301845° / -080 409654° Altitude: 2681ft Datum: WGS-84 Azimuth/Bearing: 152° N48W 4258mils (True) Elevation Angle: +18.7° Horizon Angle: -01.5° Zoom: 1X 11673+00</p>				
GPS Location	37.31	Field Station#	11670+00	GPS Location	37.31	Field Station#	11673+00
Description	See photo for GPS location. ROW stabilized with seed and mulch. Water bars in place.			Description	See photo for GPS location. End treatment undermined.

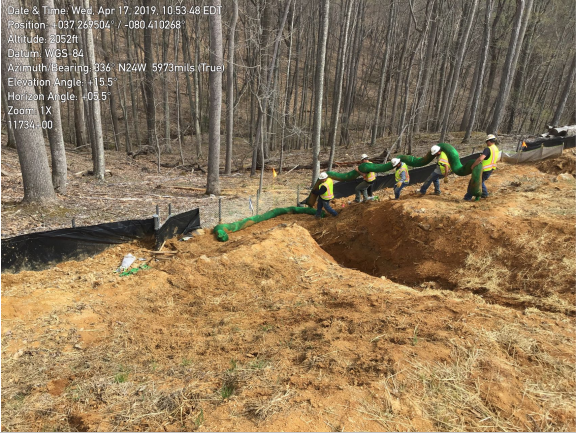
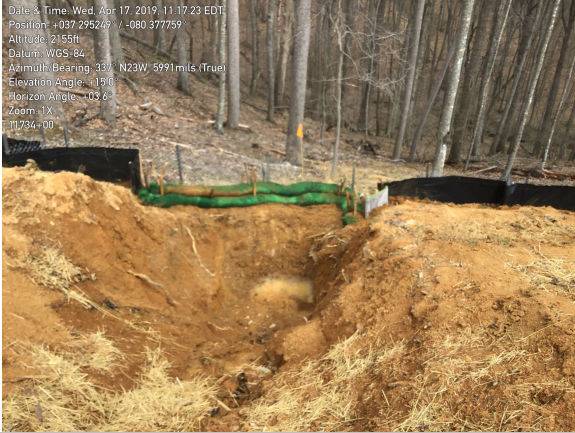
GPS Location	37.31	Field Station#	11734+00		
Description	See photo for GPS location. Environmental crew replacing priority one silt fence end treatment with triple stack 12" CFS.				
Insert image here					
GPS Location	37.31	Field Station#	11734+00		
Description	See photo for GPS location. End treatment upgraded and replace.				
Insert image here					
GPS Location		Field Station#

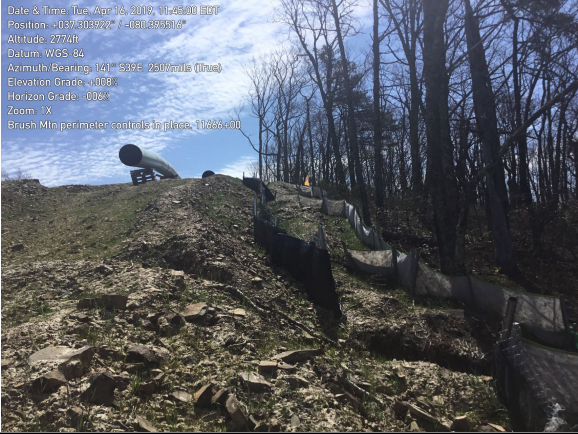
<p>Date & Time: Tue, Apr 16, 2019, 11:45:31 EDT Position: +037.304271° / -080.354215° Altitude: 3542ft Datum: WGS-84 Azimuth/Bearing: 170° S10E 302mils (True) Elevation Grade: +015% Horizon Grade: -007% Zoom: 1X Brush Mtn end treatments functional 11662+00</p>  		<p>GPS Location 37.13 Field Station# 11666+00</p> <p>GPS Location 37.13 Field Station# 11662+00</p>	
Description		Correct coordinates on photo. Perimeter controls functional.		Description	
<p>Date & Time: Tue, Apr 16, 2019, 12:13:46 EDT Position: +037.312037° / -080.397432° Altitude: 2048ft Datum: WGS-84 Azimuth/Bearing: 331° N29W 588mils (True) Elevation Grade: -023% Horizon Grade: +006% Zoom: 1X Brush Mtn 11634+50 perimeter controls in place</p>

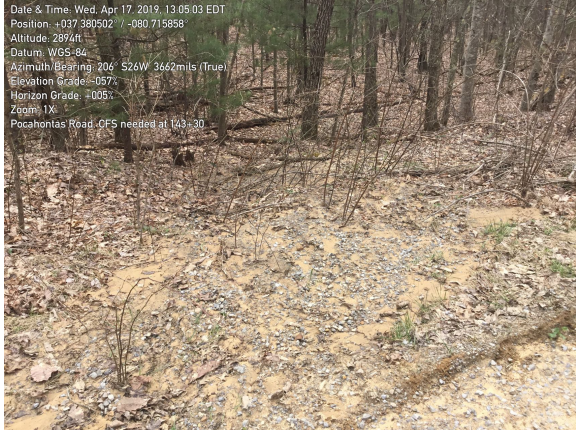
GPS Location	37.38	Field Station#	142+96	GPS Location	37.31	Field Station#	143+30
Description	Correct coordinates on photo. Sediment has migrated beyond the LOD. A PAR will be issued.			Description	Correct coordinates on photo. Sediment has migrated beyond the LOD. A PAR will be issued.		
<p>Date & Time: Wed, Apr 17, 2019, 10:11:20 EDT Position: +037.391332 / -080.685297 Altitude: 2887ft Datum: WGS-84 Azimuth Bearing: 056° N56E 056/mils (True) Elevation Grade: +030 Horizon Grade: +003 Zoom: 1X Pocahontas Road, CFS needed at 299+00</p>  		<p>Date & Time: Wed, Apr 17, 2019, 11:13:06 EDT Position: +037.390764 / -080.686020 Altitude: 2887ft Datum: WGS-84 Azimuth Bearing: 032° N32E 056/mils (True) Elevation Grade: +016 Horizon Grade: +001 Zoom: 1X Pocahontas Road, 298+00 Check dam replaced</p>

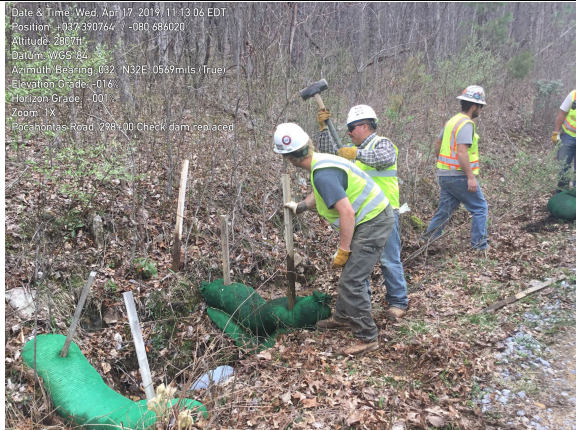
GPS Location	37.31	Field Station#	299+00	GPS Location	37.31	Field Station#	298+00
Description	Correct coordinates on photo. Check dam replacement in progress.			Description	Correct coordinates on photo. Check dam replacement in progress.		
<p>Date & Time: Wed, Apr 17, 2019, 11:28:01 EDT Position: +037.387947 / -080.687832 Altitude: 2840ft Datum: WGS-84 Azimuth Bearing: 230° S50W 408/mils (True) Elevation Grade: +027 Horizon Grade: +007 Zoom: 1X Pocahontas Road, 291+50 CFS maintenance</p>  		<p>Date & Time: Wed, Apr 17, 2019, 12:11:33 EDT Position: +037.387607 / -080.707701 Altitude: 2855ft Datum: WGS-84 Azimuth Bearing: 052° N52E 0924/mils (True) Elevation Grade: +032 Horizon Grade: +000 Zoom: 1X Pocahontas Road, 172+20 End treatment maintenance</p>  					
GPS Location	37.31	Field Station#	291+50	GPS Location	37.31	Field Station#	172+20
Description	Correct coordinates on photo.			Description	Correct coordinates on photo. End treatment maintenance and/or replacement in progress.

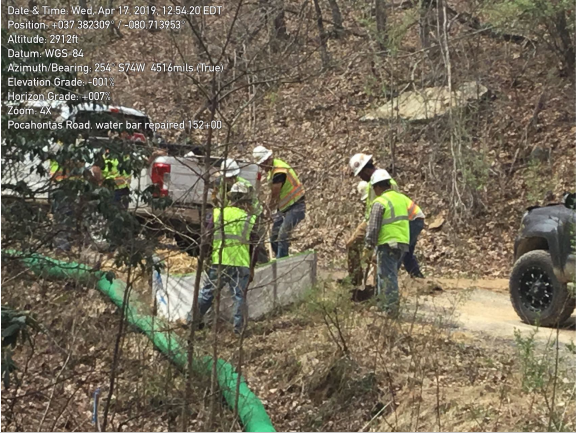
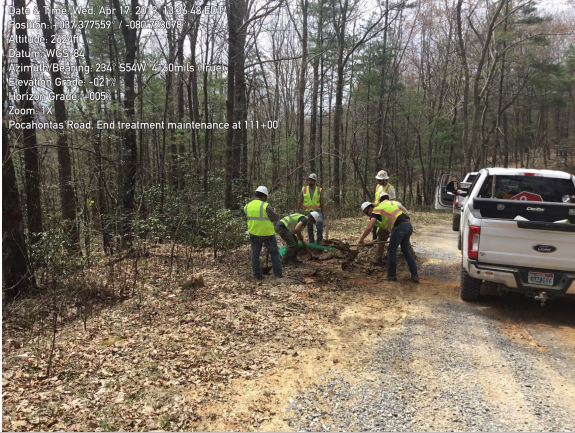
GPS Location	37.31	Field Station#	152+00	GPS Location	37.31	Field Station#	111+00
Description	Correct coordinates on photo. End treatment maintenance and/or replacement in progress.			Description	Correct coordinates on photo. End treatment maintenance and/or replacement in progress.

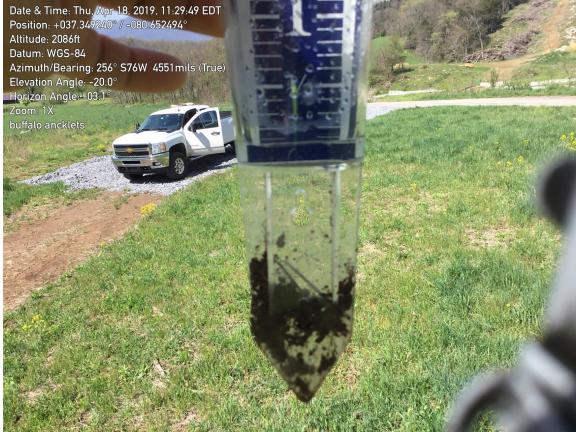
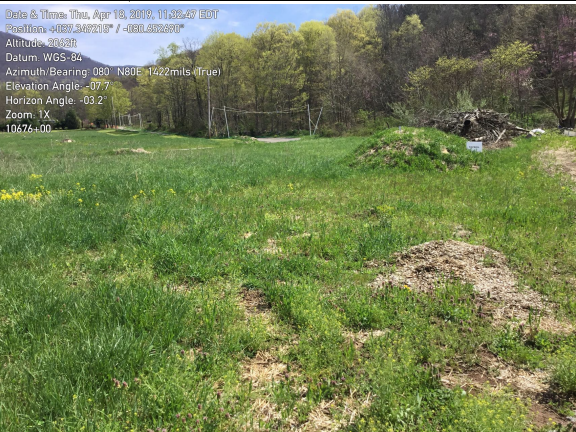
<p>GPS Location 37.33 Field Station# 10677+00</p> <p>Description Stream ECDs in good condition</p>

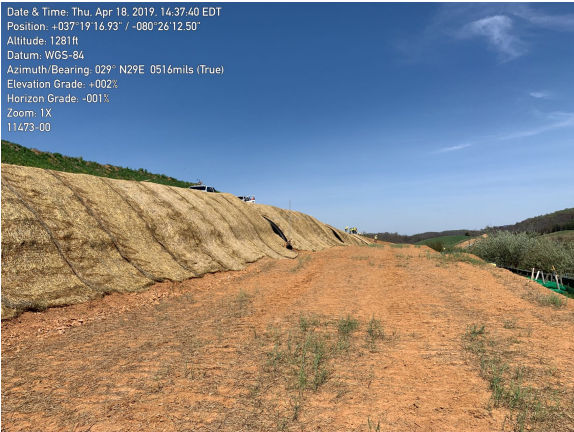
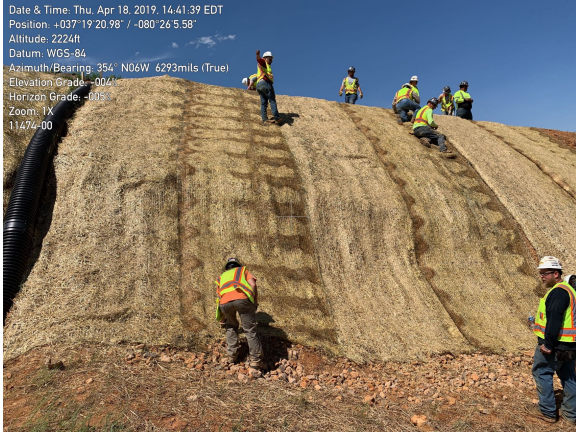
GPS Location	37.32	Field Station#	11473+00	GPS Location	37.32	Field Station#	11474+00
Description	Crew installed curlex			Description	Crew installing curlex
